Re: **89447 / Searchlight**
12.5 Miles West of Searchlight
Searchlight, Nevada 89046
EBI Project #61073335

As requested by *American Tower Corporation*, EBI Consulting (EBI) performed limited sampling of suspect asbestos containing materials (ACM), lead-containing paint (LCP) and a visual mold inspection at 89447 / Searchlight (the Subject Property).

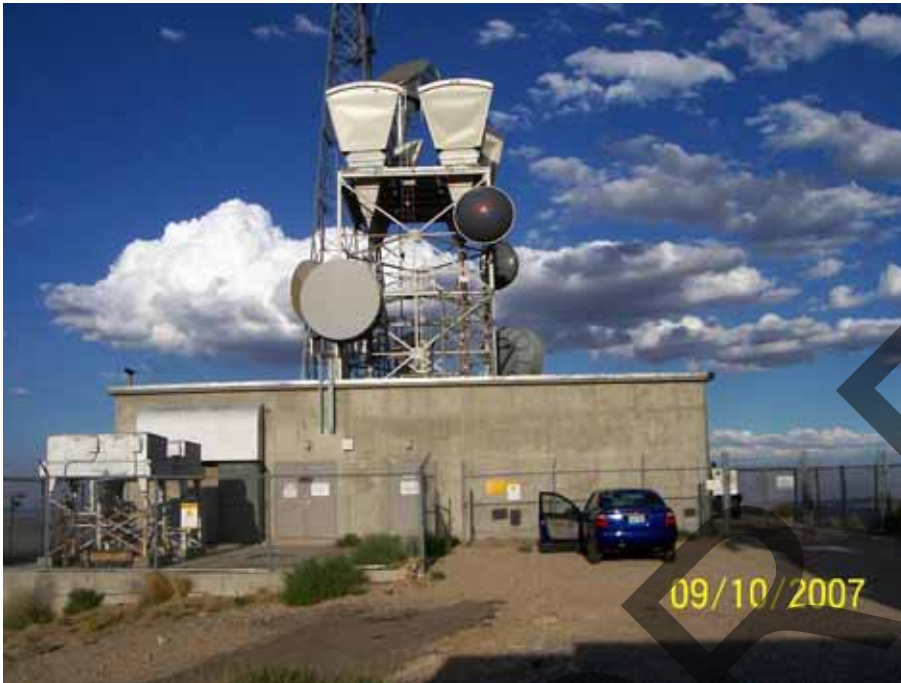
1. American Tower Corporation site and equipment building.

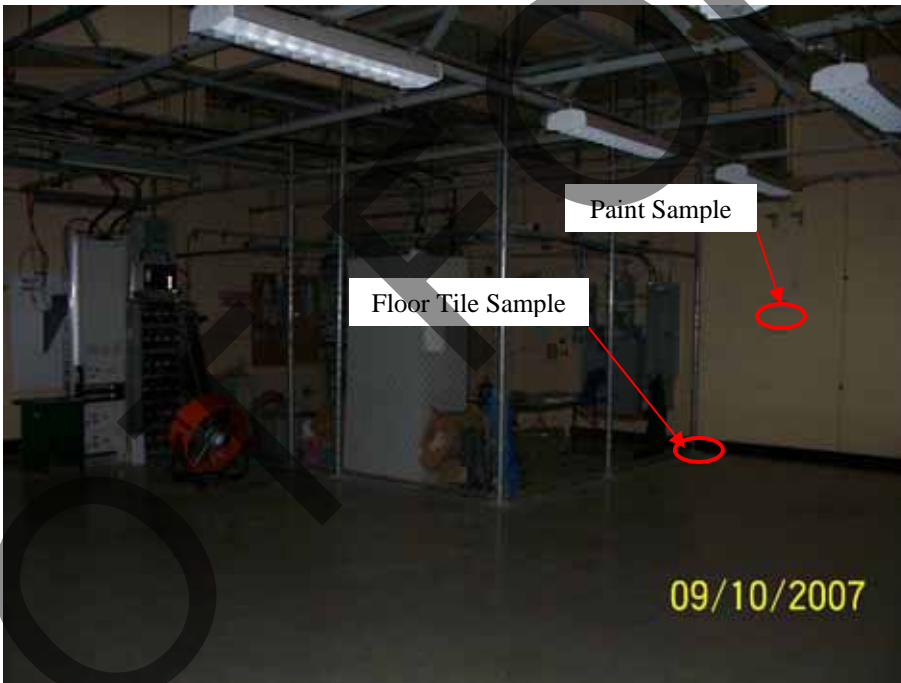
2. View of the interior of the Subject Property building from the entrance.

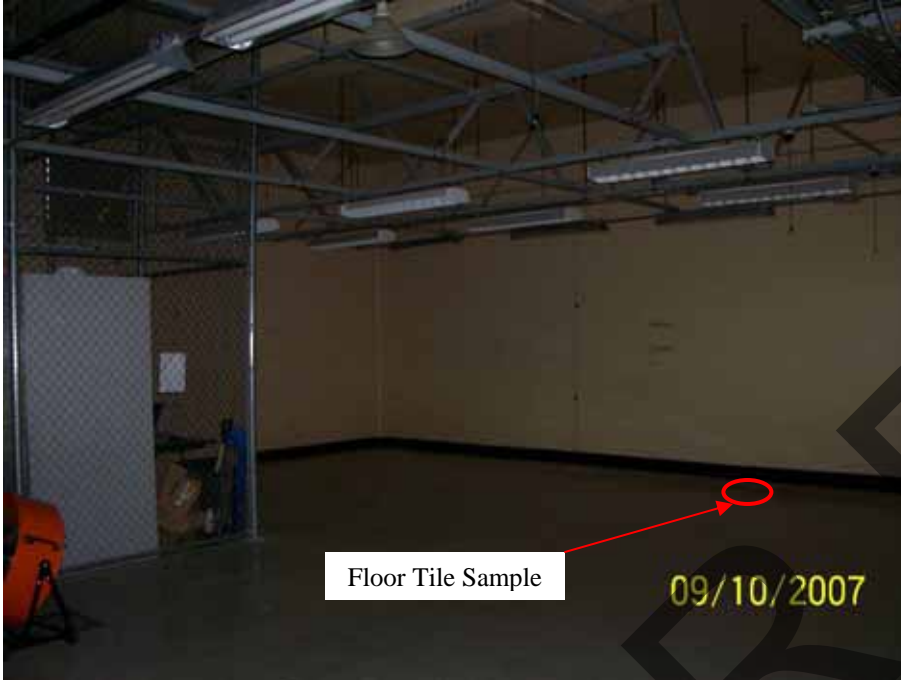
3. View of the interior of the Subject Property building from the northeast corner.

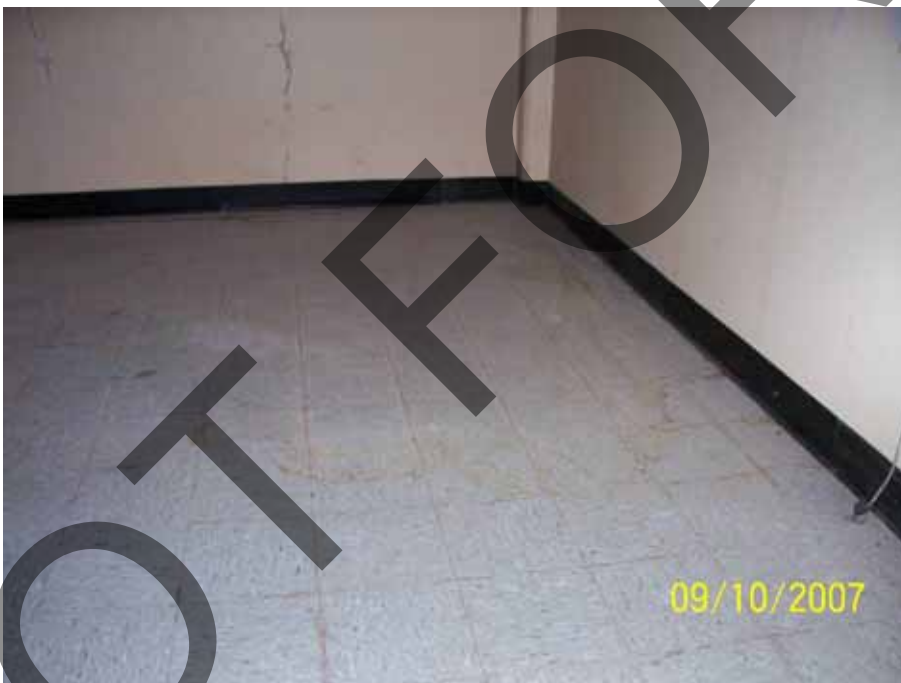
Representative observations revealed obvious visual (no olfactory) indications of the presence of inactive moisture in the form of water stains and peeling interior paint in the southwest portion

of the Subject Property building. Based on the conditions as observed at the time of the inspection, mold does appear to be a concern at the Subject Property.

4. Water stained floor tile in the southwest portion of the Subject Property building.

EBI recommends that all water or mold impacted materials that may be impacted during future construction/installation activities be removed and replaced by a licensed contractor.

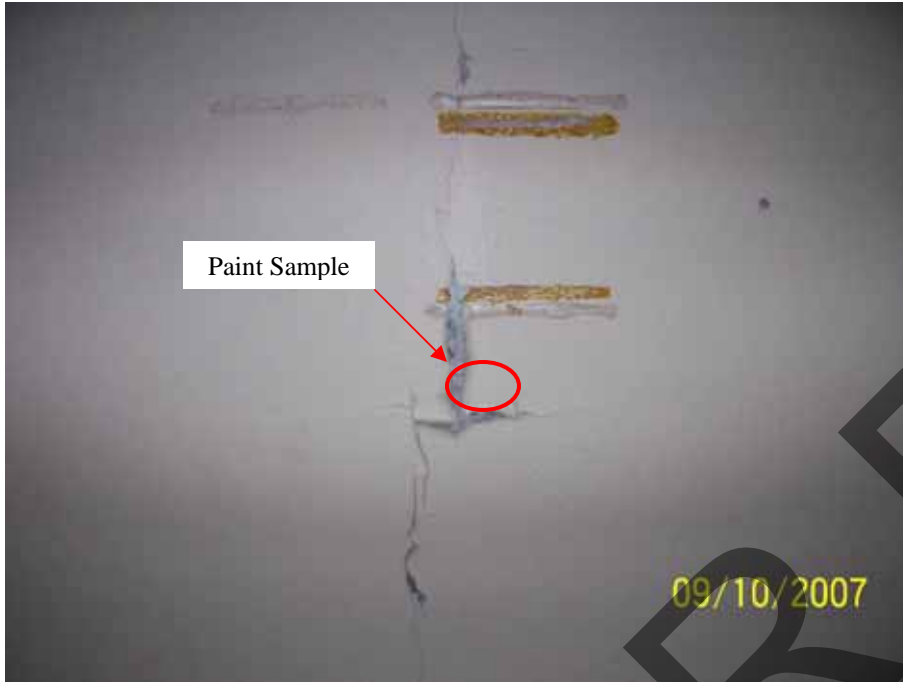
5. Peeling paint along the western interior wall.

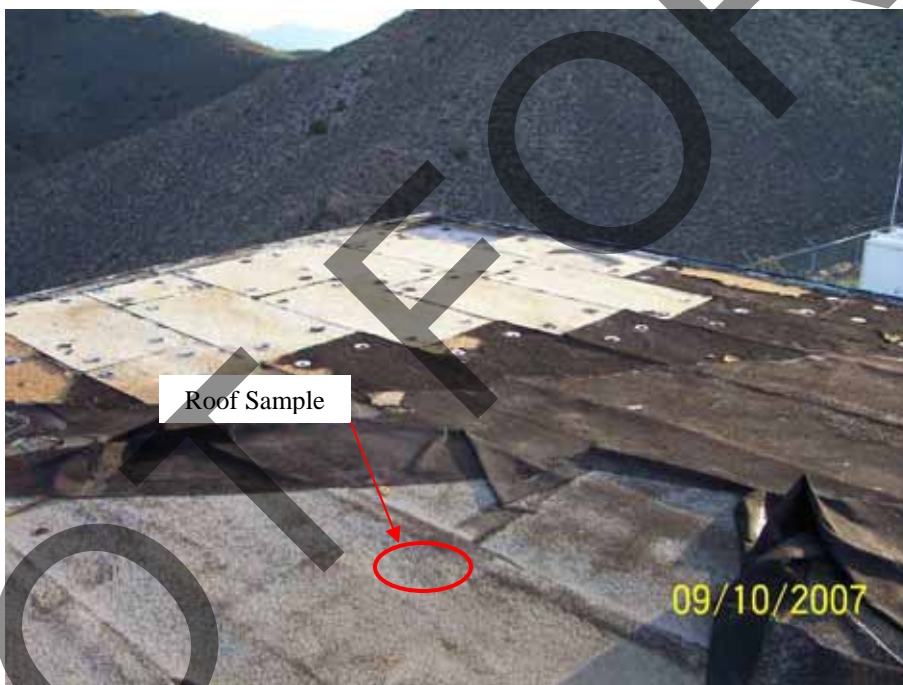
6. View of the damaged roof in the southwest portion of the Subject Property building roof.

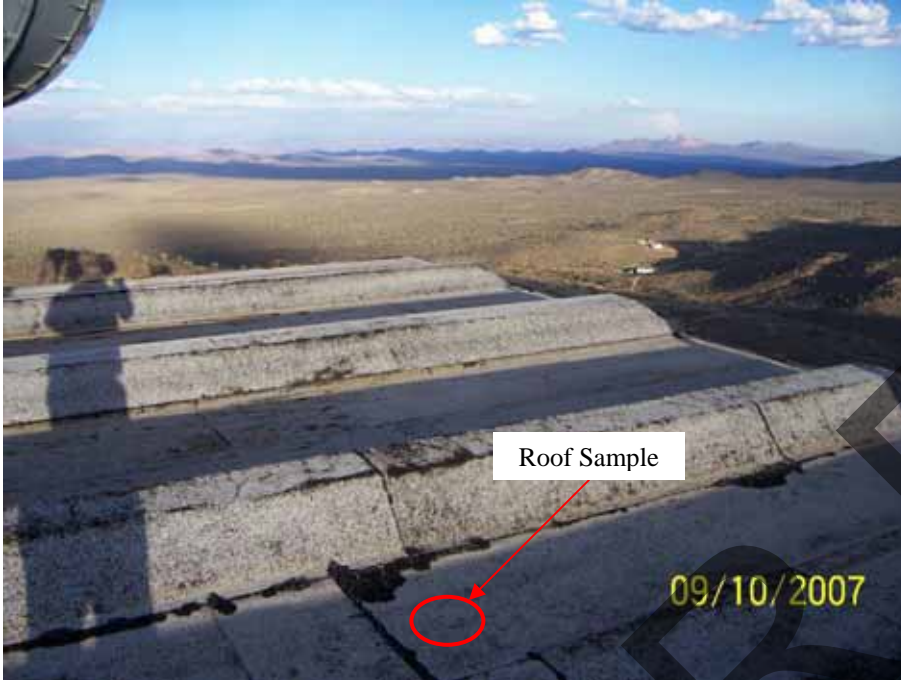
7. View of the Subject Property building roof.

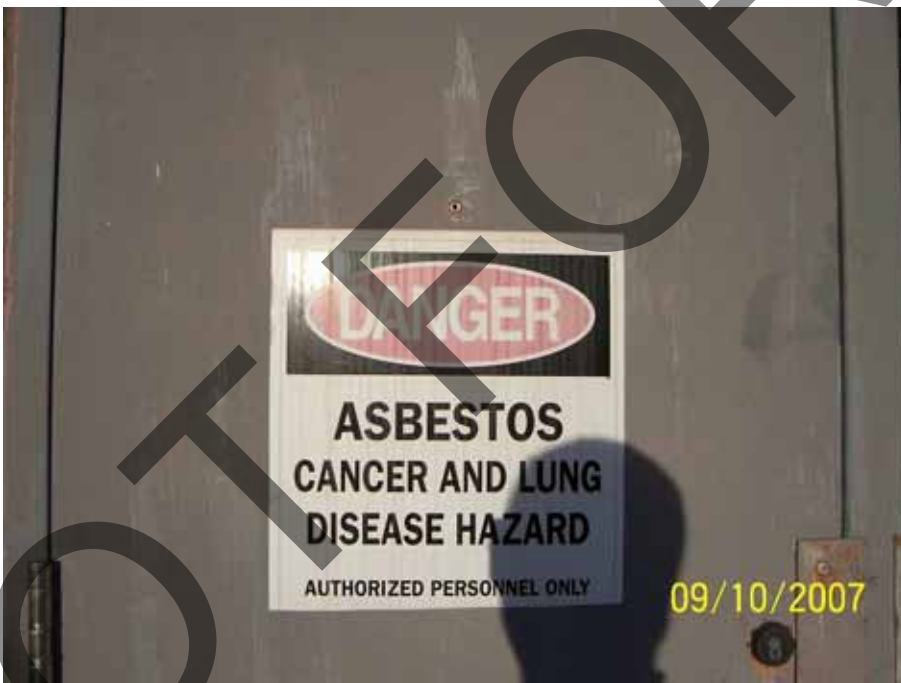
8. Asbestos sign on the Subject Property building.
