TANK 2A INSPECTION REPORT

CSA 64 RECOATING TANKS 2A AND 2B PROJECT

**COUNTY SERVICE AREA 64
HESPERIA, CALIFORNIA**

Inspection Report for San Bernardino County

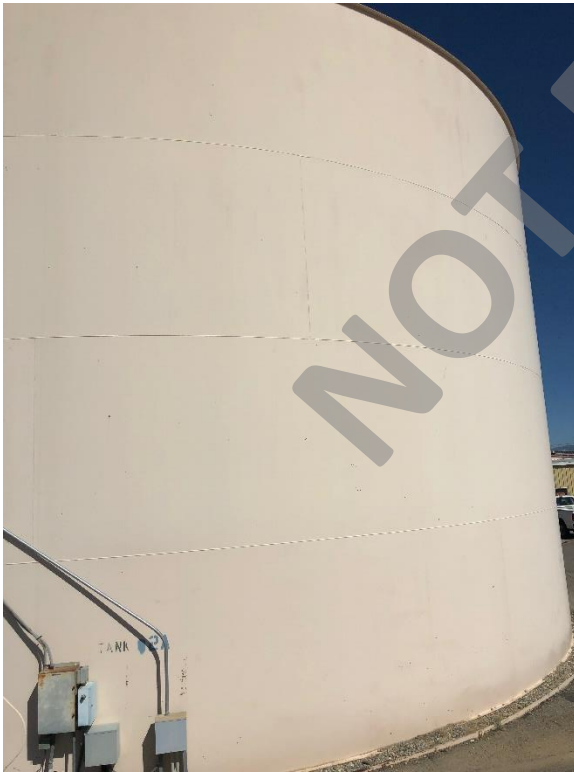
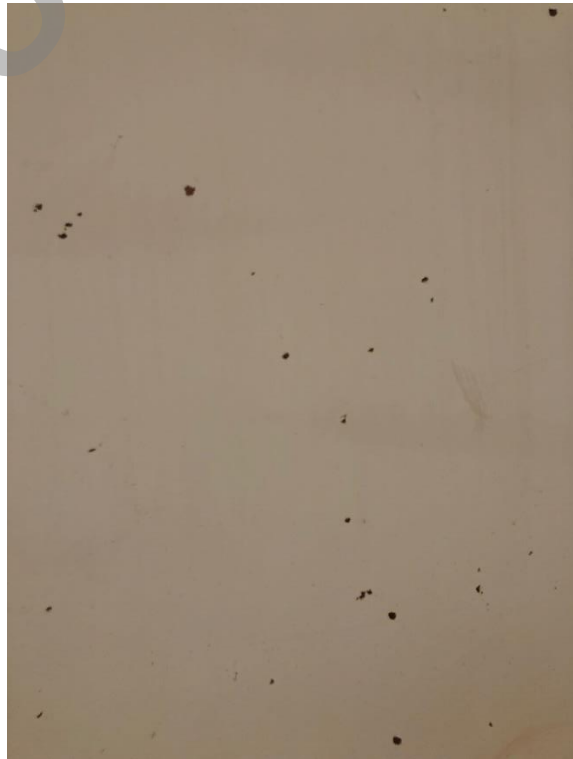
Wall Panels

Coating Conditions Overall: Good.

Percent of De-lamination: 2%.

Percent of USC: 2%.

Summary: The exterior wall panels have good coating conditions overall. De-lamination and surface corrosion noted.

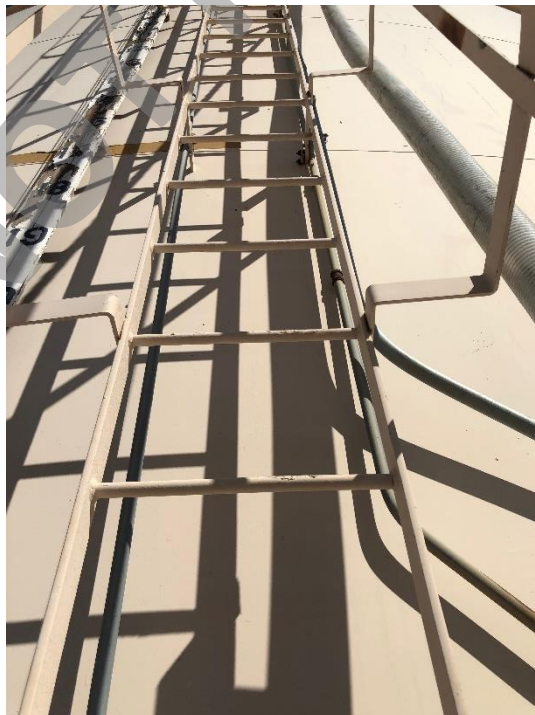
Ladder

Coating Conditions Overall: Good/ Fair.

Percent of De-lamination: 3%.

Percent of USC: 3%.

Summary: The exterior ladder has good to fair coating conditions overall. De-lamination and surface corrosion present. The ladder rungs are $\frac{3}{4}$ " in diameter. The ladder width is at least 16" and the distance between the ladder and tank is 9.75".

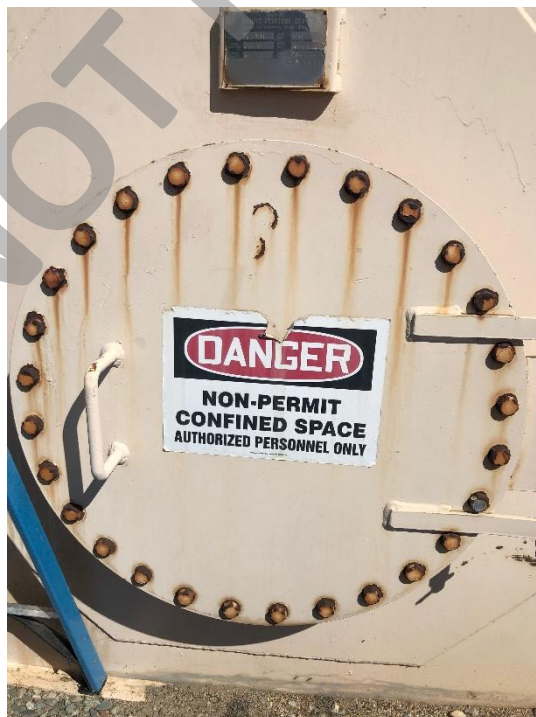
Manway (s)

Coating Conditions Overall: Fair.

Percent of De-lamination: 1%.

Percent of USC: 5%.

Summary: The manway has fair coating conditions overall. Minor de-lamination occurring. Surface corrosion noted.

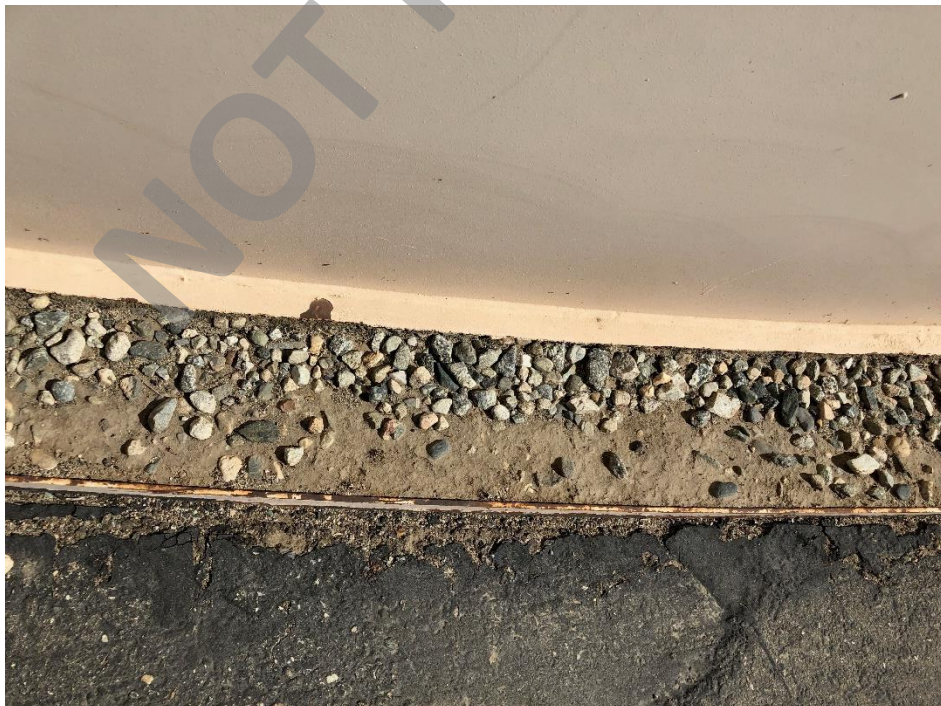
Foundation

Summary: The foundation consists of a metal foundation ring with gravel fill.

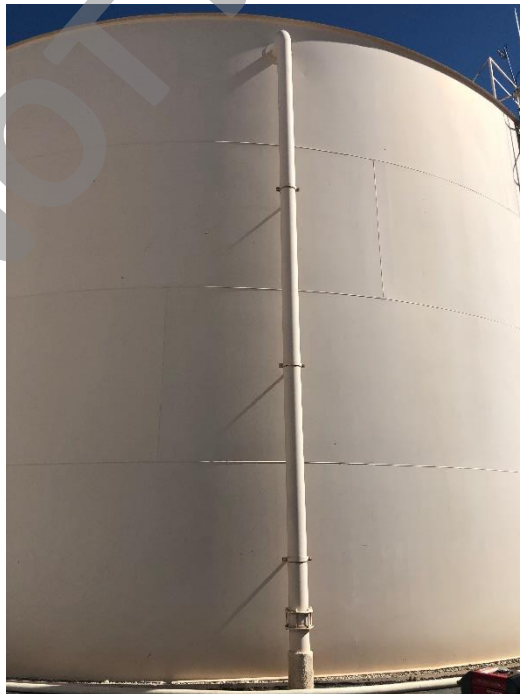
Overflow

Coating Conditions Overall: Good.

Percent of De-lamination: 1%.

Percent of USC: 1%.

Summary: The overflow has good coating conditions overall. Minor de-lamination and surface corrosion noted.

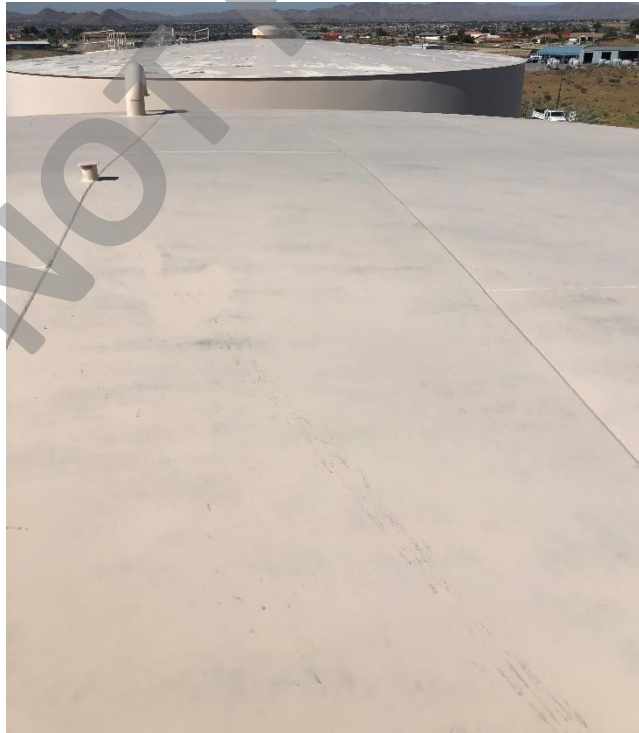
Roof Panels

Coating Conditions Overall: Good.

Percent of De-lamination: 1%.

Percent of USC: 1%.

Summary: The roof panels have good coating conditions overall. Minor de-lamination and surface corrosion present.

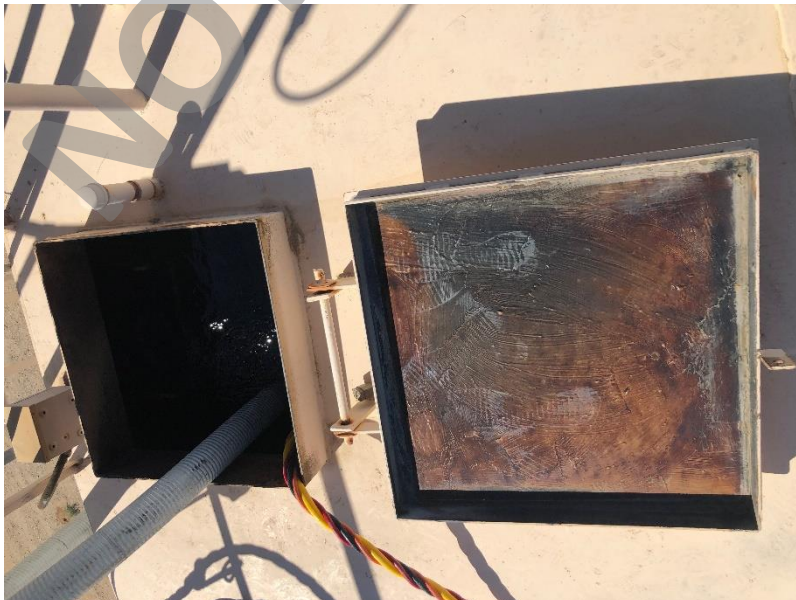
Hatch

Coating Conditions Overall: Fair.

Percent of De-lamination: 1%.

Percent of USC: 4%.

Summary: The hatch has fair coating conditions overall. Minor de-lamination occurring. Surface corrosion noted. Recommend installing a gasket to the hatch to prevent bugs/insects from entering tank.

-Recommend installing a hatch gasket to prevent bugs/insects from entering tank.

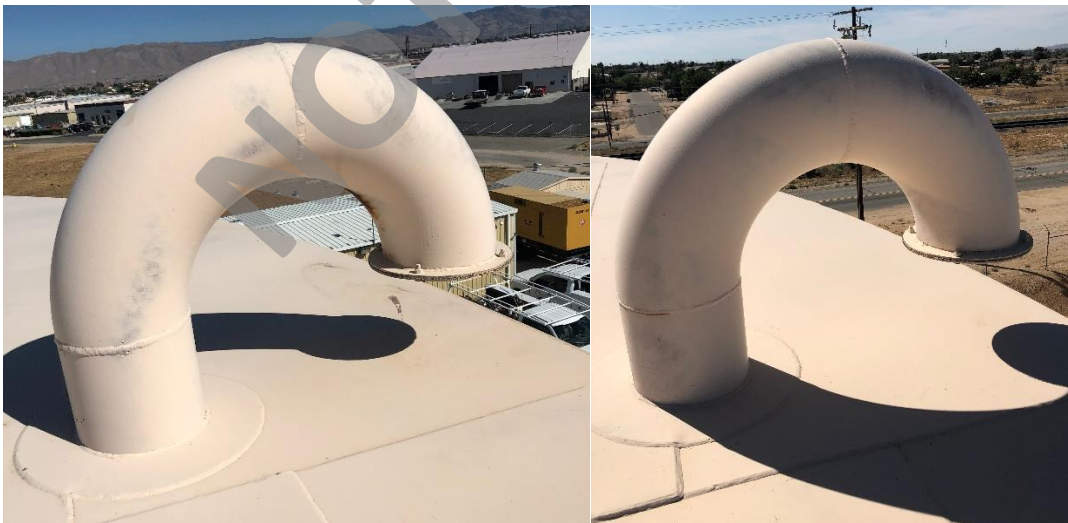
Vents

Coating Conditions Overall: Good/ Fair.

Percent of USC: 1%/ 5%.

Summary: The one vent has good coating conditions with minor de-lamination and surface corrosion. The other vent has fair coating due to surface corrosion and minor de-lamination. Fine mesh screens are present and intact.

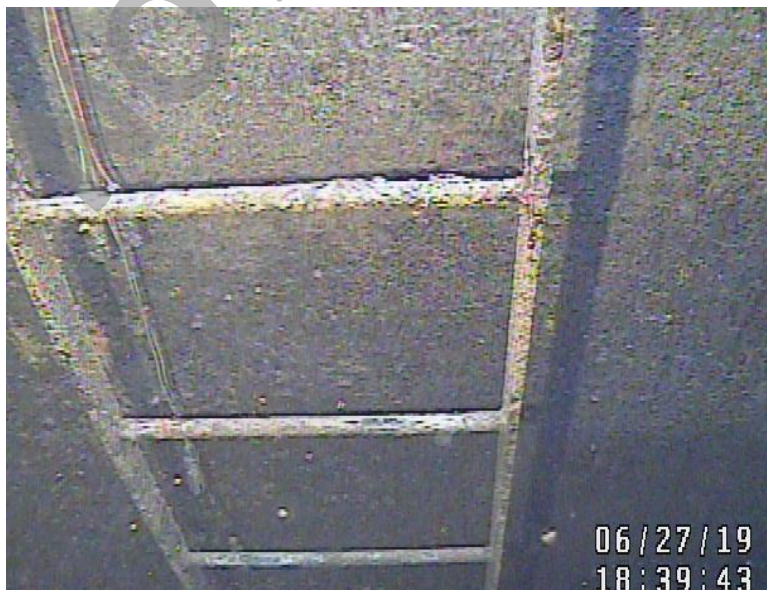
Ladder

Coating Conditions Overall: Poor.

Percent of USC: 50%.

Percent of De-alloying: 2-3%.

Summary: The interior ladder has poor coating conditions overall. Heavy surface corrosion noted. De-alloying occurring. Oil accumulating on the upper ladder portion. The coating is cracking on 75% of the ladder.

-The interior ladder has poor coating conditions due to heavy surface corrosion, cracking of the coating and minor de-alloying.

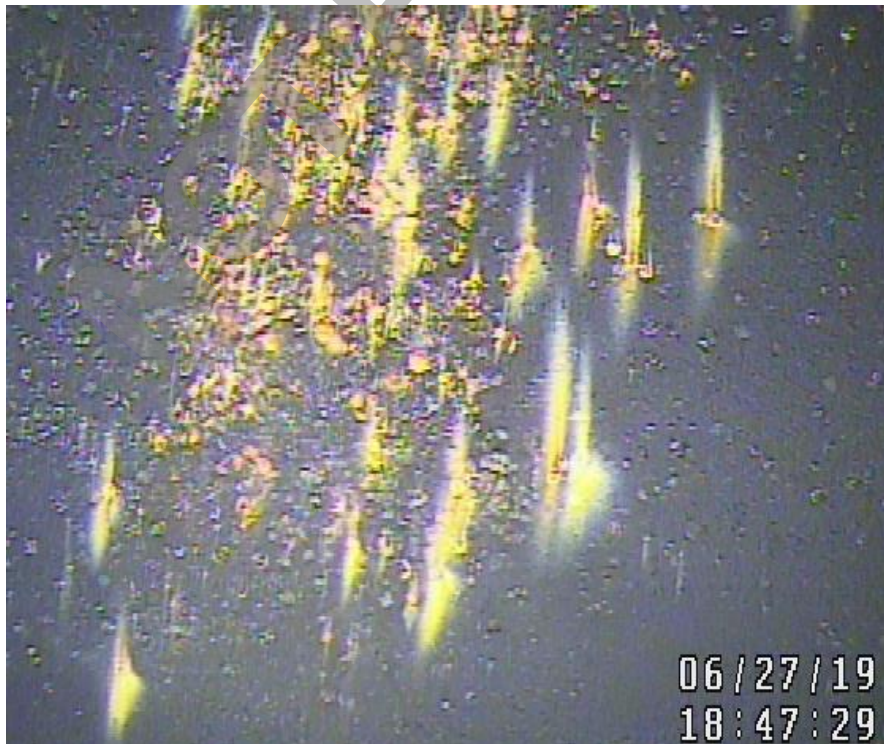
Wall Panels

Coating Conditions Overall: Poor.

Percent of De-lamination: 3-5%.

Percent of USC: 25-50%.

Percent of De-alloying: 1-2%.

Percent of Blistering: 25%.

Summary: The interior wall panels have poor coating conditions overall. De-alloying present at the 4:30 position. Pitting up to 1/8" in depth. The coating is uneven and is cracking heavily. Oil build-up noted on the top panels. Blistering occurring on the upper panels as well.

-De-alloying present on the interior walls at 4:30. Pitting also visible up to 1/8" in depth.

-The interior coating is in poor condition due to surface corrosion and cracking of the coating. Recommend an interior blast and re-coat to an SSPC SP10.

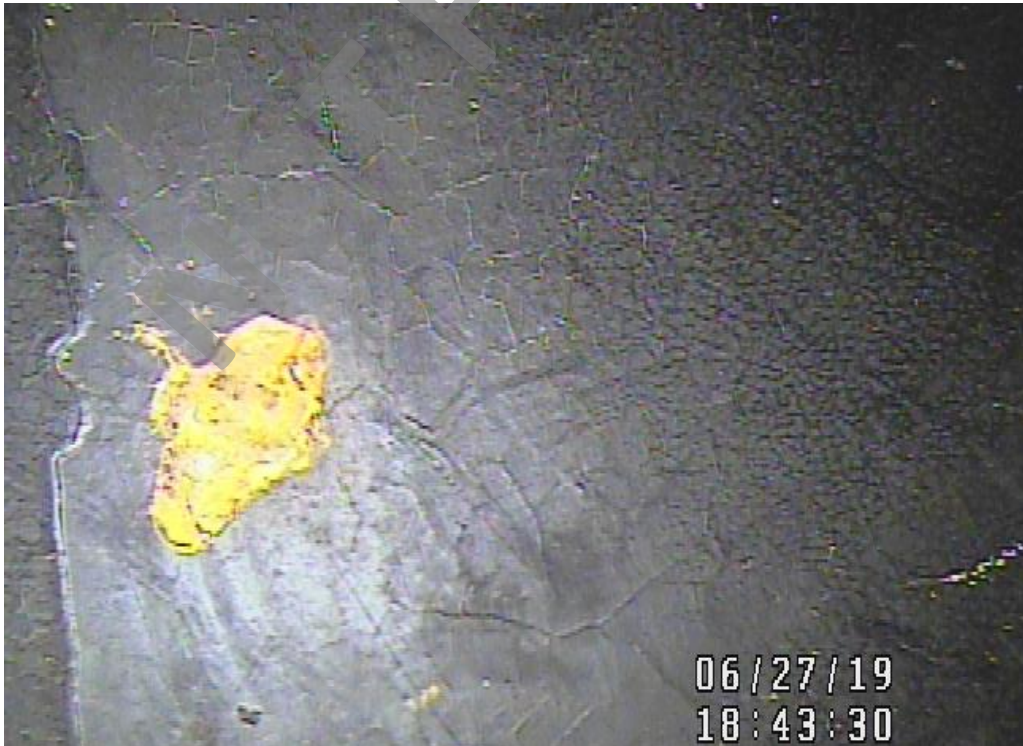
Floor Panels

Coating Conditions Overall: Poor.

Percent of USC: 5-10%.

Percent of De-alloying: Less than 1%.

Summary: The floor panels have poor coating conditions overall. Surface corrosion noted. The coating is uneven and cracking. Minor de-alloying occurring.

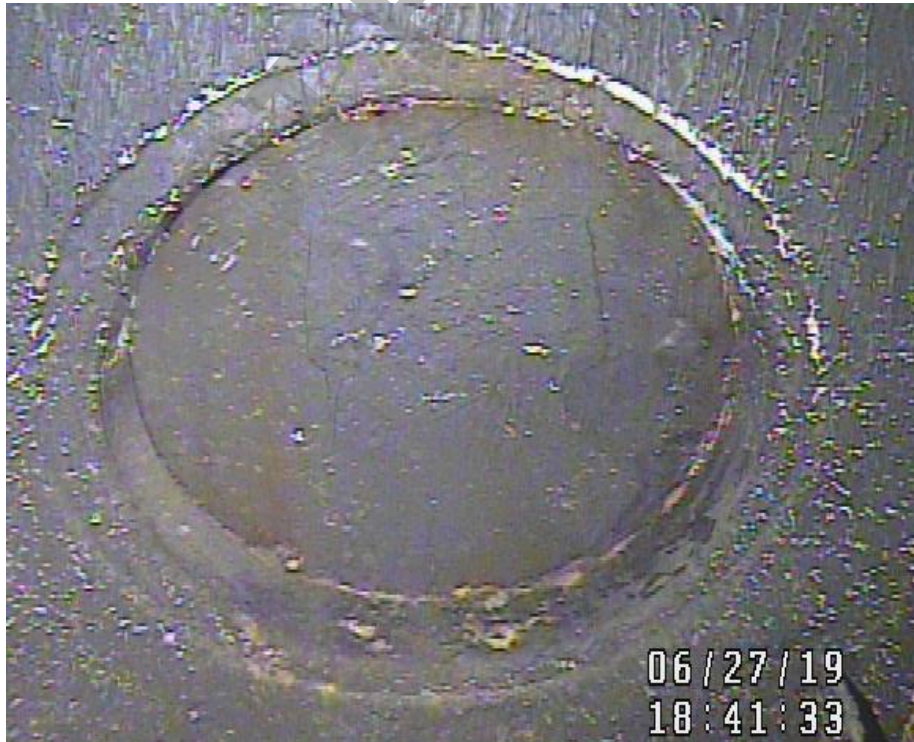
Manway (s)

Coating Conditions Overall: Poor.

Percent of USC: 15%.

Summary: The manway has poor coating conditions overall. Heavy surface corrosion present. Severe cracking of the coating.

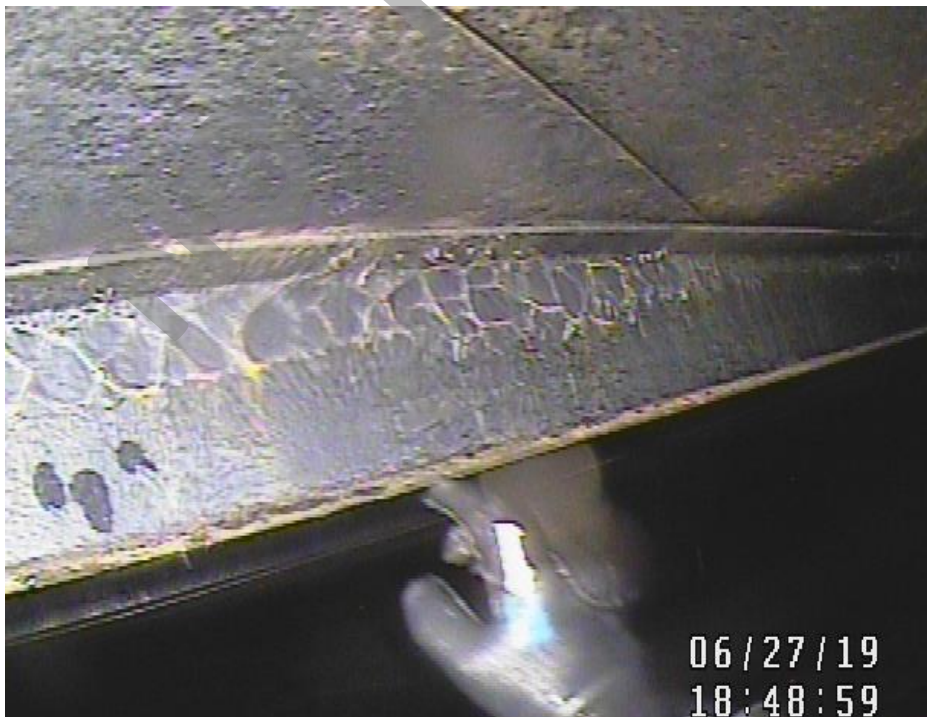
Roof Panels

Coating Conditions Overall: Poor.

Percent of USC: 50%.

Percent of De-alloying: 10%.

Summary: The roof panels have poor coating conditions overall. Heavy surface corrosion noted. De-alloying present on the cross beams. Heavy cracking of the coating occurring.

-De-alloying present on the roof's cross beams.

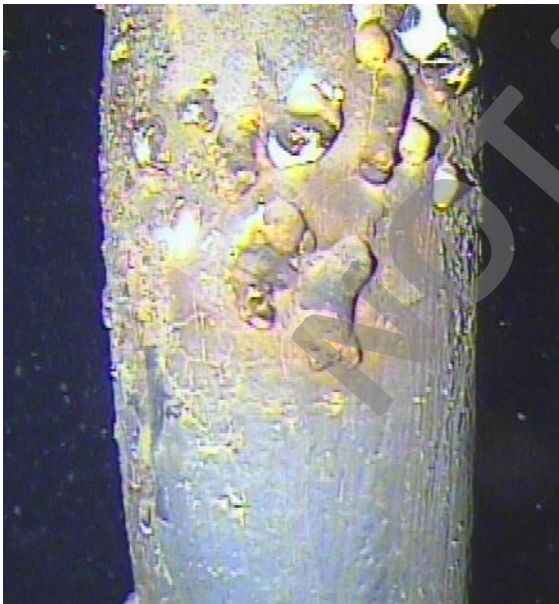
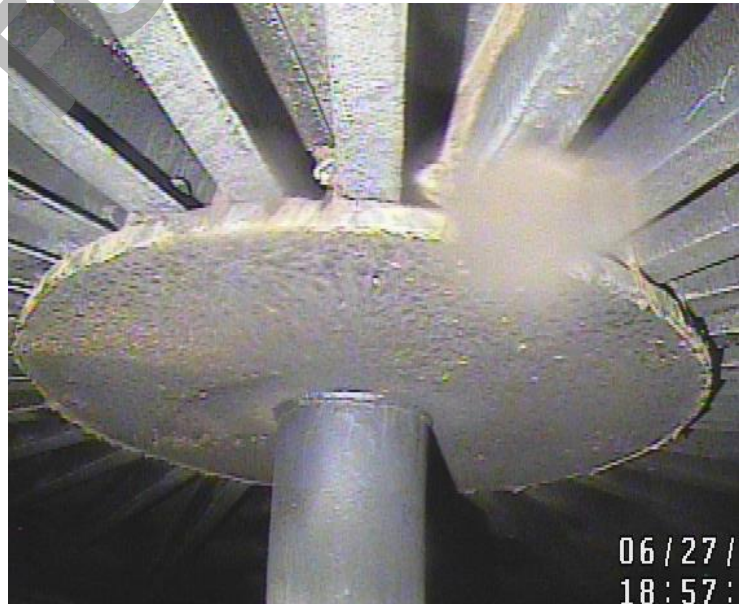
Support Column

Coating Conditions Overall: Poor.

Percent of USC: 25-30%.

Percent of Blistering: 25%.

Summary: The support column has poor coating conditions overall. Heavy surface corrosion noted. The coating is uneven and cracking. Blistering occurring. Oil build-up forming on the top of the column.

-Heavy blistering noted on the column and upper wall panels.

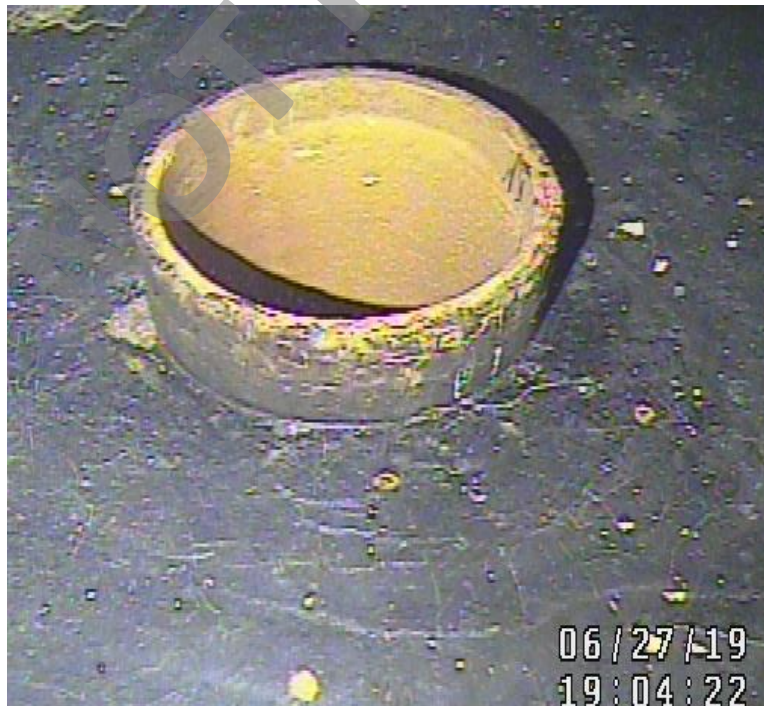
Inlet/Outlet

Coating Condition Overall: Poor.

Percent of USC: 10-25%.

Summary: The inlet/outlet has poor coating conditions overall. Heavy surface corrosion noted. The coating is cracking.

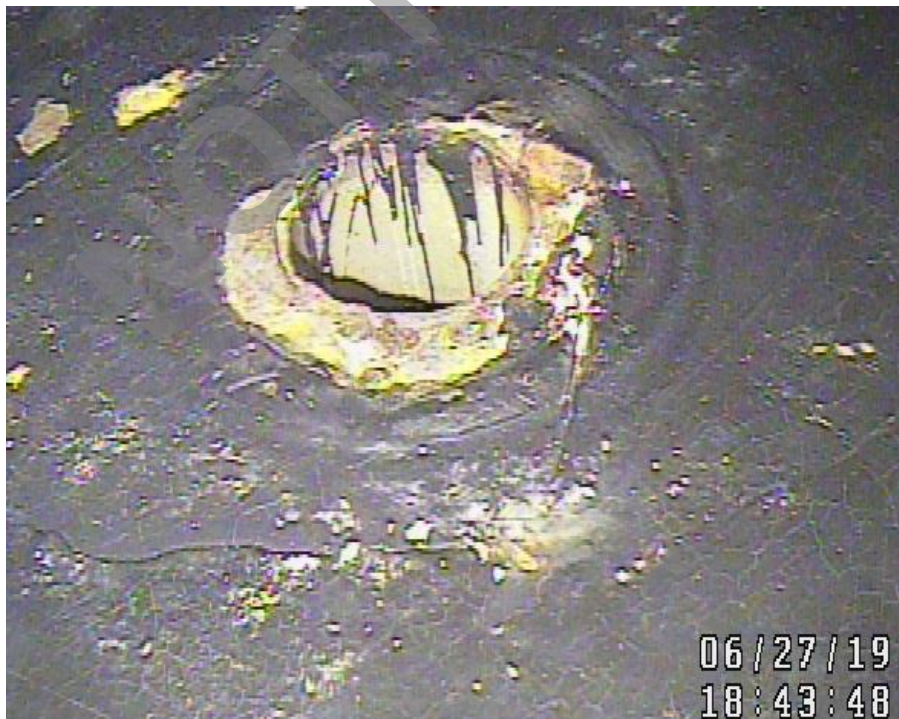
Drain

Coating Condition Overall: Poor.

Percent of USC: 50%.

Summary: The drain has poor coating conditions overall. Heavy surface corrosion noted.

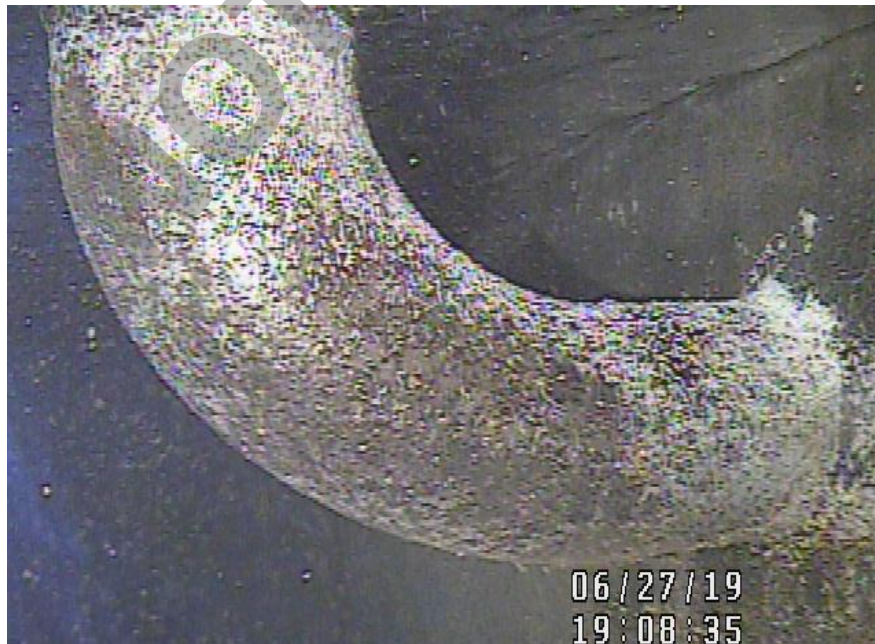
Overflow

Coating Conditions Overall: Fair.

Percent of USC: 2-3%.

Summary: The overflow has fair coating conditions overall. Surface corrosion noted. Oil build-up present. The coating is cracking.
