# **Seismic Assessment of the San Bernardino County Building Located at 303 West 5th Street San Bernardino, California**

**March 4, 2025 – DRAFT**

*Prepared for :*  
**Dahl, Taylor & Associates, Inc.**  
2960 Daimler Street  
Santa Ana, CA 92805

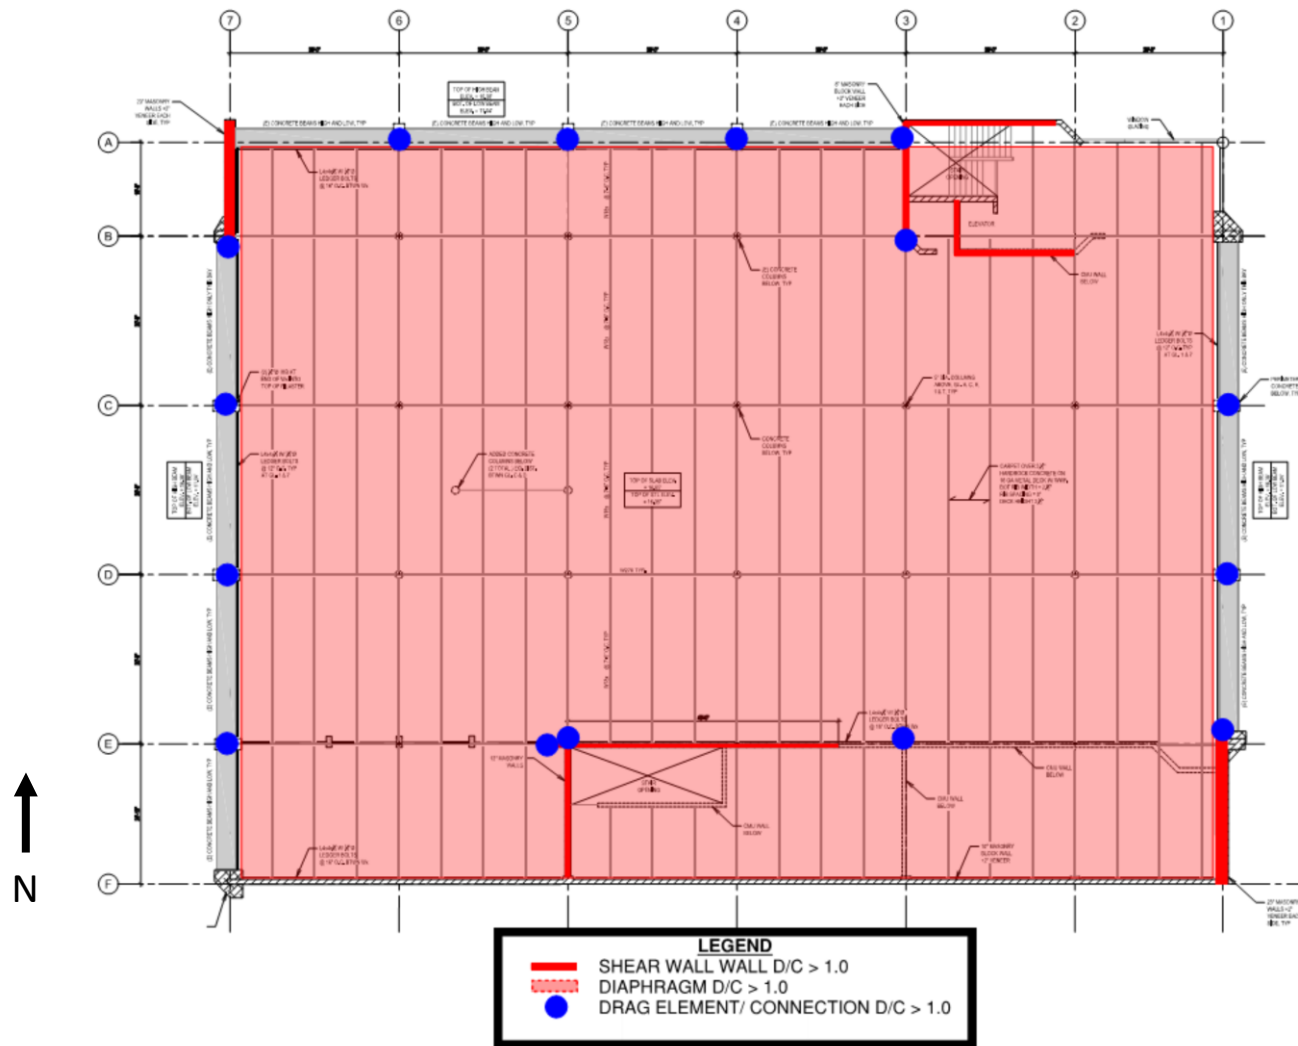
Figure 4-2: Second Floor D/C Ratio Map

To give an idea of the extent of the deficiencies, the use of the “Demand/Capacity (D/C) ratio” is used in the following discussions. The D/C Ratio is a comparison of design force to design capacity based on our preliminary calculations and computer modeling. Ratios of 1.0 and less meet the lateral loading criteria, while D/C ratios greater than 1.0 indicate that the seismic forces exceed the allowed capacity of an element. Some components with D/C ratios greater than 1.0 are deemed acceptable due to inherent overstrength and/or ductility of their materials and their relative risk to life-safety and business interruption. A summary of maximum D/C ratios for the masonry shear walls, drag elements, diaphragms, beams, connections, and footings is presented in Table 4-1. Refer to Figure 4-1
