SB COUNTY PROPERTY ASSESSMENT - 303 W. 5TH STREET

Date: September 19, 2023
Job Number: 23005335.00
Engineer: Craig Chamberlain, S.E.
PE Number/State: CA SE 4588

MODIFIED FEMA-310 WORKSHEET

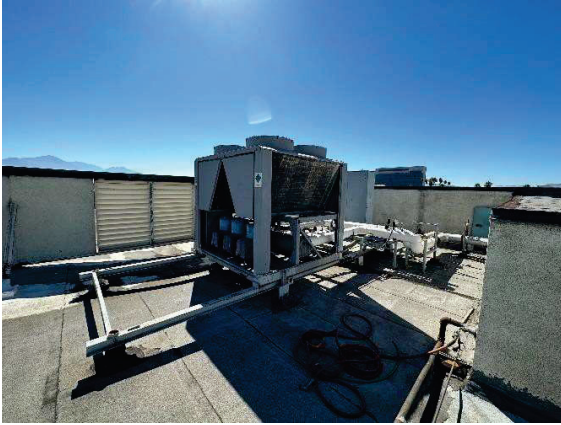
M1 – existing air – cooled chiller

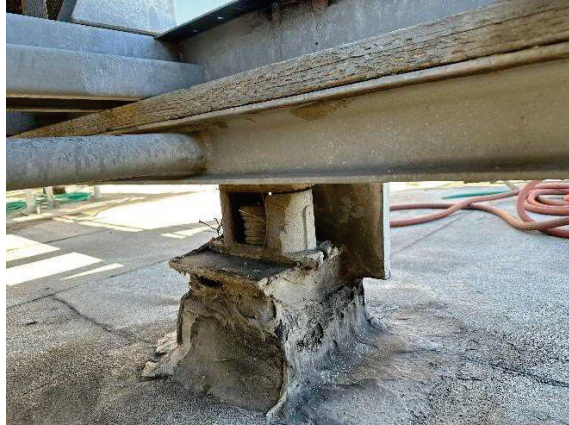
M2 – existing air-cooled chiller roof curb mount

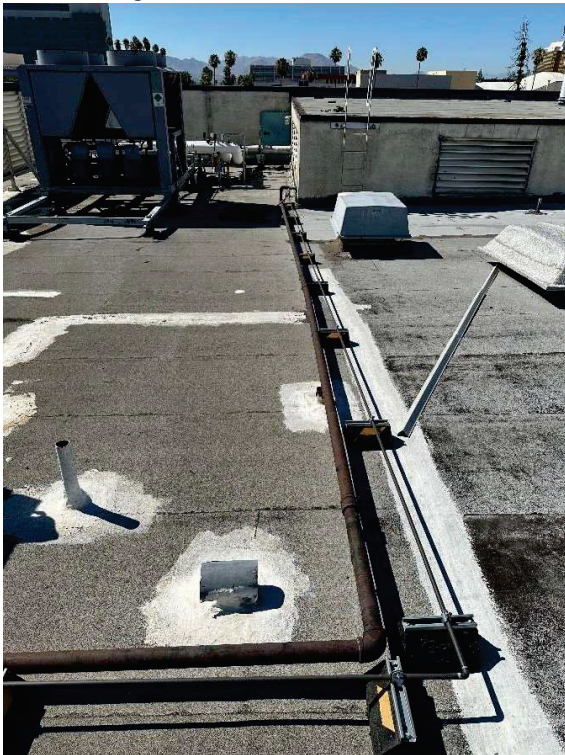
M3 – roof gas piping without roof support

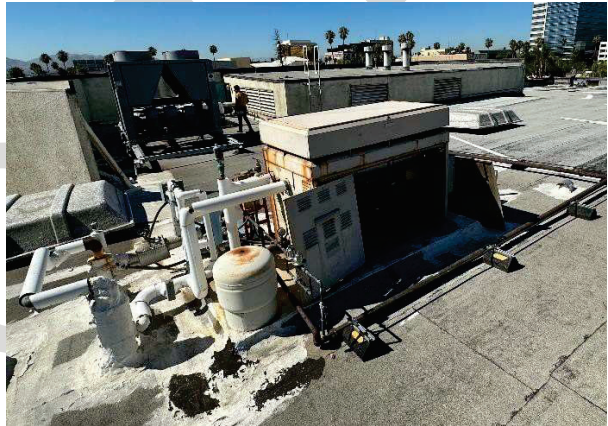
M4 – existing hot water boiler

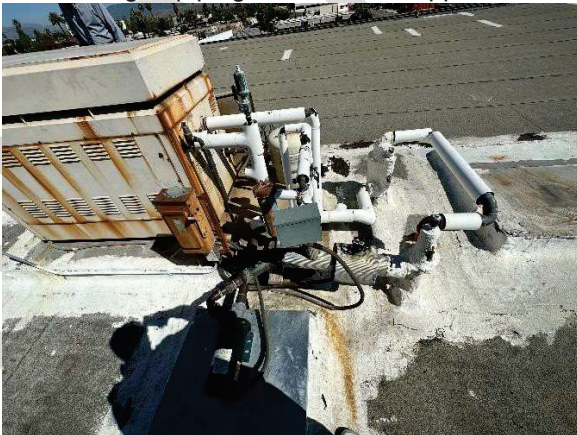
M5 – existing hot water boiler piping assembly

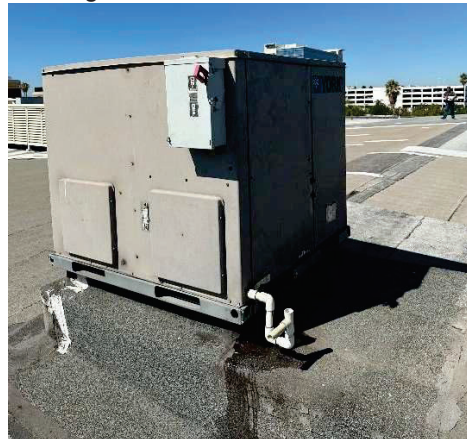
M6 – typical existing rooftop heat pump

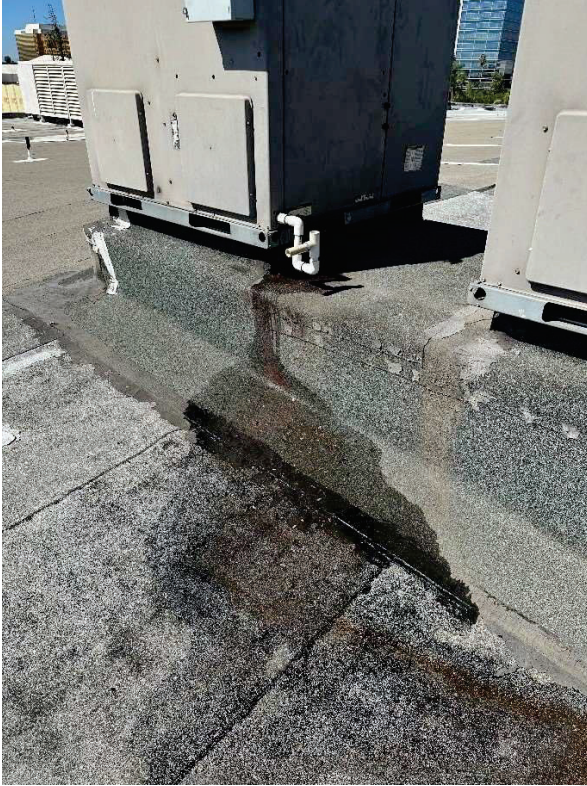
M7 – typical heat pumps leaking condensate

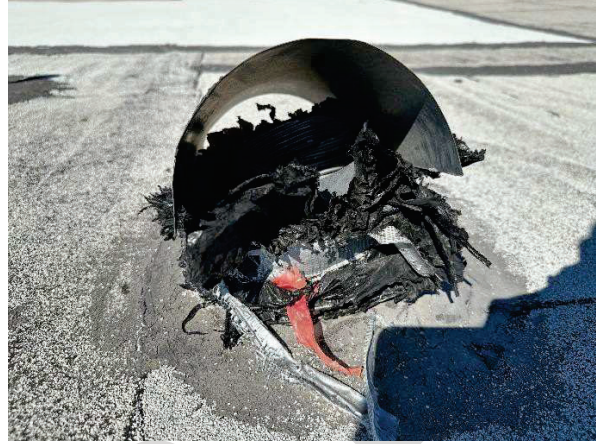
M8 – typical roof caps needs reseal

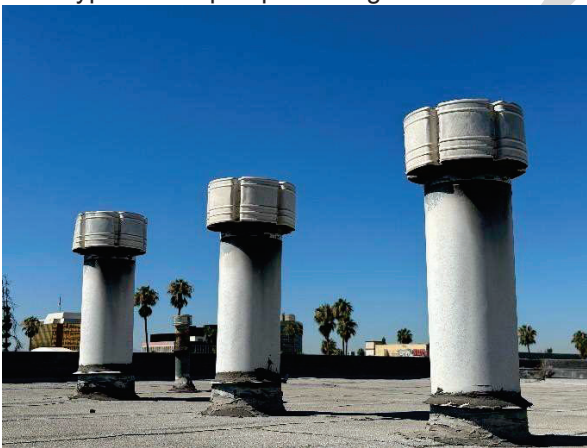
M9 – existing duct furnace flue

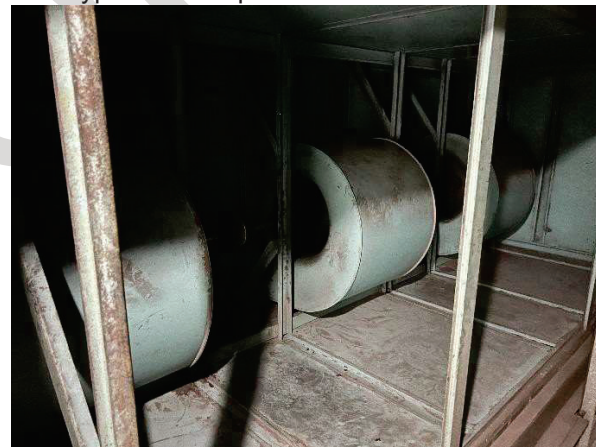
M10 – existing air handler centrifugal fan

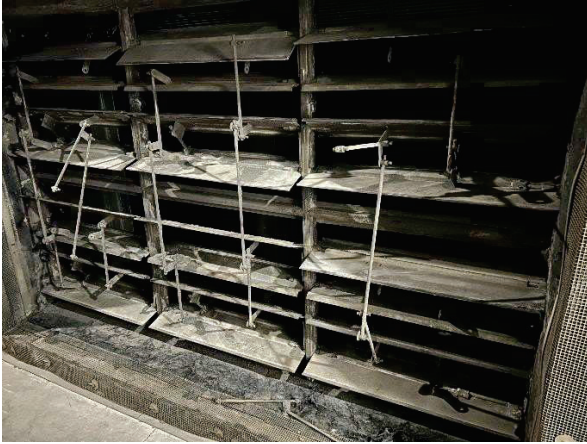
M11 – existing damper linkage

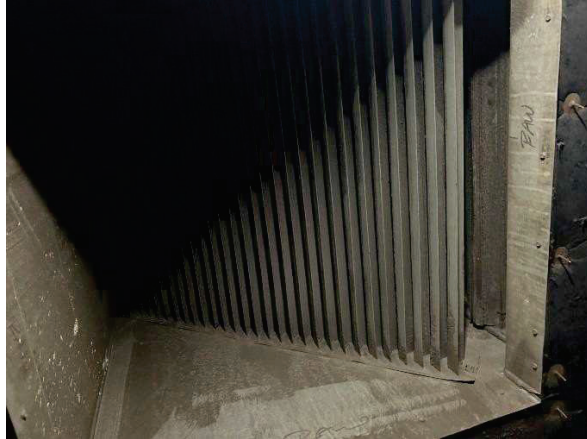
M12 – existing fresh air intake

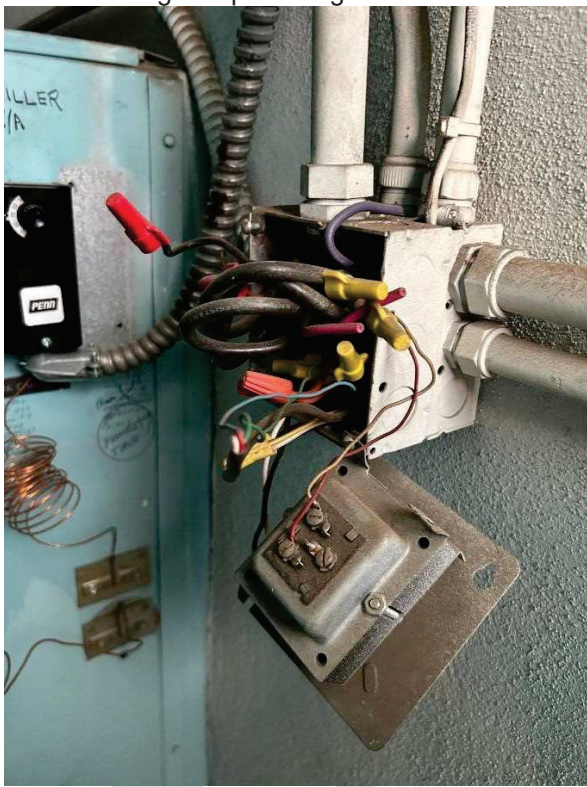
M13 – disrepair control wiring

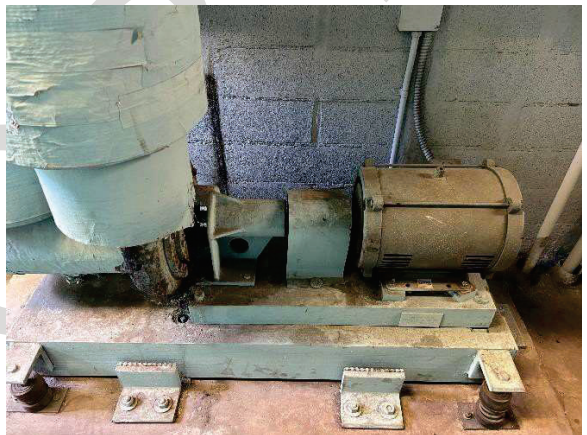
M14 – existing chiller pump

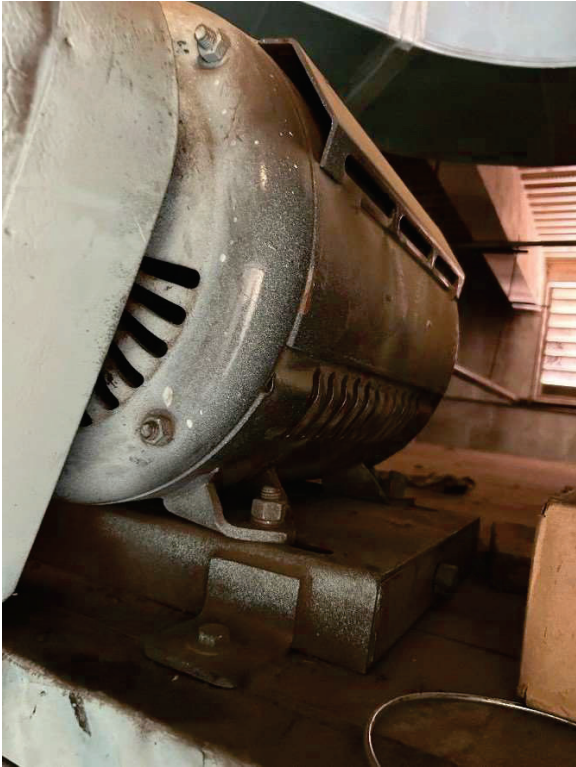
M15 – air handler motor

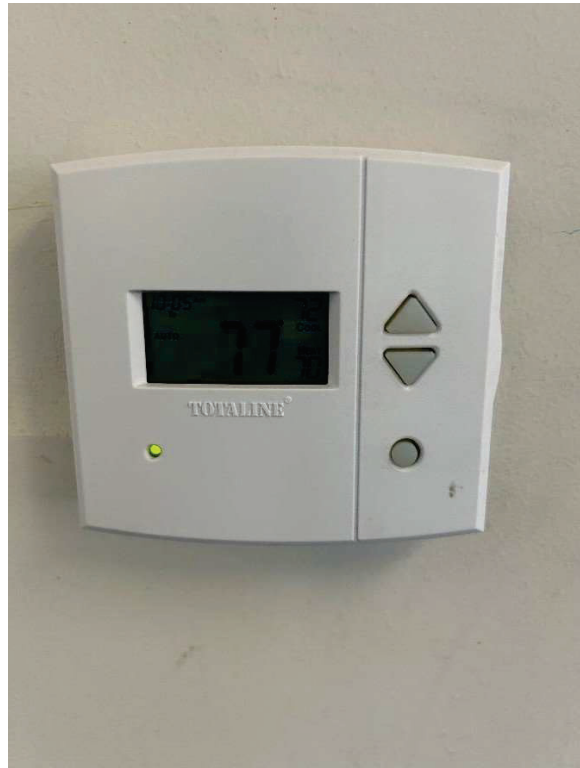
M16 – typical heat pump thermostat

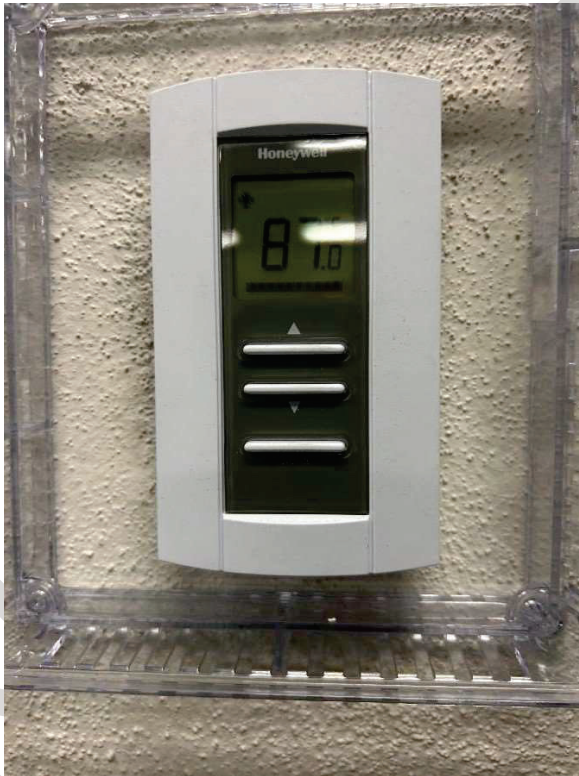
M17 – typical vav box thermostat

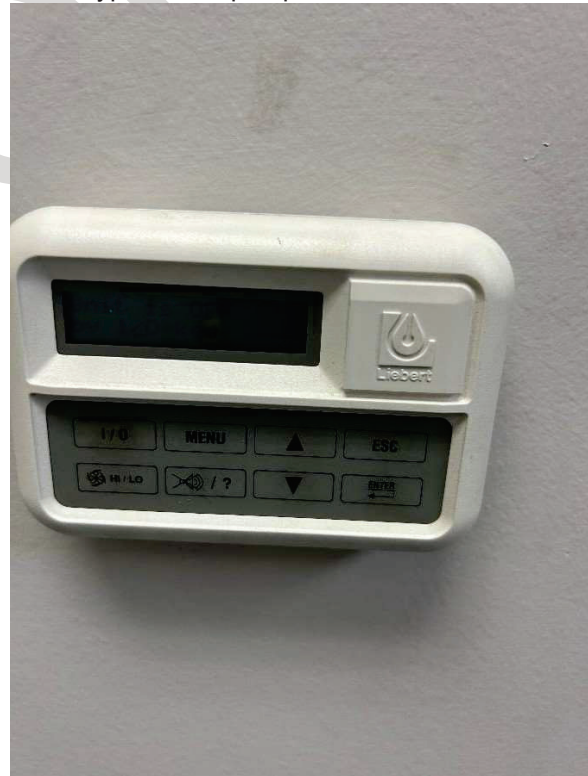
M18 – Liebert unit thermostat

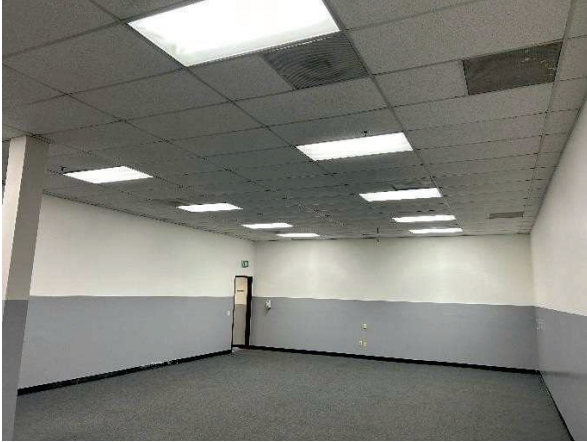
M19 – typical T-bar lay-in type diffuser

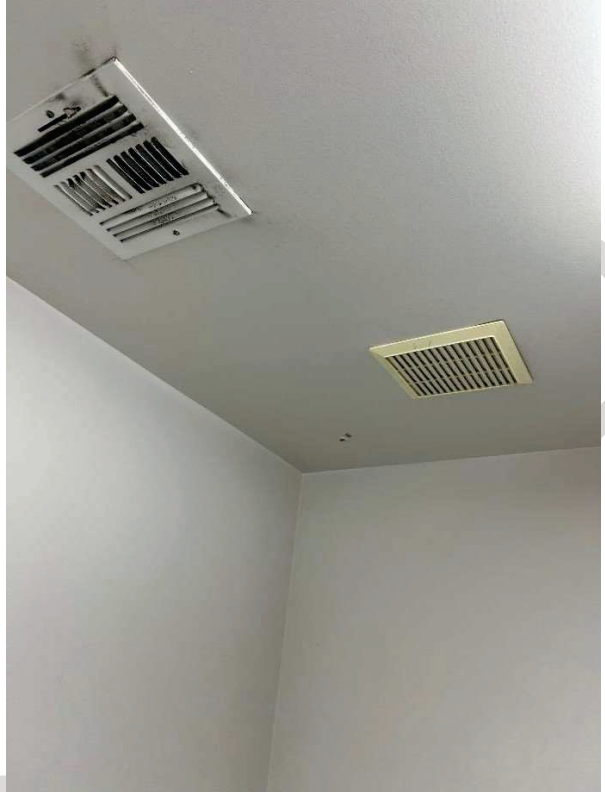
M20 – typical surface mount type grill

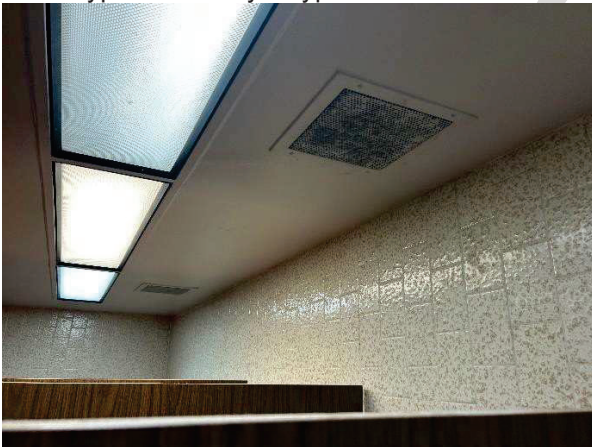
M21 – typical surface mount diffuser

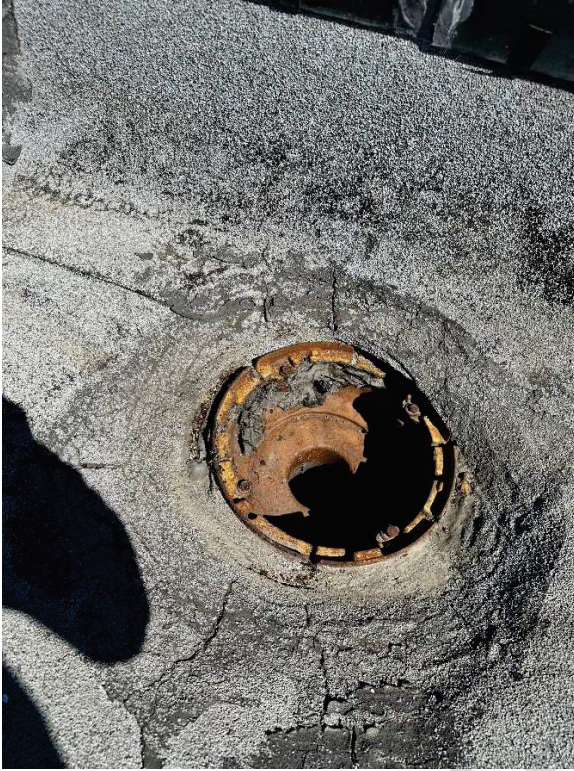
P1 - roof drain without cover

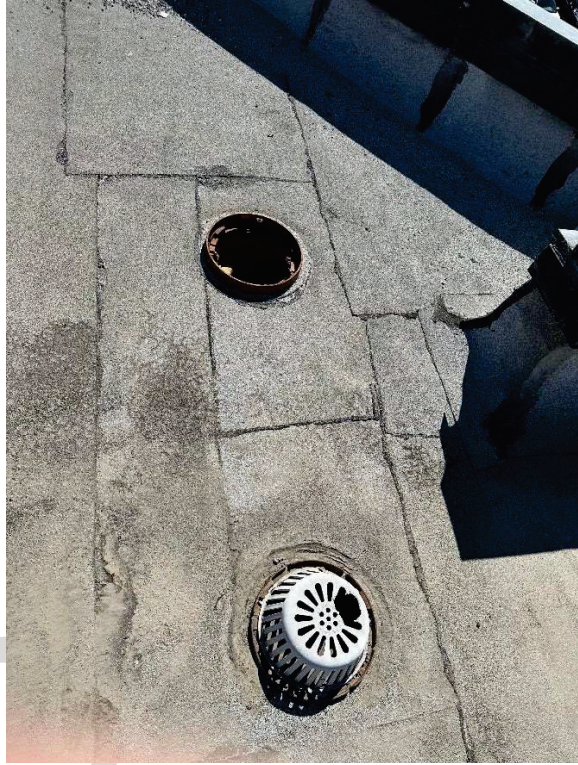
P2 – damaged roof drain cover

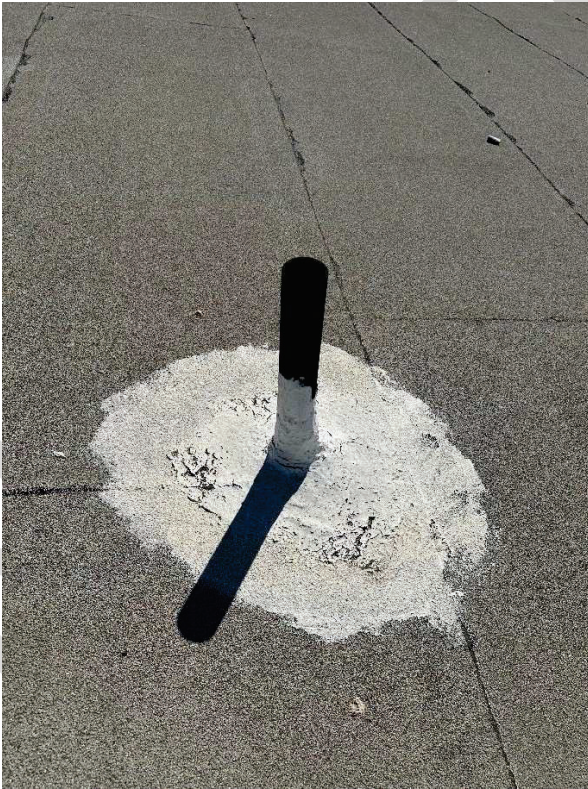
P3 – typical existing plastic roof vent

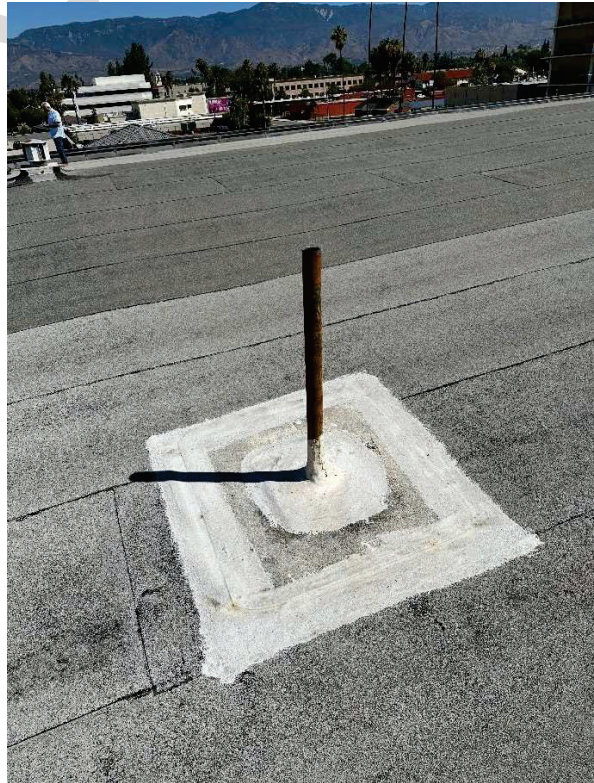
P4 – existing metal roof vent

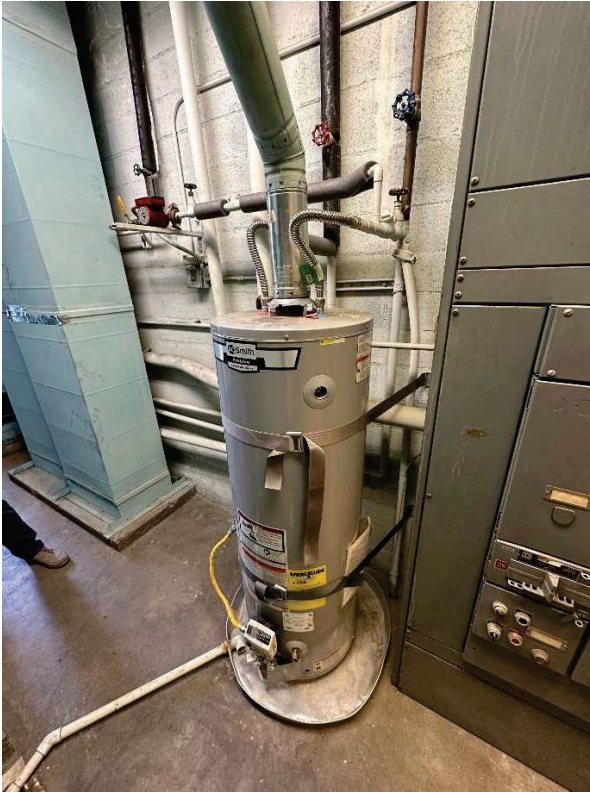
P5 – existing A.O. smith water heater

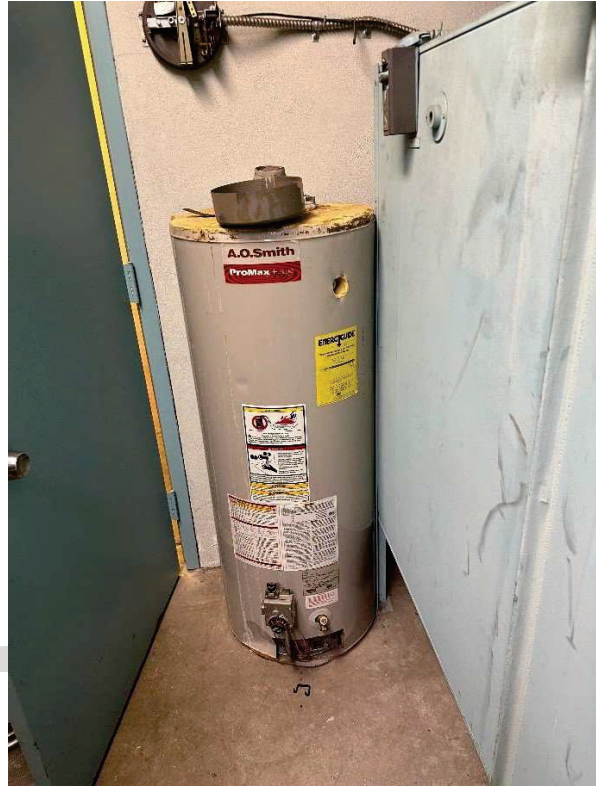
P6 – abandoned water heater in mechanical room

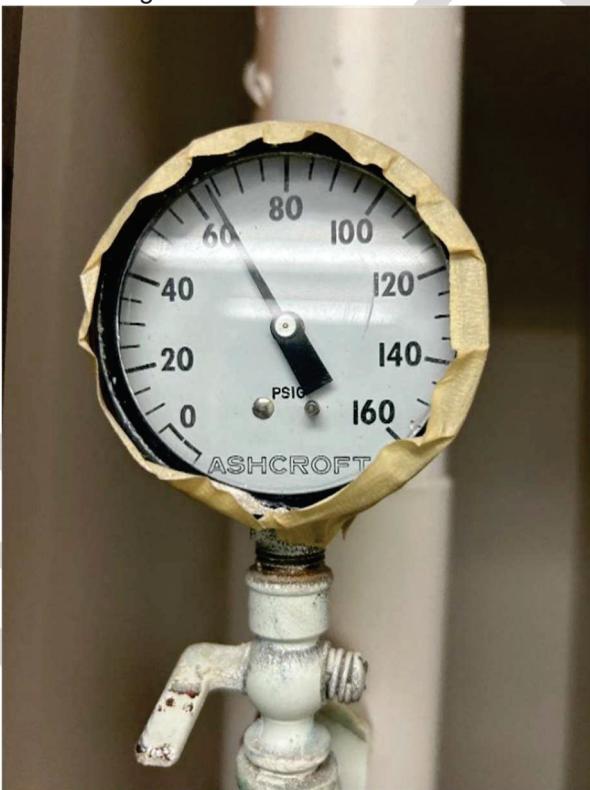
P7 – existing water meter

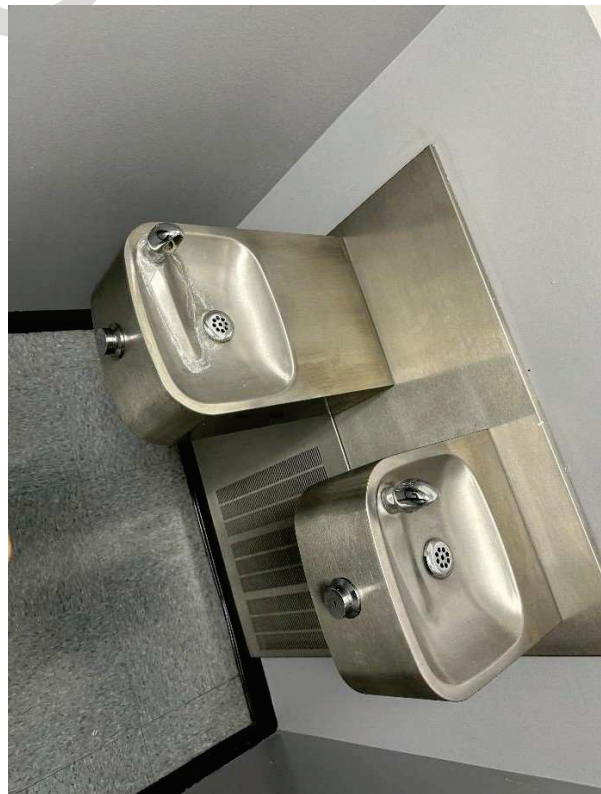
P8 – typical existing drinking fountain

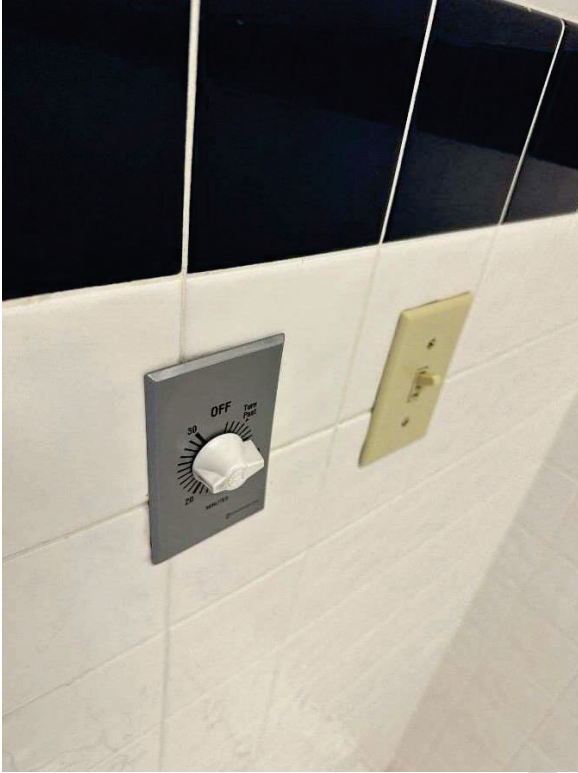
P9 – typical existing time clock exhaust fan in private rest room

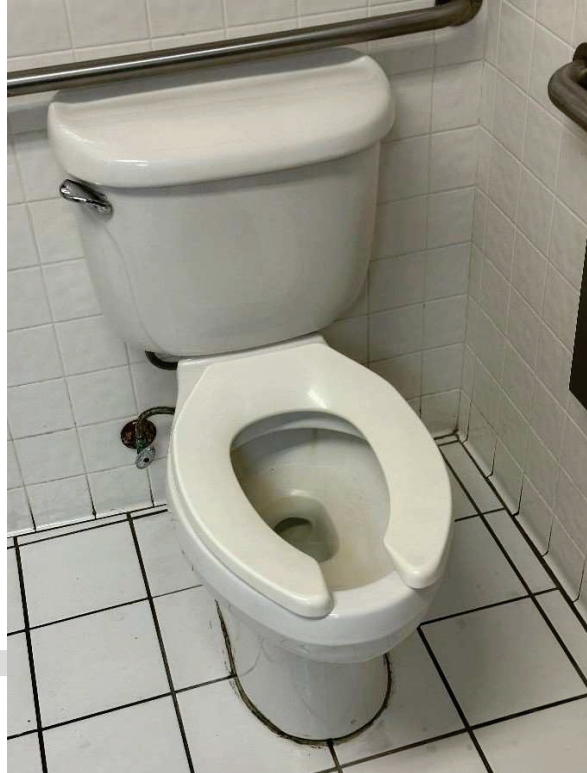
P10 – typical existing flush-tank type water closet in private restroom

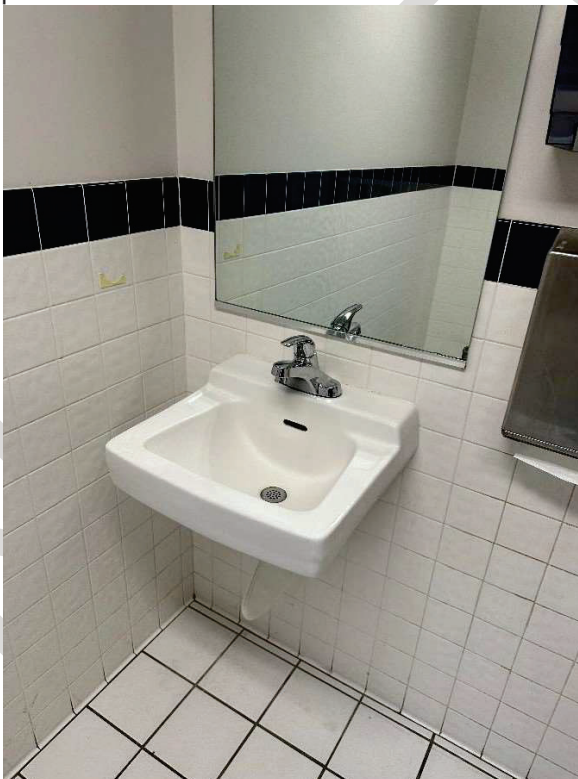
P11 – typical lavatory in private restroom

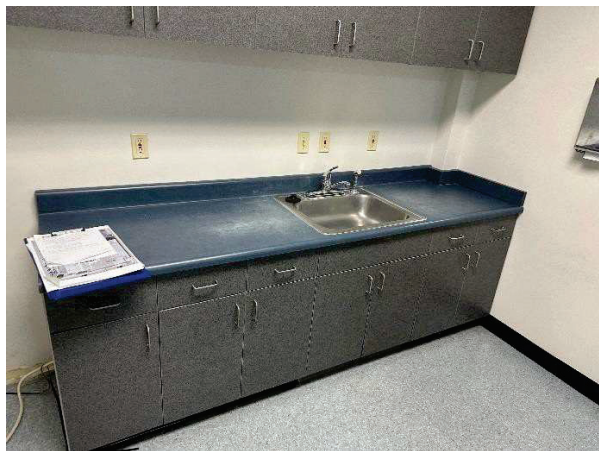
P12 – existing cabinet and sink in breakroom

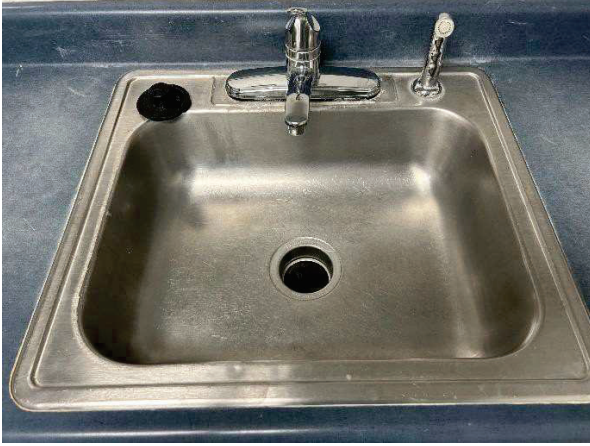
P13 – existing kitchen sink

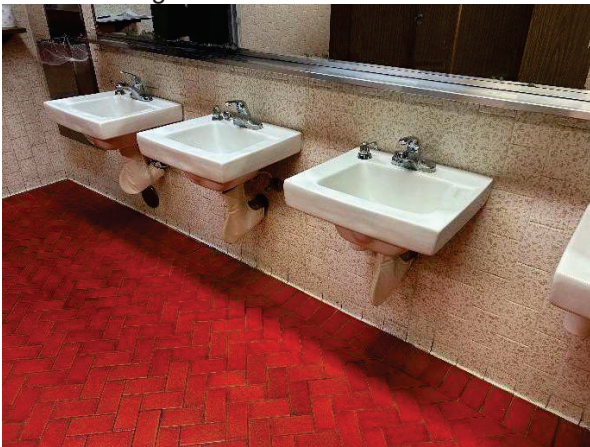
P15 – typical existing lavatory assembly in main restroom

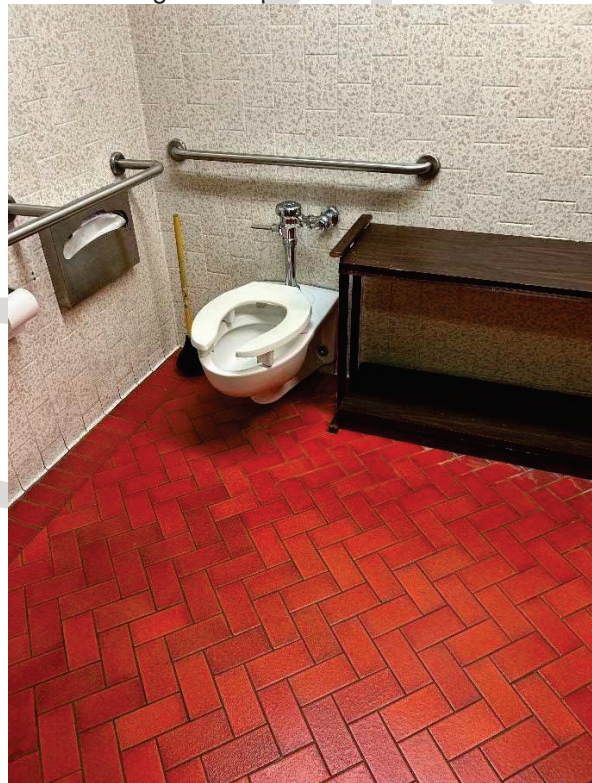
P16 – typical existing flush-valve water closet

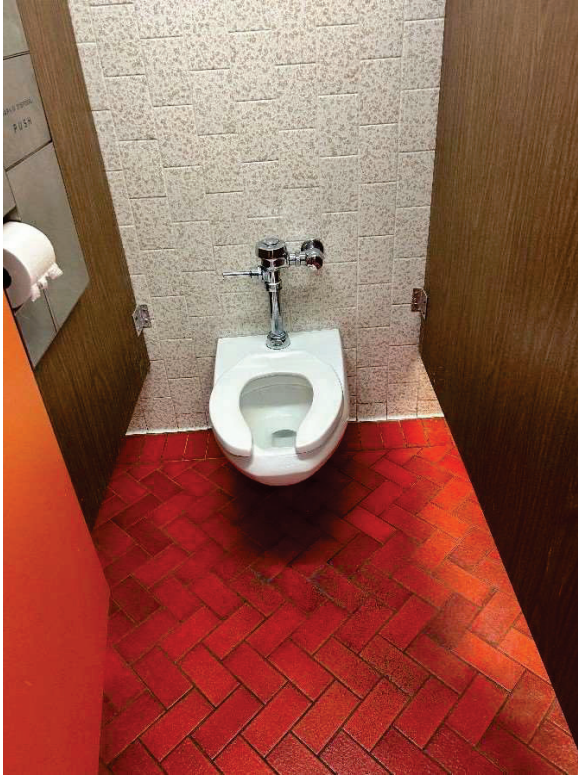
P17 - typical existing flush-valve water closet

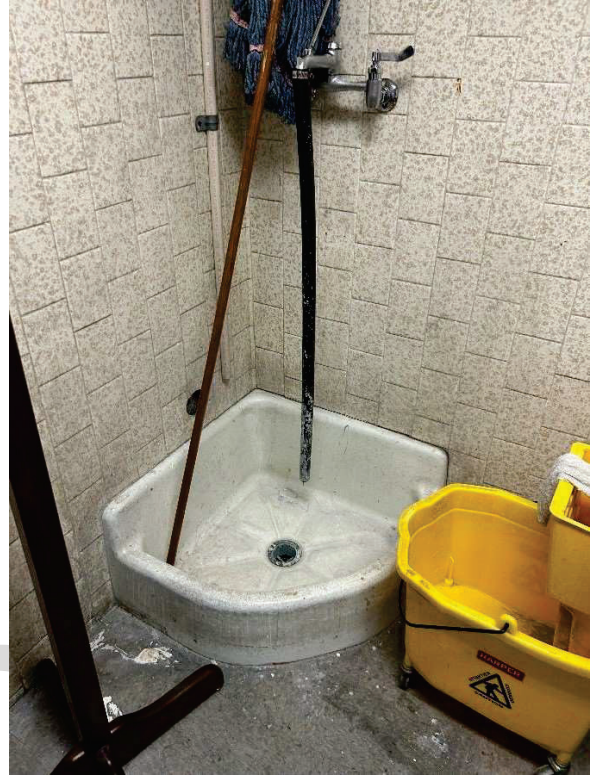
P18 - existing mop sink in janitor closet

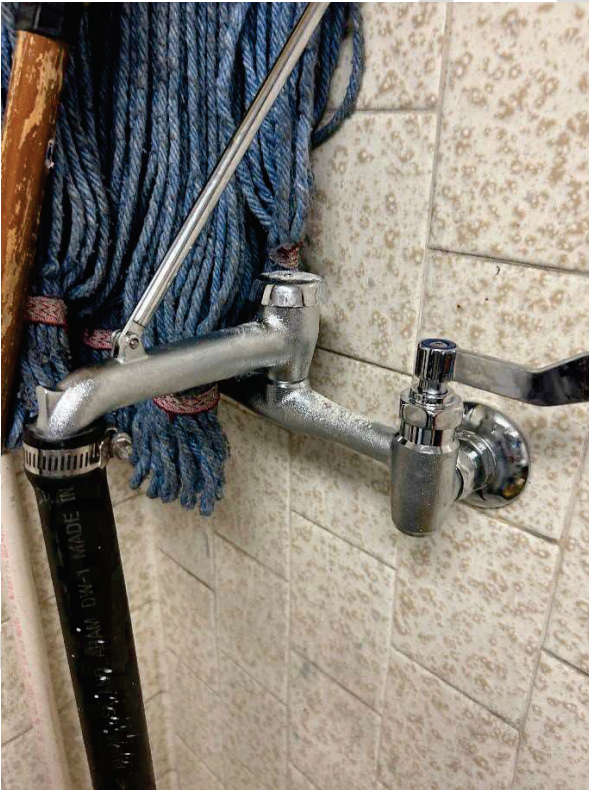
P19 – existing wall mount faucet in janitor closet

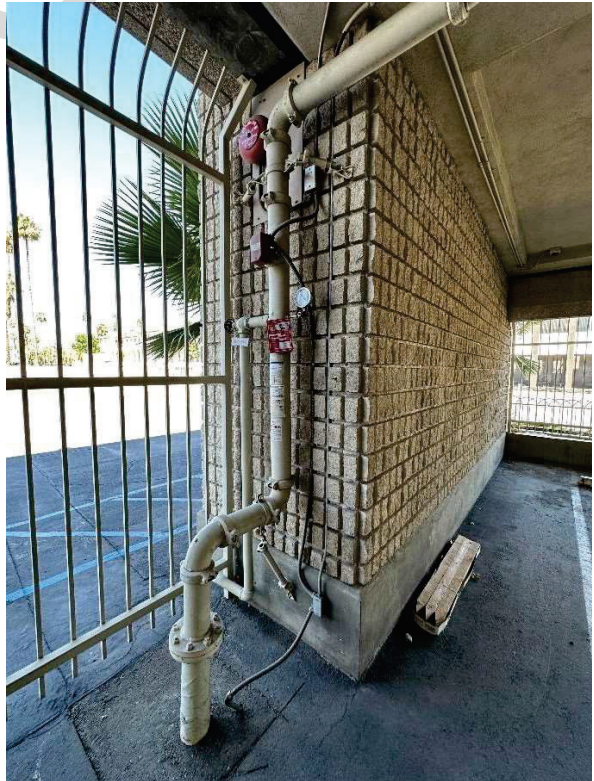
P20 – existing fire riser

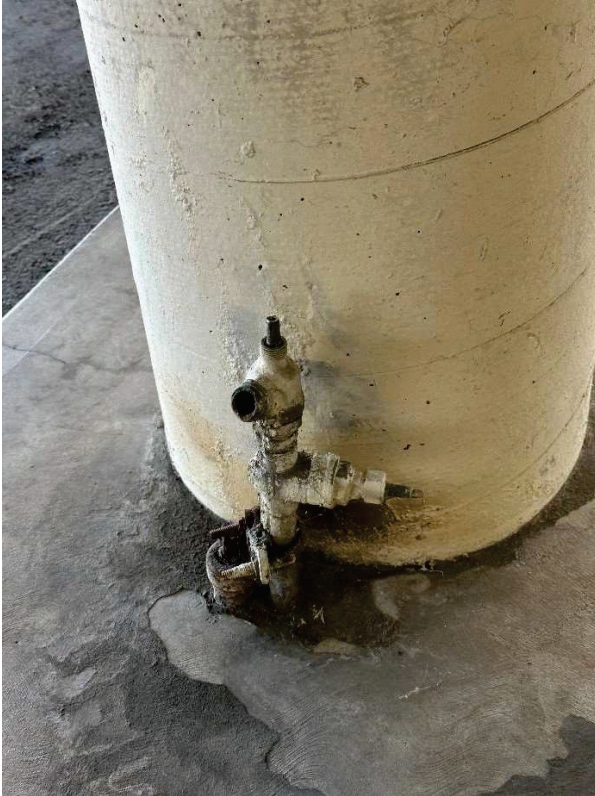
P21 – existing hose bibb

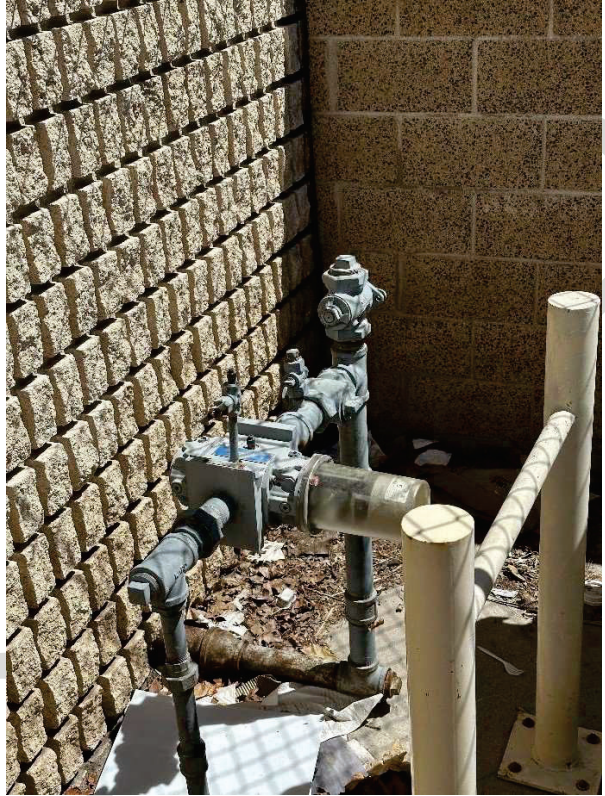
P22 – existing gas meter

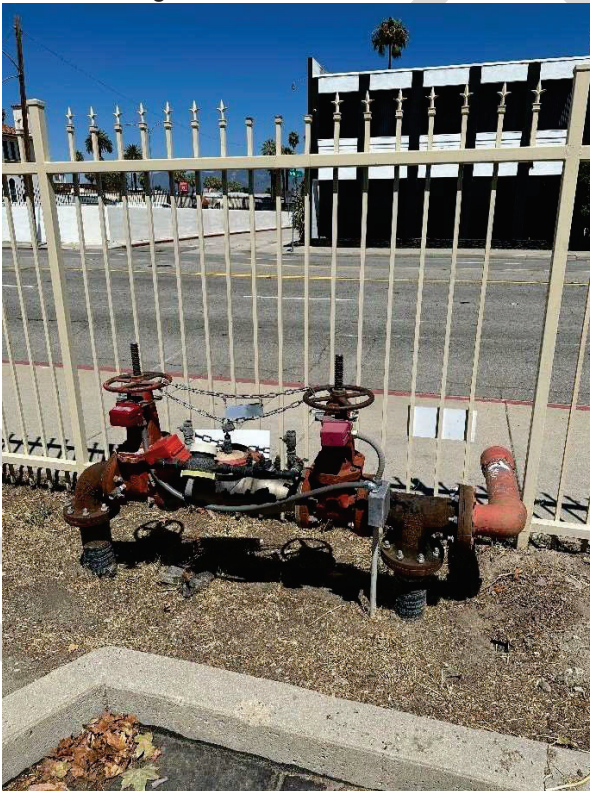
P23 – existing fire sprinkler backflow preventer

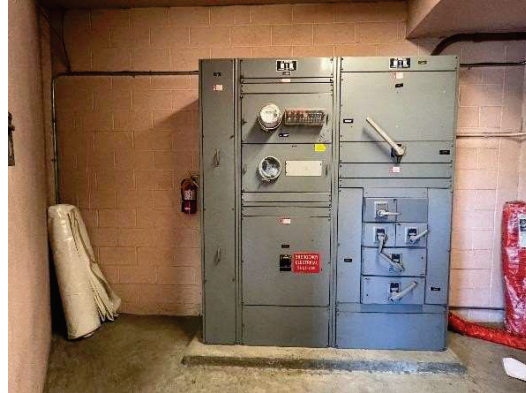
E2 - Main Switchboard "MSB"

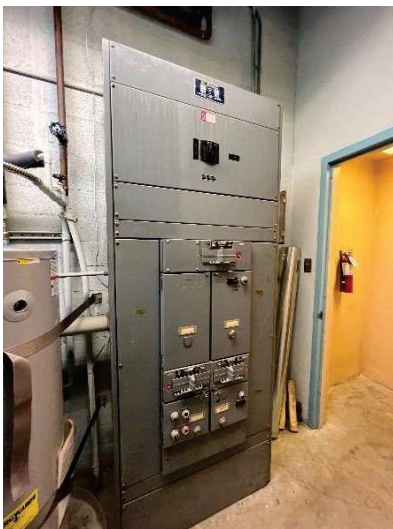
E3 - MCC 3P600A, 3P, 3W 480V (1981) @ 2nd Floor Mezzanine

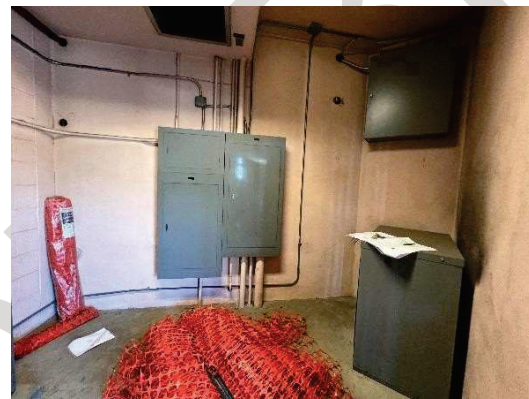
E4 - Panels HA, DLA and Transformer T1 @ Main Electrical Room

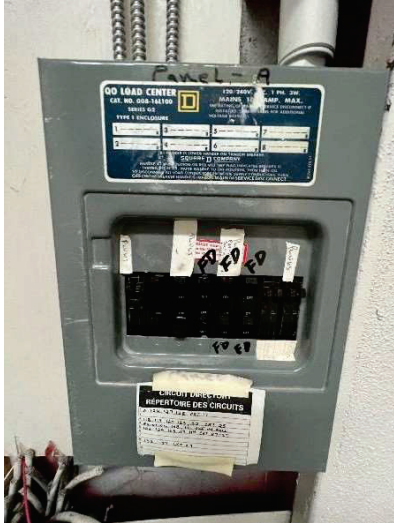
E7 - Panel A 2P100A, 120/208V (1981) @ 2nd Floor Stair Closet

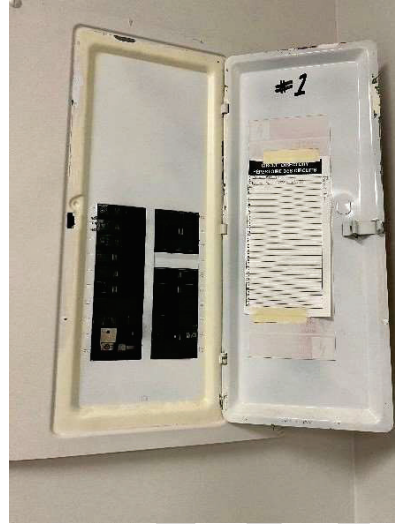
E8 - Panel X, 3P70AMCB, 120/208V, 3P, 4W (1981) @ 2nd Floor Telecomm Room

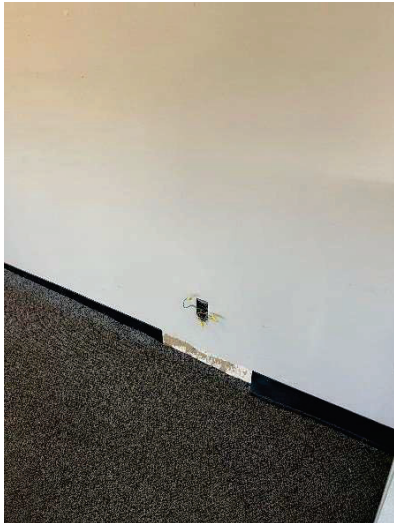
E10 - Open power outlet box without devices @ 2nd Floor Clerical Office

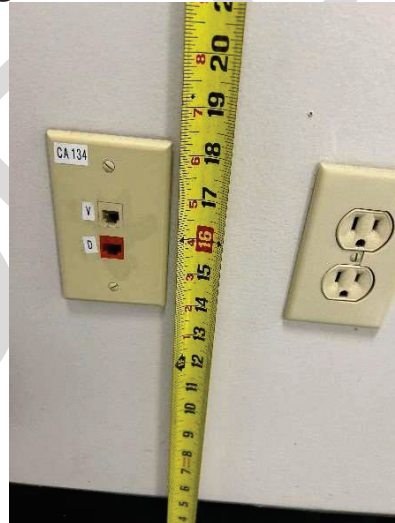
E11 - Typical communications and power receptacle outlets with mounting heights of 16" above finish floor on center of devices

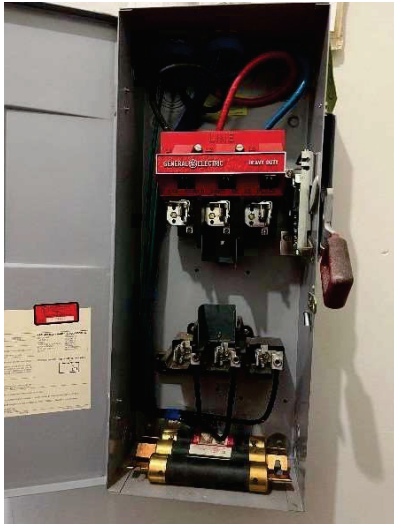
E14 - Typical elevator equipment disconnect switch without auxiliary contacts for proposed elevator recall function (1981))

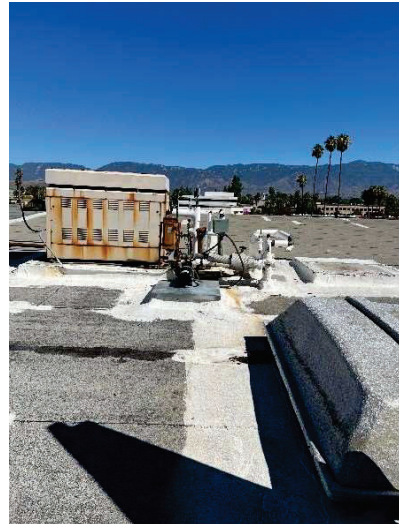
E15 - Corroded disconnect switch on roof serving the boiler (1981)

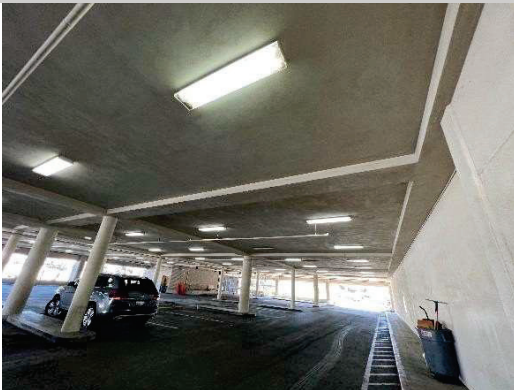
E16 - Typical surface 1' x 4' fluorescent fixture at garage and utility rooms

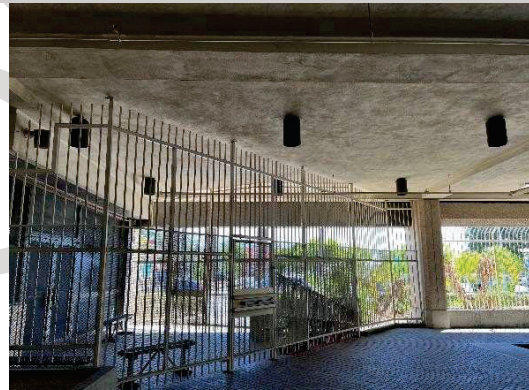
E17 - Typical cylinder fluorescent surface fixture at garage lobby

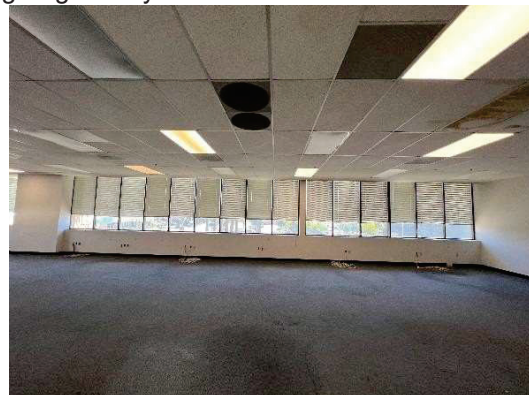
E19 - Typical 2' x 4' recessed fluorescent fixtures at offices

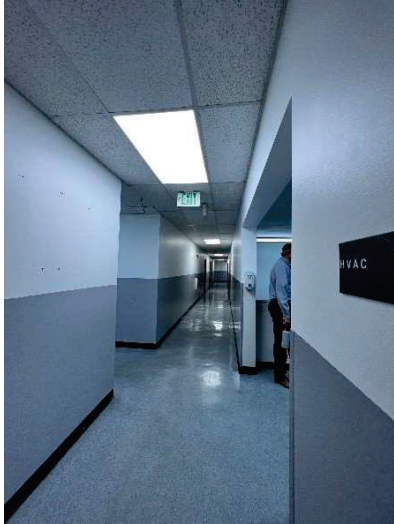
E20 - Typical corridor recessed 2'x 4' fluorescent fixture

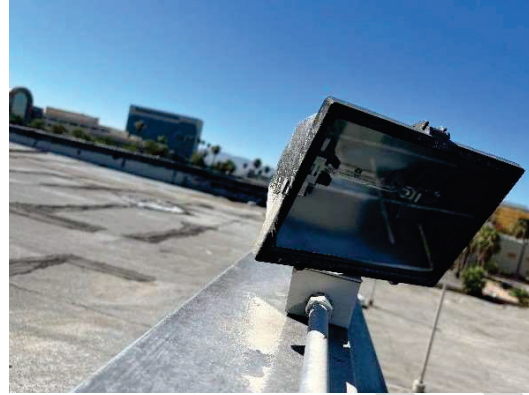
E21 - Typical parapet halogen type spot light fixture on roof

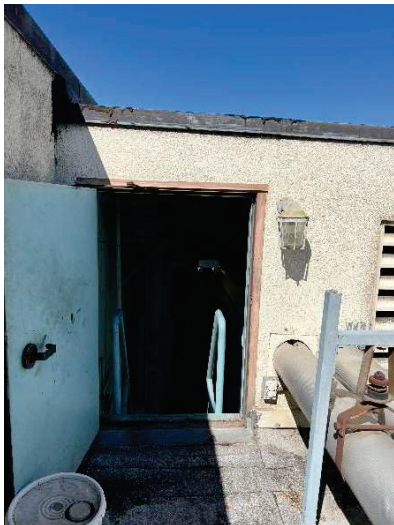
E22 - Incandescent wall mounted fixture at roof

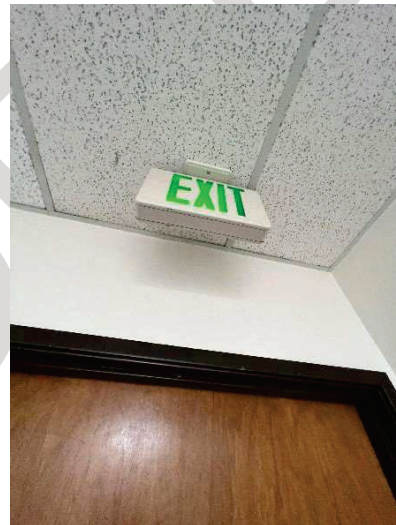
E23 - Typical exit illuminated signage along egress path

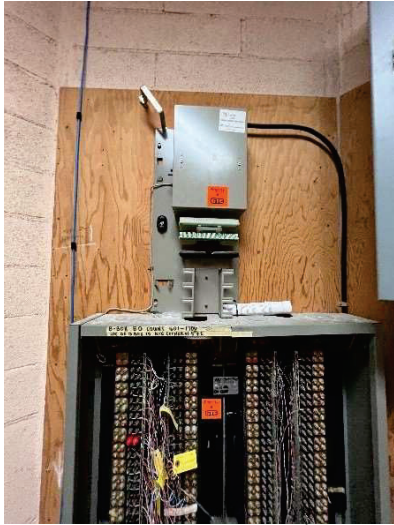
E26 - Communication MPDE @ 2nd Floor
Telecomm/Electrical Room

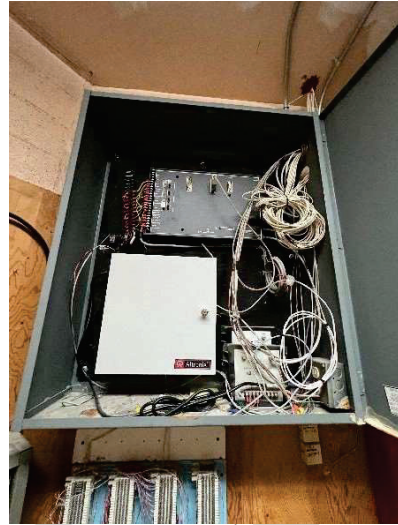
E27 - Security Cabinet @ 2nd Floor
Telecomm/Electrical Room

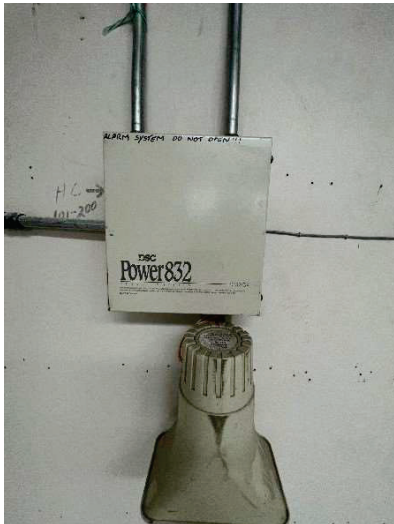
E28 - Remote security cabinet @ 2nd Floor Stair
Closet

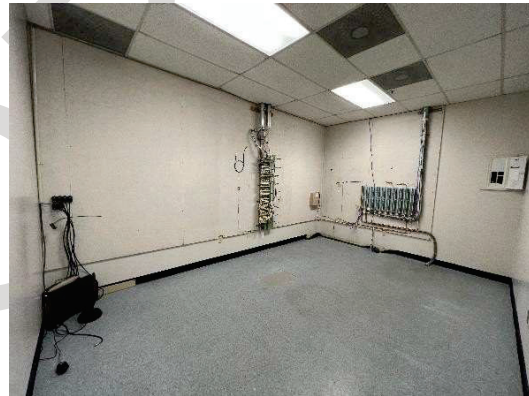
E29 - Secondary Communication Backboard @ 2nd
Floor Telecomm Room

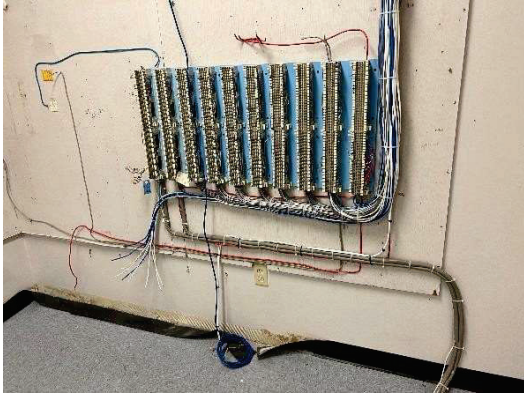
E30 - Telecom Backboard with Punchdown in 2nd Floor Telecomm Room

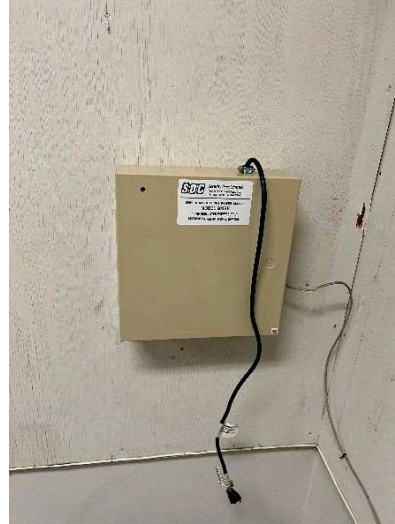
E31 - Security Door Control Cabinet in 2nd Floor Telecomm Room

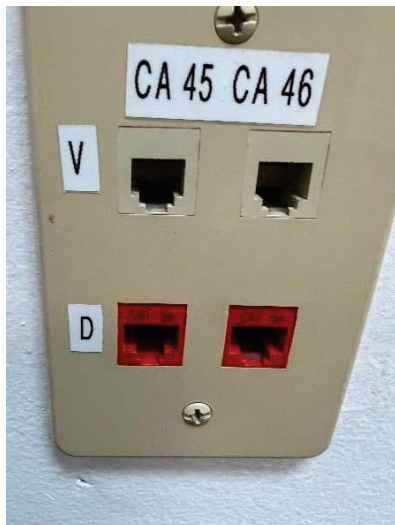
E32 - Typical voice/data jacks utilizing CAT5E horizontal cabling

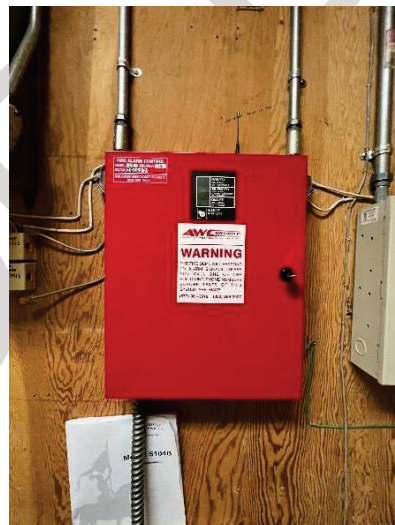
E33 - Main Fire Alarm Control Panel in 2nd Floor Telecomm/Electrical Room
