# **WELL REPORT**

# PRADO EAST WELL PROJECT

SAN BERNARDINO COUNTY CHINO, CALIFORNIA

## Well Service Report

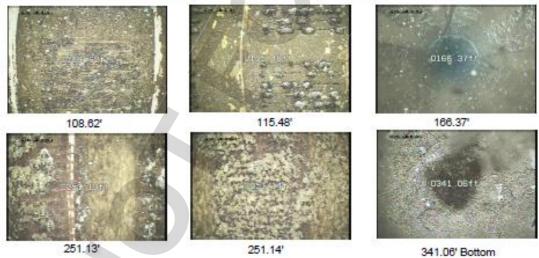
The video logs indicated that Well No. 3 has a 14-inch steel casing to a depth of 341 feet. Mill slotted perforations were found to begin at a depth of 108.6 feet and extended to a depth of 341 feet below the ground surface. The static water level was

below the ground surface. The static water level was at a depth of 32.22 feet.

Company Name; County of SB Prado Well Investigation	Date: 2/15/2024			
Well Name: #3	Depth: 341'			
Location: Prado - Hellman Ave	Water Level: 32.22 Oil? No			
City: Chino	Operator: Mike Truck: 1			
State: CA	Tool Zero: Yes			
Measured From: Top of Casing	Reason for Video: Review

Depth	Video Findings	Casing / Perforation Information			
0.3'	14" Steel Casing	Casing Size:	Depth		
3'	Start of 10" PVC Casing	10' PVC	Start 3' to 341'		
108.6	Mill Slot Perf Start				
341'	Bottom of Well				
	Perforations are plugged fill at bottom of well				
		Perforation:	Mill Slot

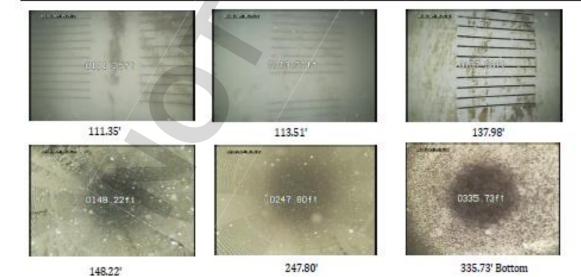
"vacuum" the brushed and other settled material from the bottom of the well. The brush and bail process was successful which was documented on March 18, 2024, through a video log of the well (Figure 4).

After completing the brush and bail of Well #3, a video log was done to show if the brush and bail was successful in removing build-up and debris from the well. The video showed the well has a 14-inch steel conductor casing and a 10-inch PVC liner to a depth of 335 feet. Mill slotted perforations were found to begin at a depth of 111 feet and extended to a depth of 335 feet below the ground surface. The static water level was at a depth of 31 feet.

Date: March 18, 2024				
Depth: 335				
Water Level: 31' Oil?				
Operator: Ryan Truck: 1				
Tool Zero: Yes				
Reason for Video: Review

Depth	Video Findings	Casing / Perforation Information			
03'	14" Steel Casing	Casing Size:	Depth		
3'	Start of 10" PVC Casing	10" PVC	Start 3' to 335'		
111'	Mill Slot Perf Start				
335'	Bottom of Well				
		100 100			
		Perforation:	Milled Slot		
			b v makturokvansk		
			13

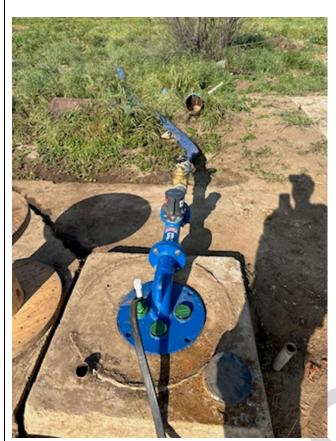
Figure 5a: Test Pump, meter, and discharge hose set for pumping test.

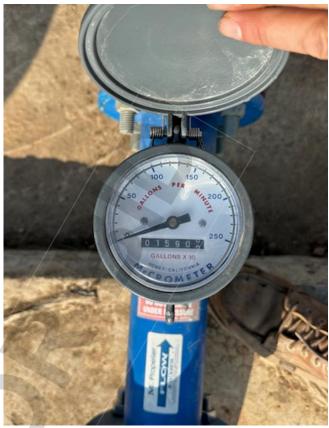
Figure 5b: Meter reads 15900 at start of Pumping test, estimate flow from testing ~180,000 gallons.
