Converse Consultants

September 8, 2023

Subject: LIMITED ASBESTOS & LEAD-BASED MATERIALS SURVEY REPORT
303 West 5th Street
San Bernardino, California
Converse Project No. 22-16-180-01

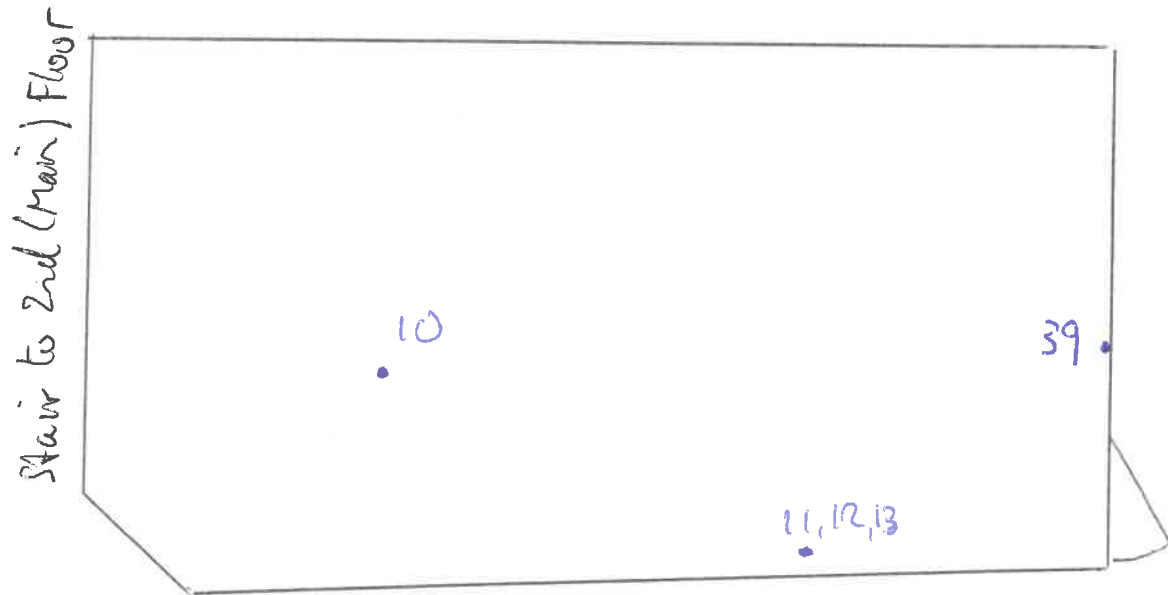
Bulk Sample Location Map - HVAC Mezzanine
303 W. 5th St., San Bernardino, CA

Roof penetration mastic, and water valve gaskets on 1-inch diameter water pipe on the HVAC Mezzanine were found to contain asbestos and are considered an ACM. The roof mastic and the gaskets will need to be abated prior to any renovation activities that may impact them.
