PROPERTY ASSESSMENT REPORT

SAN BERNARDINO COUNTY

303 W. 5TH STREET DESIGN-BUILD PROJECT

IMEG #23005335.00

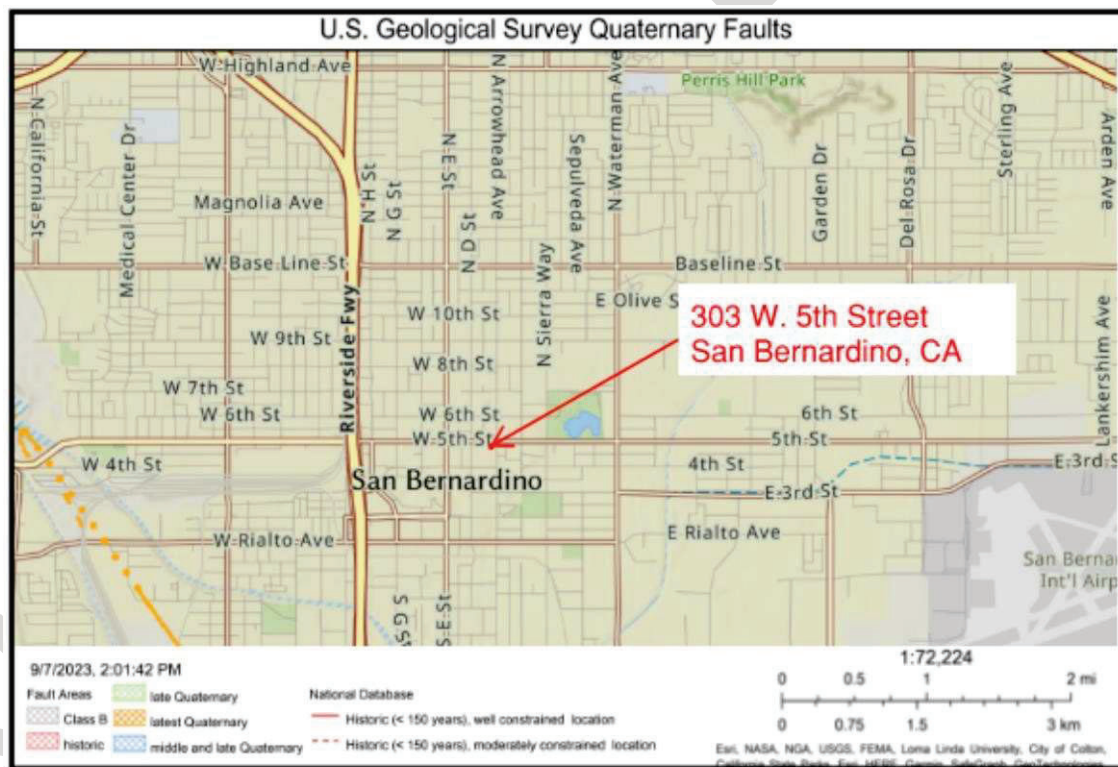
Figure 1: Fault Map near 303 W. 5th Street

- 1) 303 W. 5th Street is located in the seismically active region of San Bernardino County in Southern California as shown in Figure 1. There are many active and potentially active faults in the vicinity, the most significant being the San Jacinto Fault just south of the site. It is anticipated that this area will experience a significant earthquake in the next 30 to 50 years, and therefore this building will experience moderate to severe ground shaking. The fault map in Figure 1 below shows the location of the site relative to nearby faults.
- 2) The site is indicated to be in an area of high potential liquefaction.

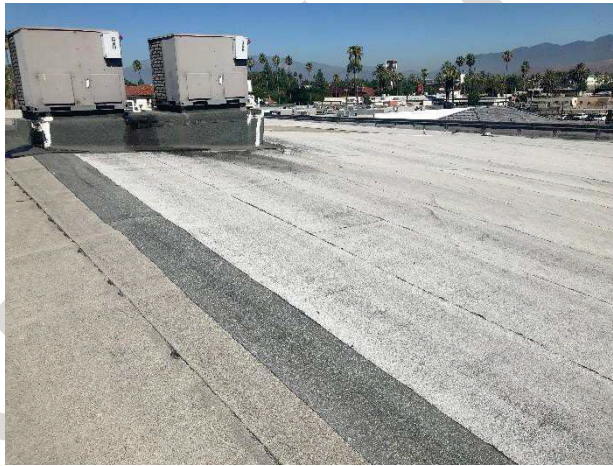
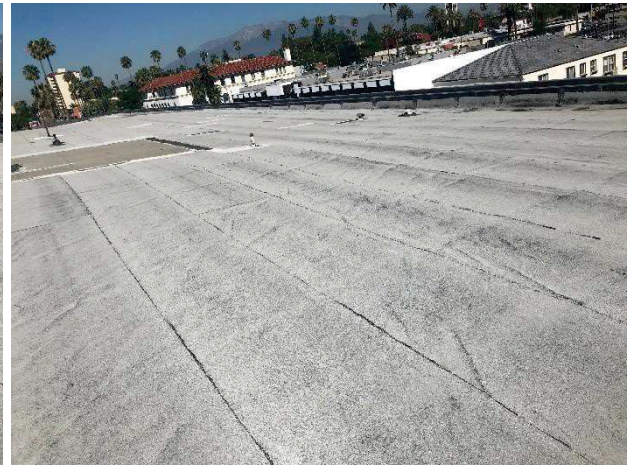
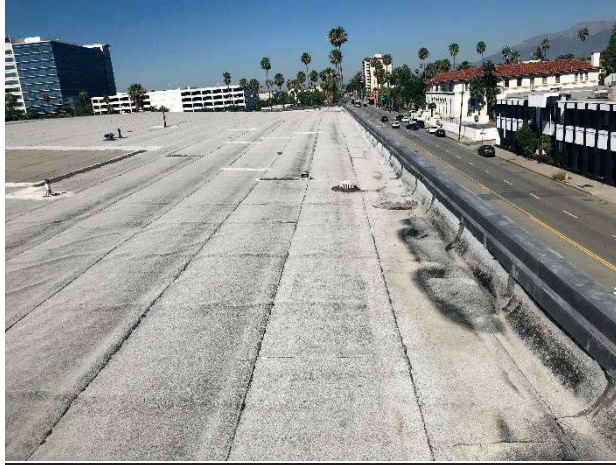
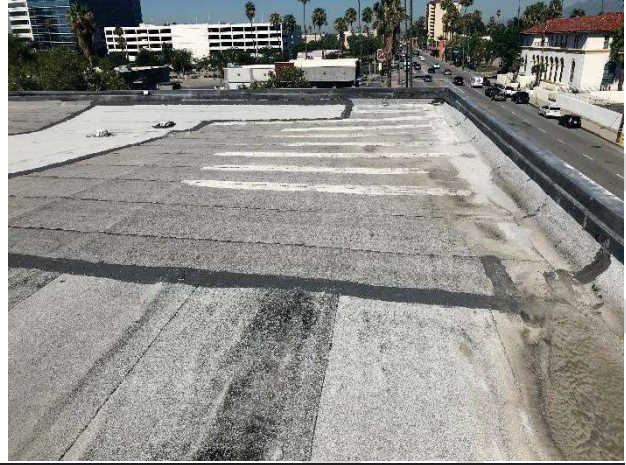
- e. The flashings have been haphazardly patched with black tar.
- f. The coping is rusty, but in general, in fair condition. A few seams have been patched with black tar. Electrical conduit is attached to the metal coping inside and top surface.

- g. Roof drains are in place, but stains on the roof surface indicate prior drain blockage. Overflow drains drop through the overhang so that rain overflow drops 2 stories to the sidewalk below.

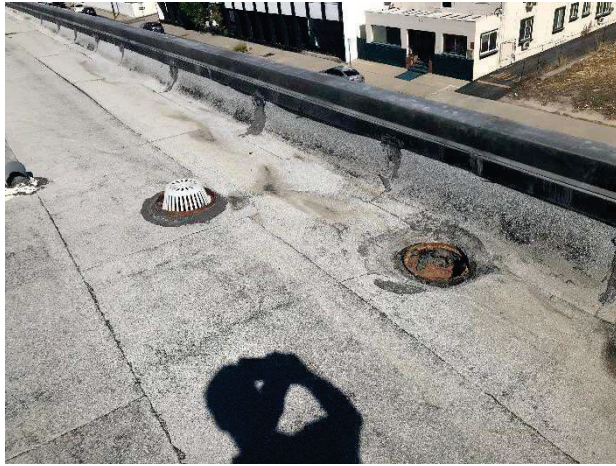
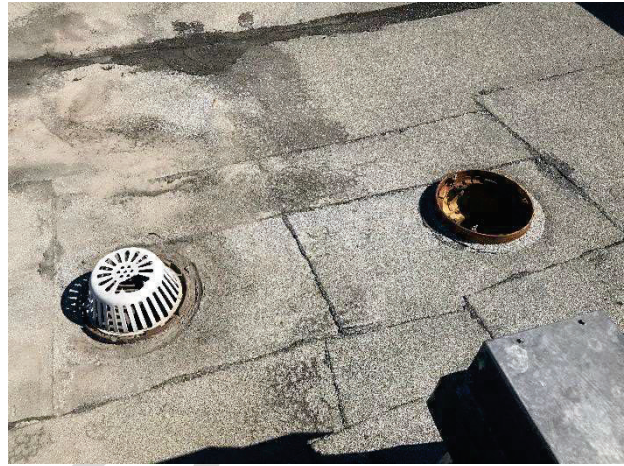
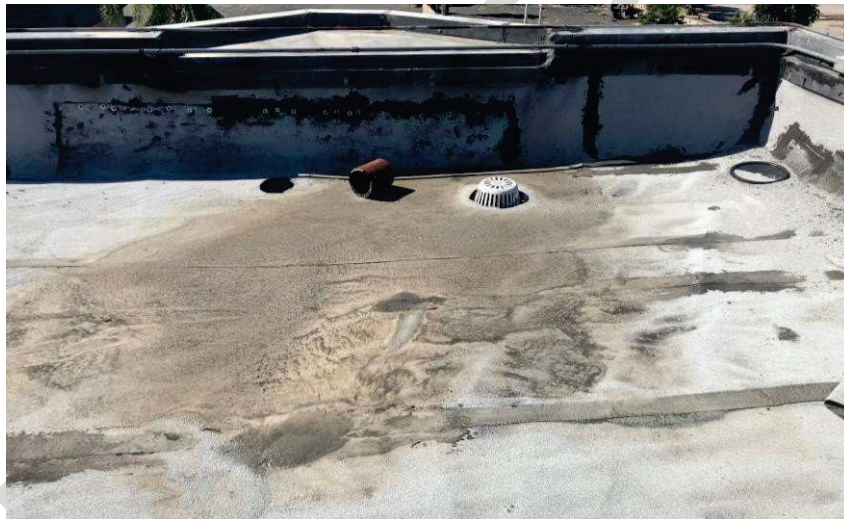
Some roof drain leakage was noted in the interior of the offices. Roof drain piping should be fully inspected. The existing piping appears to be cast iron, which may be replaced with PVC piping where rusted or damaged piping is recommended to be replaced anyway.

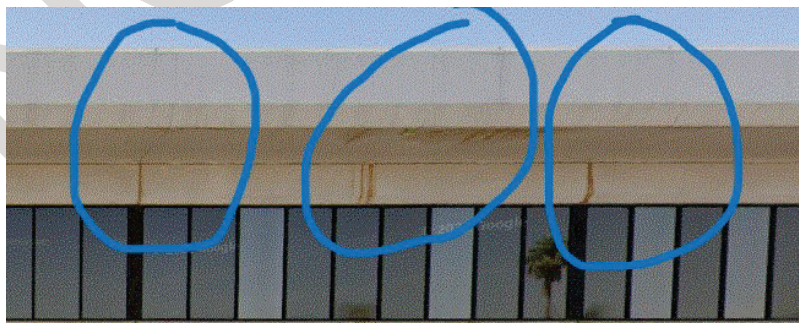
Staining on the stucco tells the story of moisture seeping between stucco joints. Mild weather will prevent any significant damage, but all joints should be maintained. Recommend caulking stucco joints and cleaning stains from stucco.

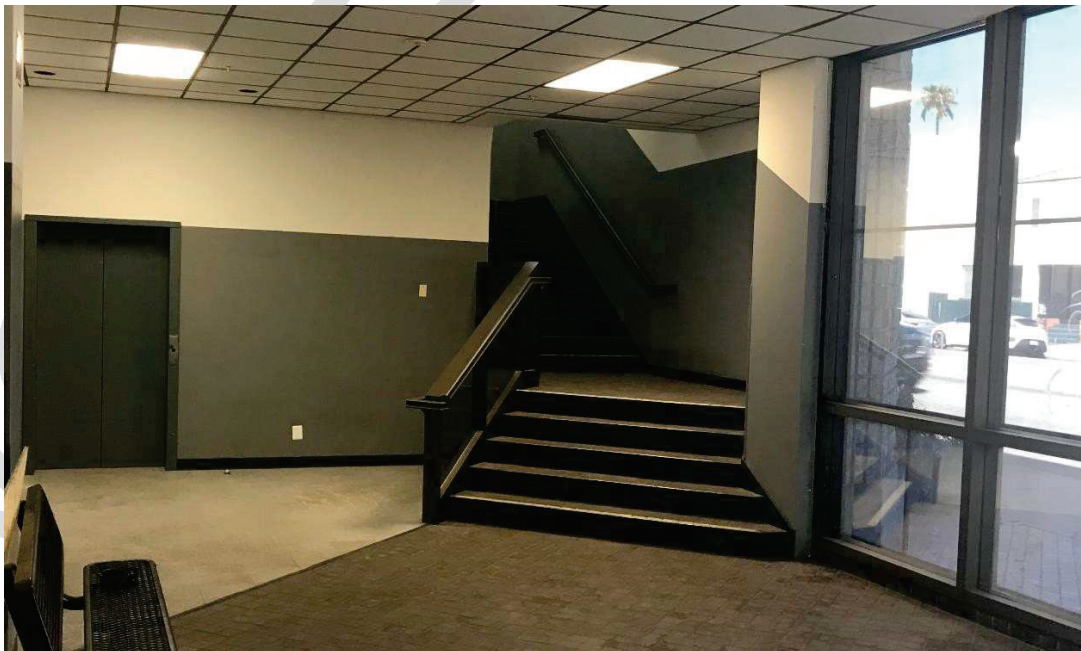
Both sets of stairs between the ground and upper floor are compliant with riser heights and tread depth, handrail heights and extensions, guardrail heights, clear width, and required nosing materials. The main stair on the north side of the building between the public lobby and the existing service window is lacking a handrail at the bottom on the north side of the stair.

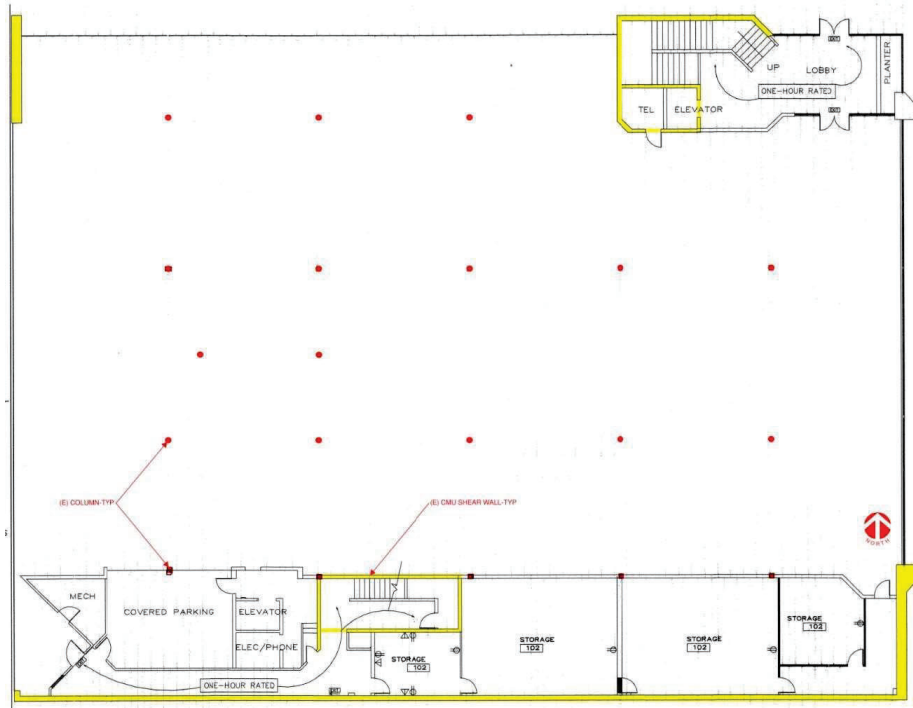
Photo S1 - CMU shear wall and column layout plan

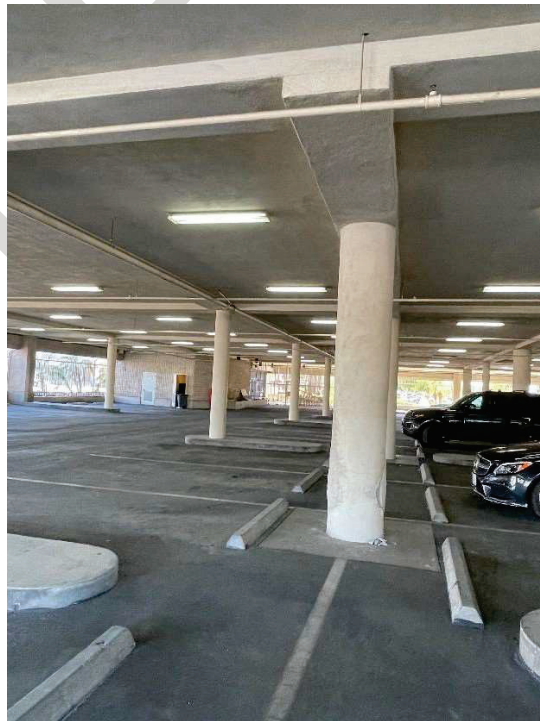
Photo S2 – View of two columns added in previous retrofit

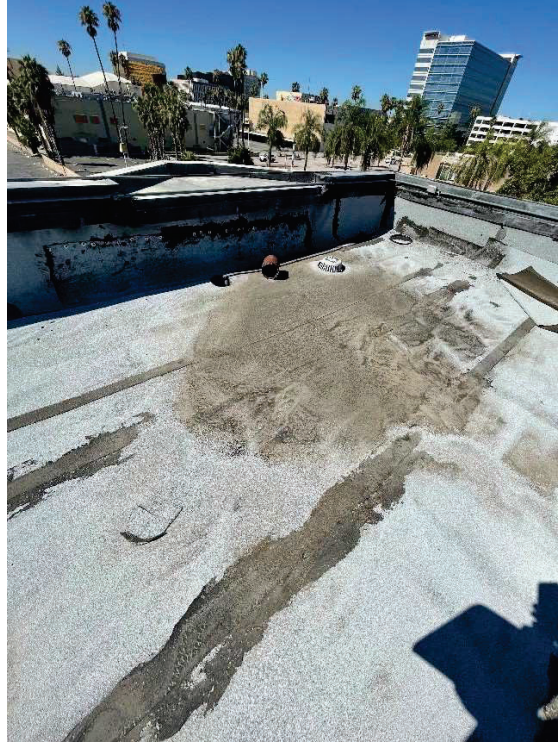
Photo S3 – View of ponding on corners of roof

- 1) The overall building appears to be in reasonably good condition and similar to other buildings of the same type and period of construction.
- 2) MEP units need to be replaced in the future (5 to 10 years) as per MEP professional recommendations. Structural anchorage and roof framing analysis/strengthening may be required for the new equipment support.
- 3) Support should be provided for the gas line that lacks proper support and bracing.
- 4) The two columns in the parking area that appear to be from a prior building renovation or retrofit should remain in place.
- 5) Rooftop drainage should be cleaned and verified at all locations to prevent ponding on the roof. Adequate roof slope and drainage should also be confirmed.

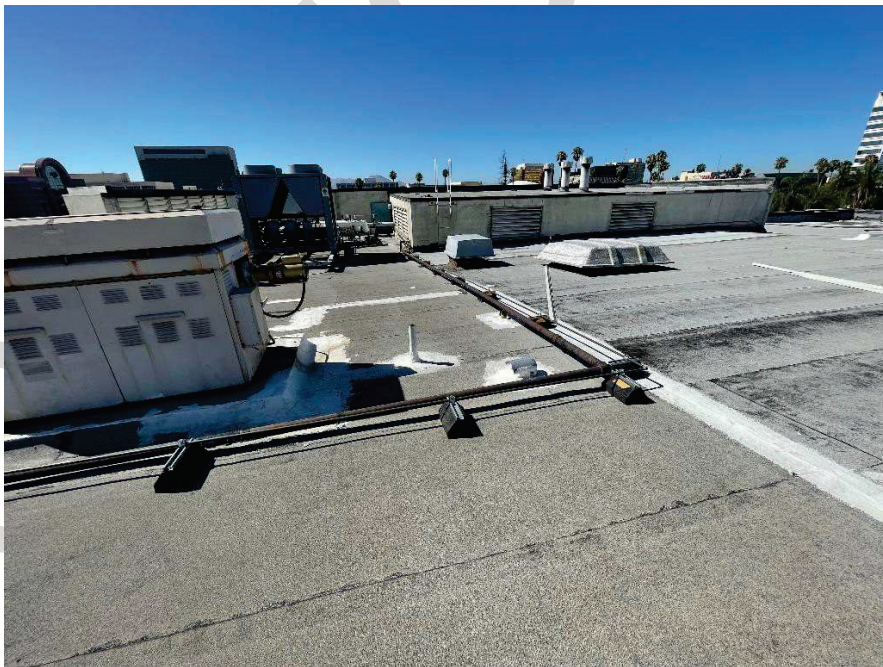
- 6) The main gas line on top of the roof appears to have no seismic bracing or load bearing support, see Appendix B.
- 7) During the overall site walkthrough, no to minimal observations of cracking or settlement were observed around the building.

Photo S4 - View of main gas line with no seismic bracing support
