TANK 2B INSPECTION REPORT

CSA 64 RECOATING TANKS 2A AND 2B PROJECT

**COUNTY SERVICE AREA 64
HESPERIA, CALIFORNIA**

CSA 64 1MG 2B Tank

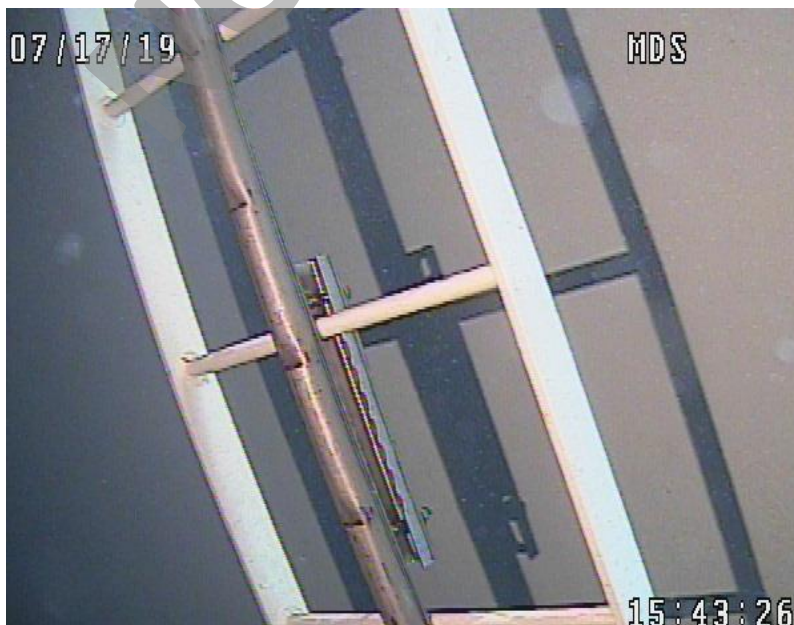
Summary: The ladder has good coating conditions overall. Minor surface corrosion and blistering noted.

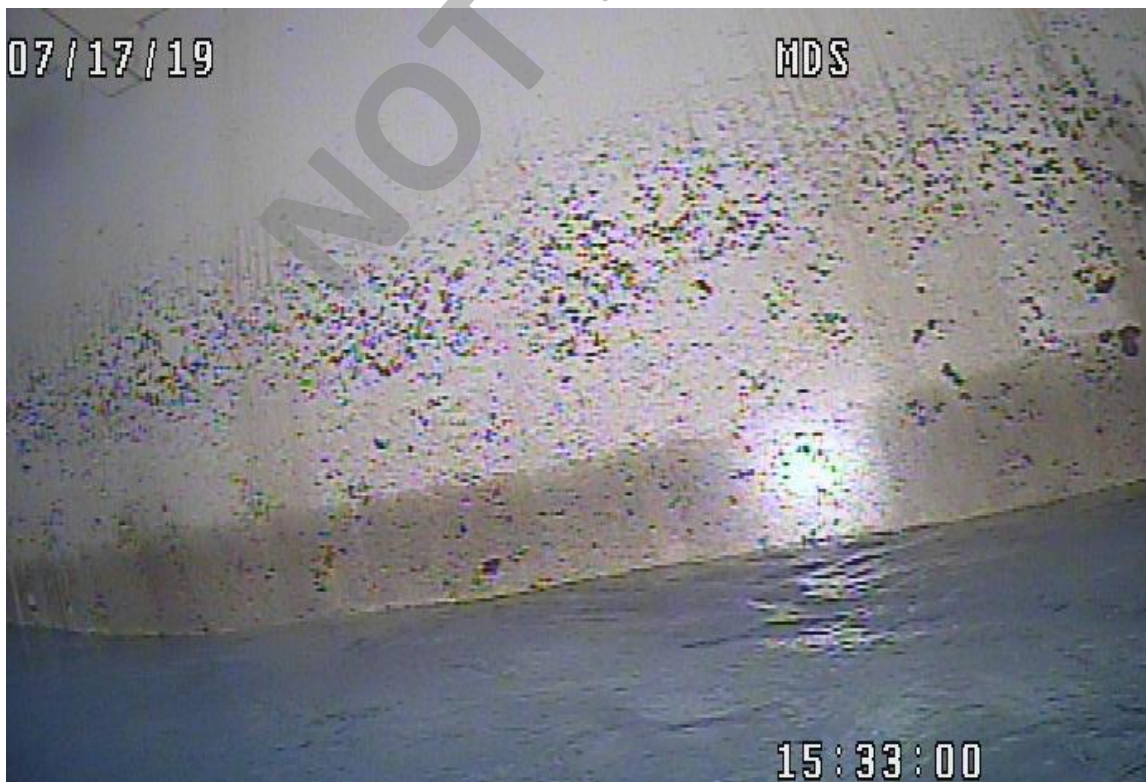
Summary: The wall panels have good coating conditions overall. Minor sediment staining occurring. Minor surface corrosion and de-lamination noted.

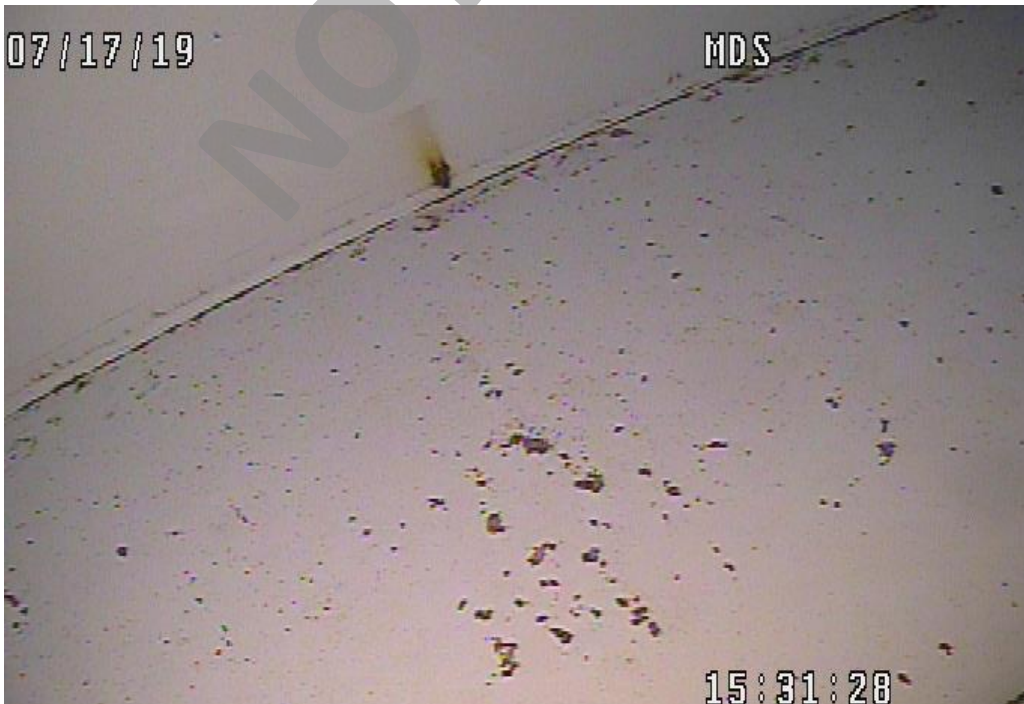
Summary: The floor panels have good coating conditions overall. Minor surface corrosion noted.

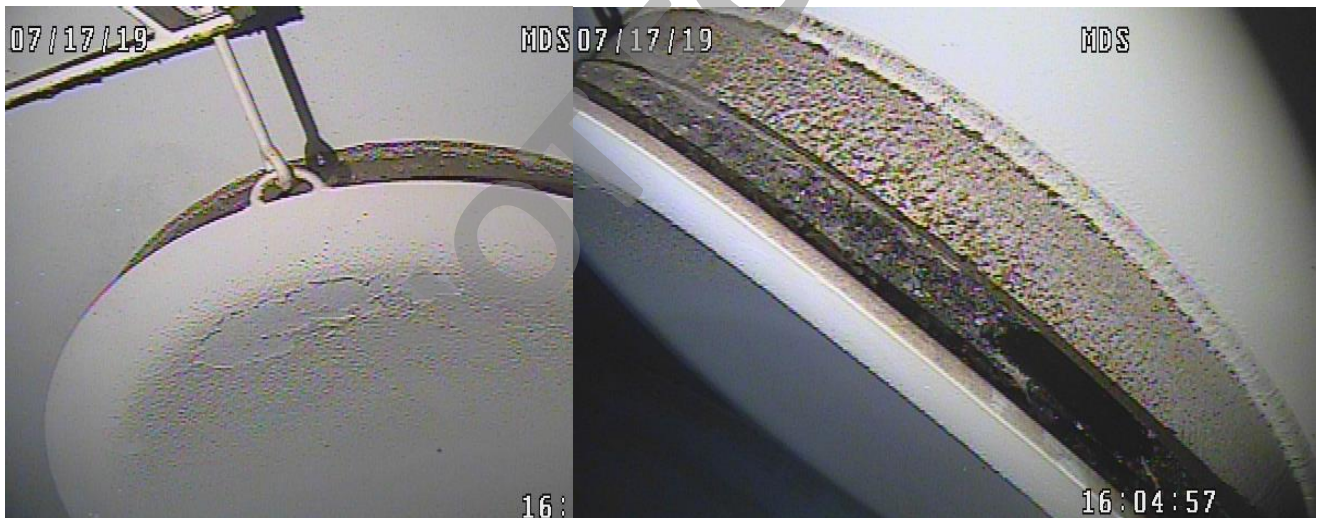
Summary: The manways have good coating conditions overall. Minor surface corrosion and calcium deposits present.

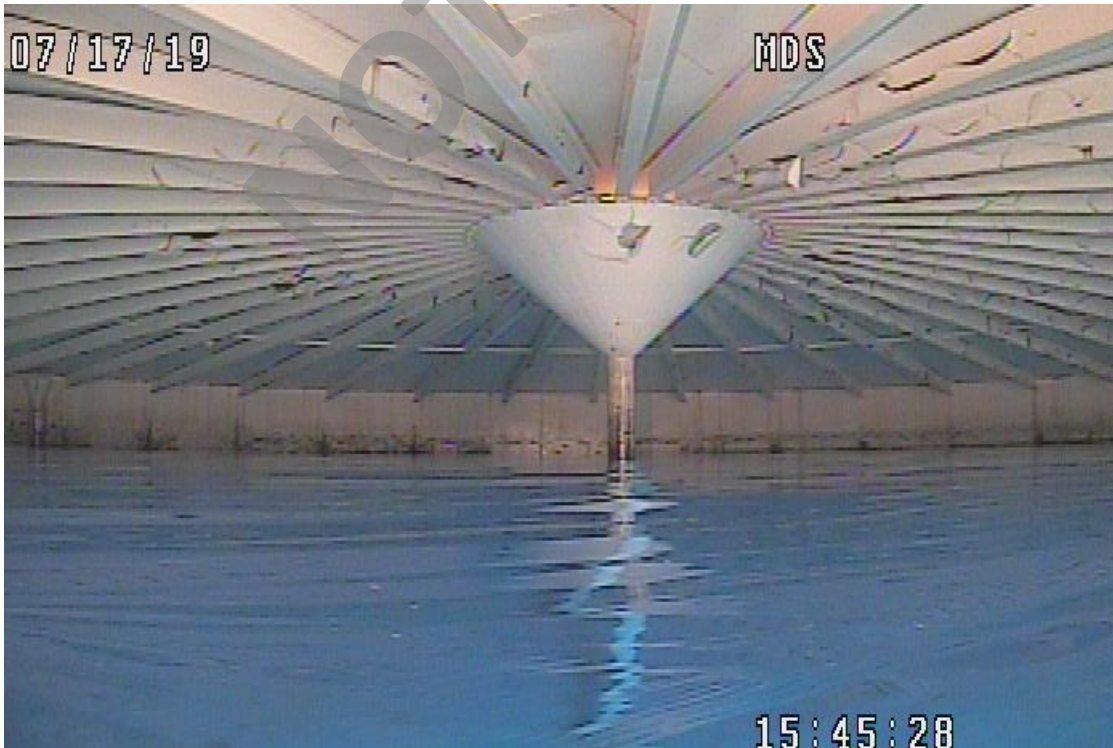
Summary: The roof panels have poor coating conditions overall. De-lamination occurring on the support beams. Heavy surface corrosion noted. Some condensation occurring around the 8:00 position.

-The interior roof has surface corrosion and de-lamination on the support beams.

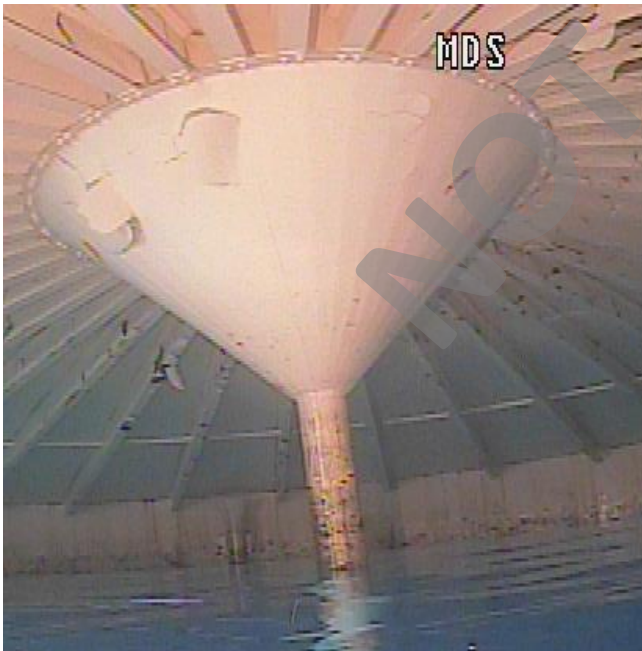
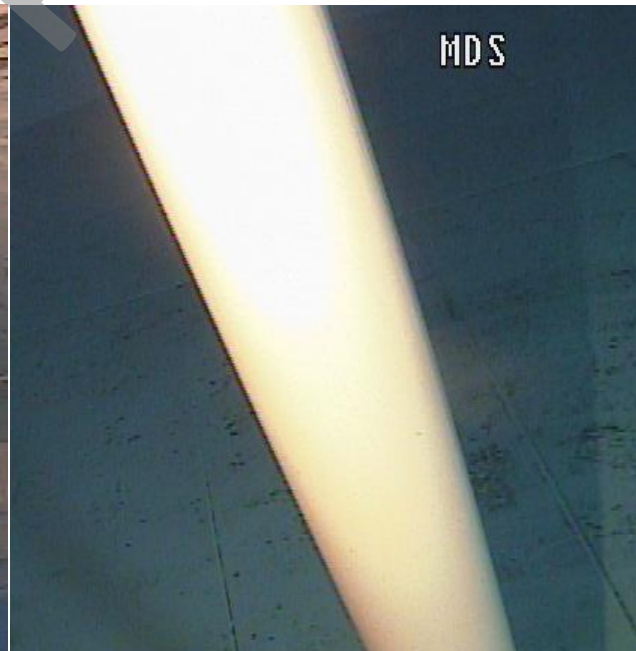
Summary: The support column has good coating conditions overall. De-lamination occurring. Minor sediment staining present.

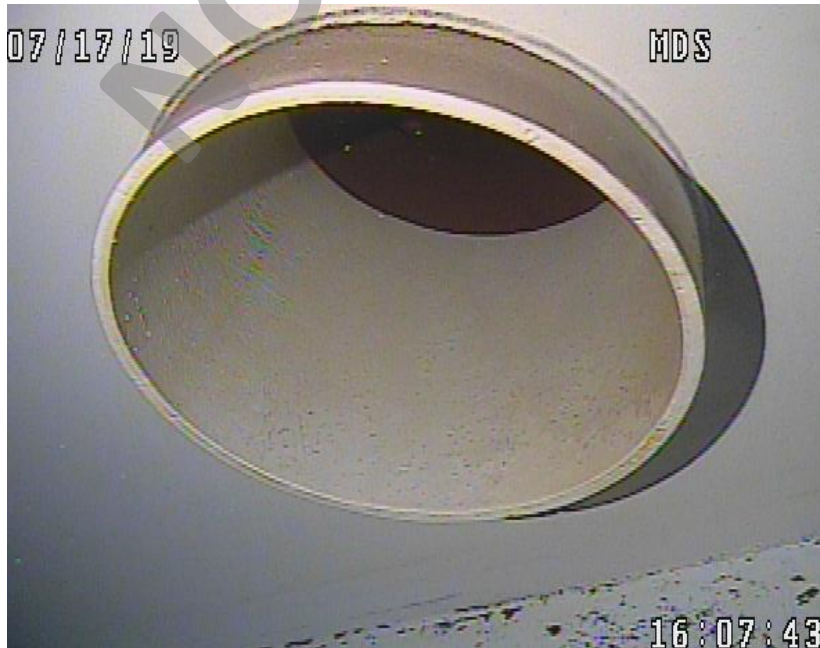
Summary: The inlet/outlet has good coating conditions overall. No major discrepancies noted.

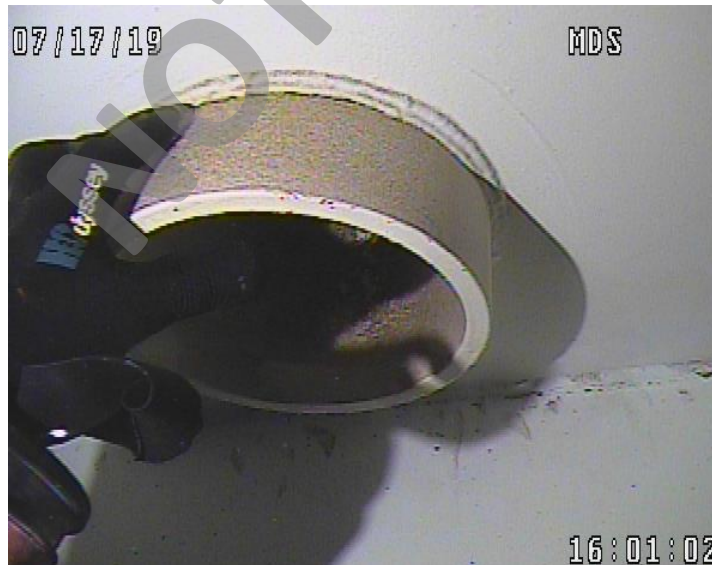
Summary: The drain has good coating conditions overall. No major discrepancies noted.

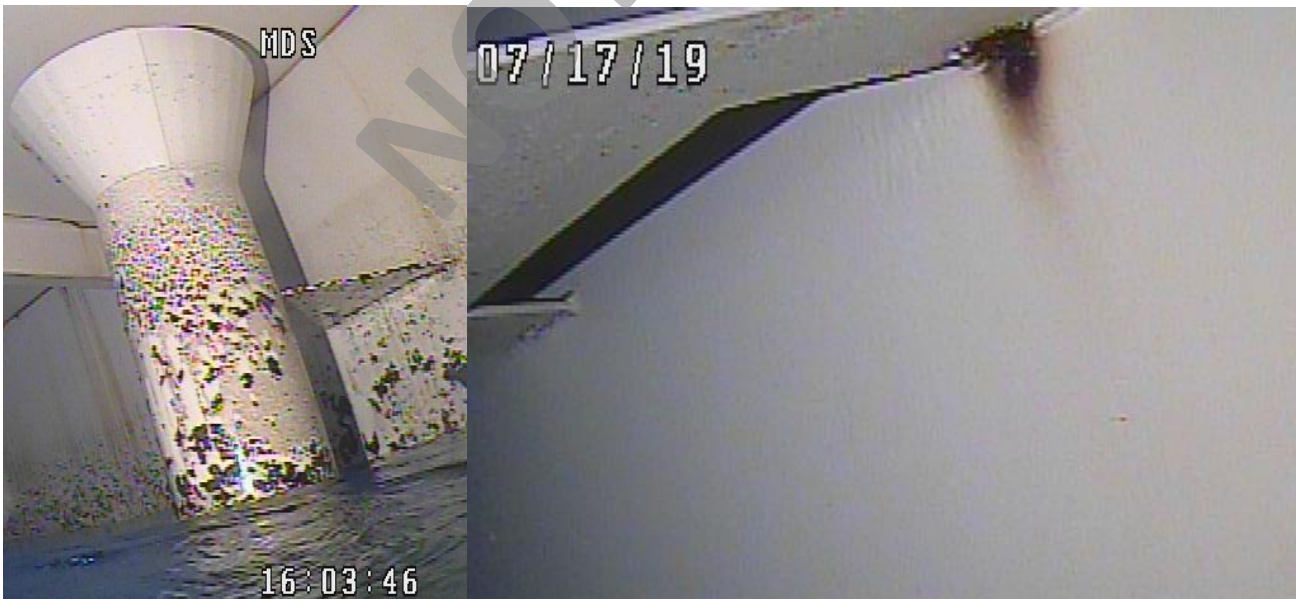
Summary: The overflow has good coating conditions overall. Minor mineral deposits forming. Heavy sediment staining occurring. Minor de-lamination and surface corrosion of the coating noted.
