Daniel J. Begley
ISA Certified Arborist WE10427A
CTSP, TRAQ, V.P. MRFSC (Ret.)
P.O. Box 26899
Running Springs CA 92382

Laurie and Ted Shelton
27375 Hwy 189
Blue Jay CA 92317

May 2, 2022

Re: Project #2020-00205 and potential impact to trees

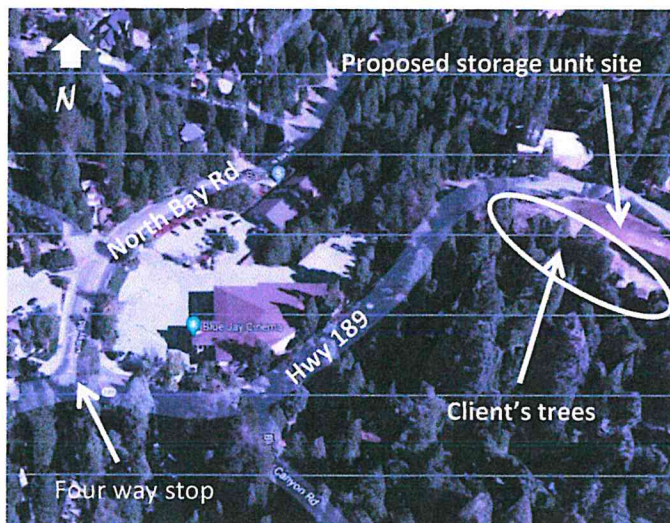
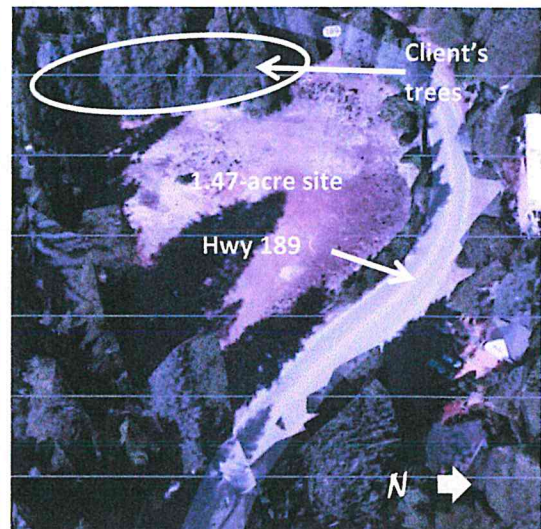
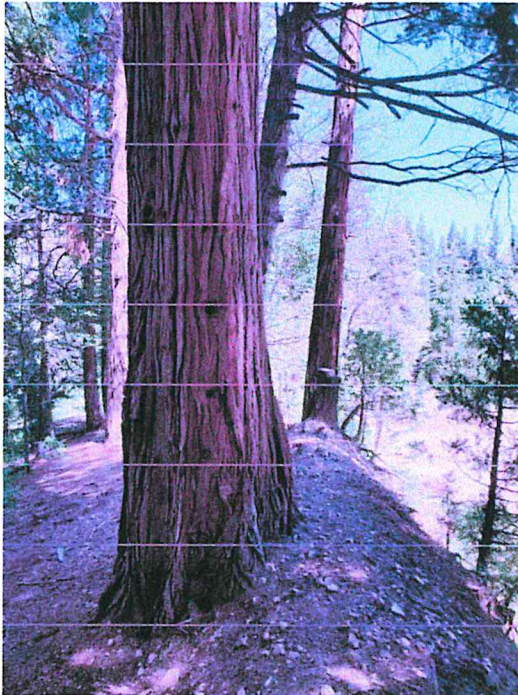
Note the significant diameter and taper developed by this California incense cedar (*Calocedrus decurrens*) which allows it to occupy this windy site atop the cut slope. Trees like these lining the top of the slope protect those downwind. The loss of such trees leads to "edge trees," which are more likely to fail during wind events. Maintain these trees at all costs.

The concerns for the health and safety of these trees are legitimate. Specifically, cutting into this slope to build a retaining wall, or for any other reason, can result in the loss of feeder roots at the least, and buttress roots at the worst. The former will stress a tree, while the latter will destabilize it. The destabilization of and the loss of this row of trees, residing atop a slope and facing the brunt of storms from the northeast, would subject the newly exposed trees behind them, making them "edge trees." Edge trees have not evolved in the wind as their former protectors did, and do not possess the requisite diameter and taper to sustain the forces of straight-line wind events. This renders them more likely to fail. That is, unless they themselves are afforded enough time to form "reaction wood" and become strong enough. There is no guarantee of that.

- Establish a Tree Protection Zone on the construction side of the trees. Ensure that all tradesmen adhere to TPP rules.
- Avoid any physical improvements within twelve (12) feet horizontally from any tree.
- Any desired tree work should be done before the construction commences.
- Avoid introducing contaminants, including trash, within the TPP.
- Do not allow backhoes, excavators, trenchers, or any other construction equipment to come in contact with these trees.
- In the unlikely event that soil is added on the cut slope, do not extend this onto the client's property. This can affect the roots ability to uptake nutrients and water.

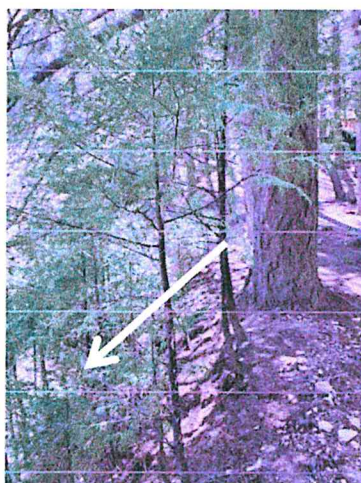
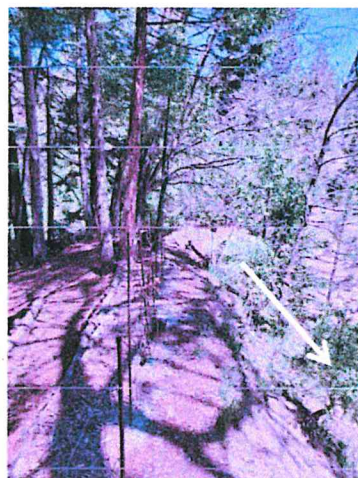
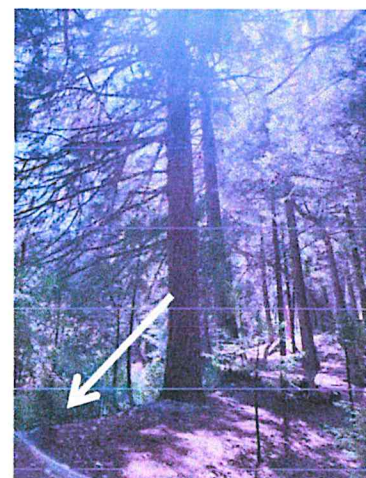
The photos below show trees along the top of the slope between the client's property and the proposed storage facility below. The white arrows point downslope. Storms from the northeast, including Santa Ana winds, blow up this slope and straight into these strong trees. Weaker trees are sheltered downwind.

The loss of these trees could also subject structures to storms formerly unable to inflict much damage to them. Additionally, a realistic and significant concern is soil movement, through erosion or mechanical disturbance. The average density of the local soil is 1.3 grams per cc. It is very loose and airy, being just over 50% soil 3 feet down from the surface. The rest is space: macro holes and micro holes. This is characteristic of granite-based soils. The looseness of this soil type is renowned, and particular care must be exercised should high angle slopes be disturbed to ensure soils supporting the trees are not likewise disturbed. Soil can simply fall away, leaving roots exposed with no earth to cling to. Without appropriate caution, these trees could be rendered hazardous. To avoid this, it is strongly advised that no improvements be made any closer than twelve (12) horizontal feet from the base of any tree. It is further advised that a certified arborist be enlisted to establish a Tree Protection Zone (TPP) to ensure damages are avoided. It is assumed that no contaminants, including solvents, gasoline or diesel fuel, cement or mortar, adhesives, or other compounds utilized during and after construction, are allowed to enter the environment.
