LIMITED ASBESTOS AND LEAD SURVEY REPORT

Site #51: Skyland
 Terracon Project LA227176
 September 9, 2022

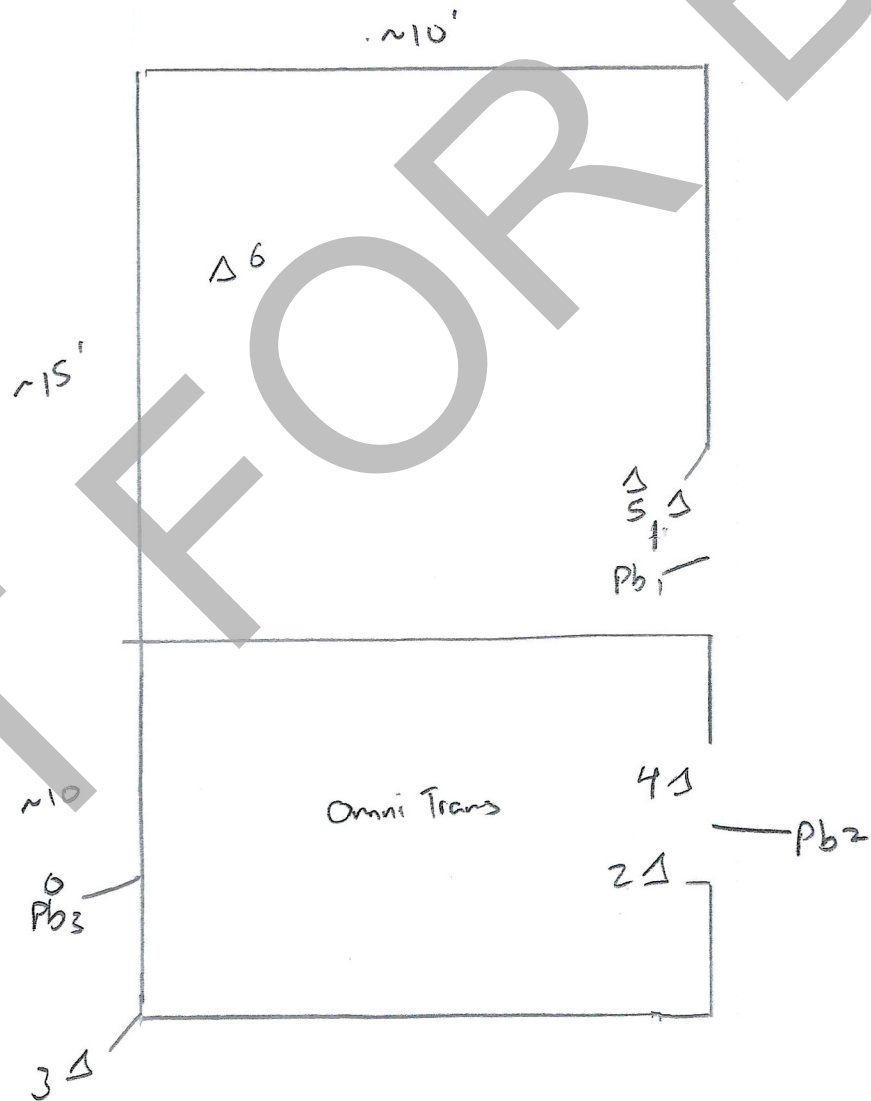
SAMPLE LOCATION DIAGRAM

Communications Shelter
