SCHOOL RECOMMENDATIONS

RUTH O. HARRIS MIDDLE SCHOOL

4.5 CRESTMORE ELEMENTARY SCHOOL

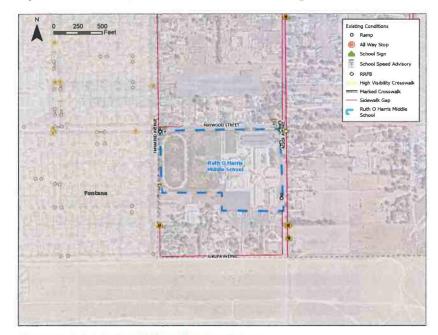
Figure 4.4.9 Existing Pedestrian Conditions

Figure 4.4.9 provides an overview of the existing pedestrian network and challenges observed during the mobility assessment. The sidewalk network surrounding Ruth O. Harris Middle School is incomplete. There are no sidewalks on the east side of Alder Avenue, the north side of Maywood Avenue and parts of Tamarind Avenue. There is currently an existing Rectangular Rapid Flashing Beacon (RRFB) on the south leg of Alder Avenue and Maywood Street with a high-visibility crosswalk. The walk audit observed that the RRFB works well and is functional.

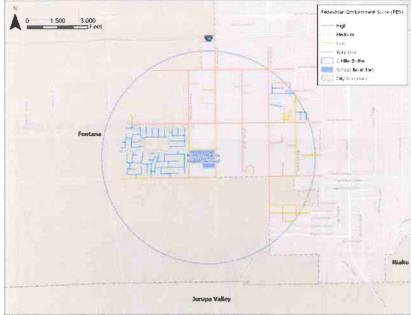
Figure 4.4.10 Pedestrian Evaluation Score

Challenges to walking were evaluated using the Pedestrian Evaluation Score (PES) developed by CR Associates. Based on the physical environment, surrounding land uses, and the street environment, a PES score was developed for nearby roadways. Figure 4.4.10 shows the results of the PES scoring. A sidewalk network with medium and high PES scores indicates low stress for walking, whereas low or very low PES scores can be considered a stressful walking environment. The roadways near Ruth O. Harris Middle School show primarily low PES scores, with a very low score on Jurupa Avenue, Alder Avenue, and Santa Ana Avenue. This indicates a stressful walking environment near the school along these roadways and may create an access barrier for students walking to school.

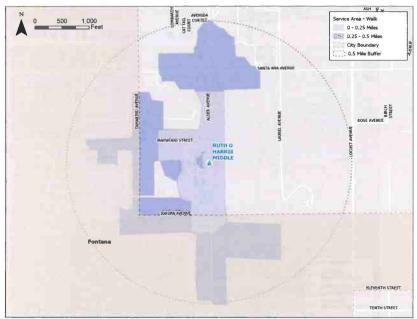
Figure 4.4.11 Existing Pedestrian Walkshed

Figure 4.4.11 shows the walkshed for Ruth O Harris Middle School. The walkshed shows the area which a student can walk a half mile from the school. The walkshed has been reviewed for sidewalk connectivity and accessibility.

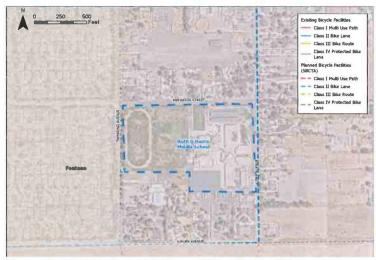
Figure 4.4.12 Existing and Planned Bicycle Conditions

Currently, there are no bicycle facilities surrounding Ruth O. Harris Middle School. There are plans to implement a Class II Bike Lane along Jurupa Avenue and Cedar Avenue through San Bernardino County Transportation Authority (SBCTA) (Figure 4.4.12).

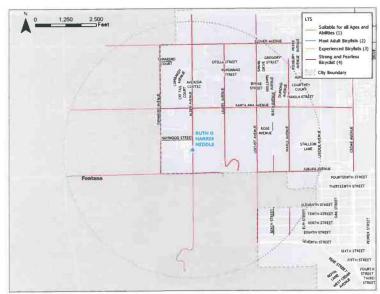
Figure 4.4.13 Bicycle Level of Traffic Stress

The bicycle environment was assessed using the bicycle Level of Traffic Stress (LTS) methodology for characterizing cycling environments, as developed by Mekuria, et al (2012) of the Mineta Transportation Institute. LTS takes into account a number of factors to classify the street network into categories according to the level of stress it causes cyclists. The LTS assessment conducted by MBI concluded that the roads immediately surrounding Ruth O. Harris Middle School have high LTS scores indicating higher stress levels for cyclists (Figure 4.4.13).

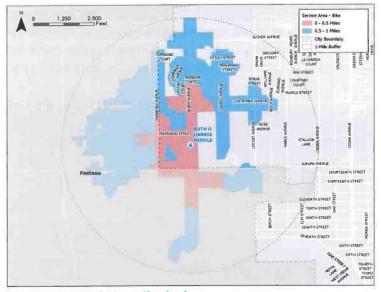
Figure 4.4.14 Existing Bikeshed

Figure 4.4.14 shows the bikeshed for Ruth O. Harris Middle School. The bikeshed shows the area which a student can bike two miles from the school.

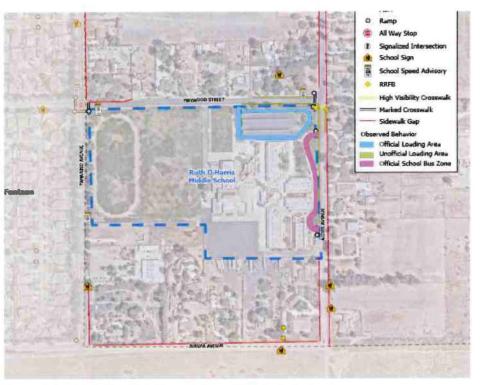
Figure 4.4.15 Existing Pick-Up and Drop-Off Vehicle Behavior

Ruth O. Harris Middle School is accessed via Alder Avenue, a two-lane road with parking along both sides, and Maywood Street, a two-lane road. Figure 4.4.15 illustrates the existing pick-up and drop-off conditions, and the behaviors observed during the mobility assessment.

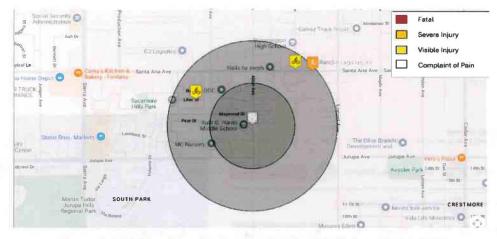
Figure 4.4.16 Bicycle and Pedestrian Involved Collisions (2019-2023)

Between 2019 and 2023, there were two bicycle collisions and no pedestrian collisions within a half mile radius of Ruth O. Harris Middle School (Figure 4.4.16). Both collisions caused a complaint of pain. Within a quarter mile radius of the school there were no bicycle or pedestrian crashes reported.

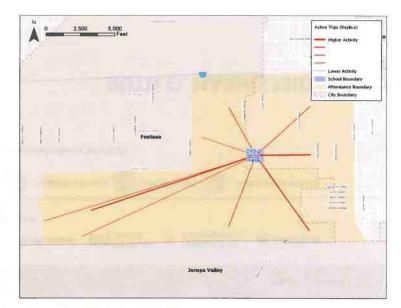
Figure 4.4.17 Active Travel Pattern

For each neighborhood, the number of trips made by each travel type was shown using lines on a map (Figure 4.4.17 and 4.4.18). A thicker line means more people are estimated to travel using that mode from that TAZ. Line thickness can be compared within the same mode of travel, such as comparing two walking routes from two different TAZs. One can also get a general sense of how walking and driving compare by looking at both sets of lines from the same TAZ side by side. For example, a thicker line for auto, compared to active for a particular TAZ indicates more of an interest in driving compared to walking or biking. It should be noted the lines are scaled differently for each mode of travel (auto and active), so they should not be compared directly. This data helps reveal how people tend to travel based on several factors, such as the existing walking or biking environment, land uses, physical barriers, population densities, and the layout of the roadway network.

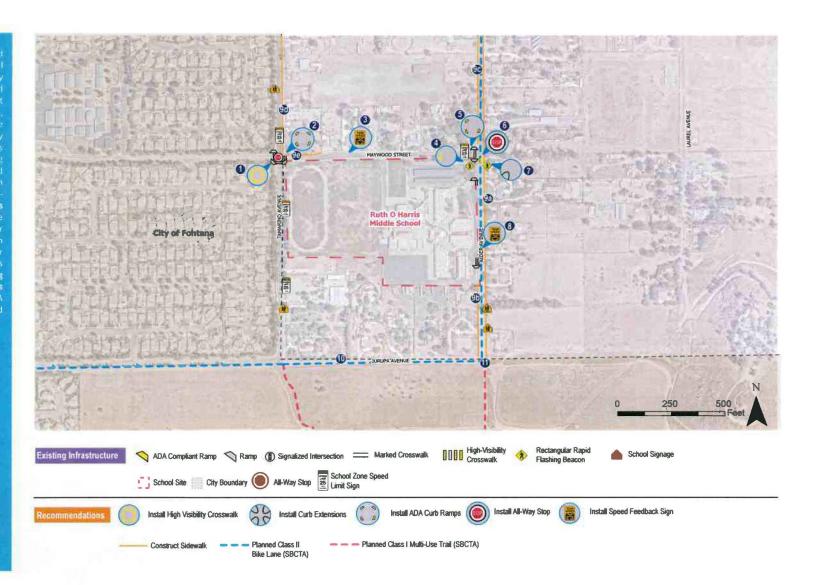
The walking and biking environments around Ruth O. Harris Middle School offer several opportunities for improvement, particularly at the intersection of Maywood Street and Alder Avenue. At this intersection, a bulb out is recommended to narrow the roadway width, creating a shorter crossing distance while allowing pedestrians to be seen more clearly by motorists. Additional improvements to this intersection include upgrading the existing crosswalks to high-visibility crosswalks and providing all-way stop control. For pedestrian accessibility, it is recommended to add ADA-compliant curbramps at all existing intersections and complete the sidewalks on the north side of Maywood Street and the east side of Alder Avenue. As part of SBCTA's Active Transportation Plan, Class II Bike Lanes are planned along Alder Avenue and Jurupa Avenue. Class I Bike Paths are planned south of Jurupa Avenue connecting to the existing utility trail. These improvements are highlighted in the graphic provided. A summary list of recommendations is included in Table 4.4.1.

ID	Improvement	Description	Location
1	High Visibility Crosswalk	Install a high-visibility crosswalks on all four legs of the intersection	Tamarind Avenue and Maywood Street
2	ADA Compliant Curb Ramps	Install ADA compliant curb ramps on all four corners of the intersection.	Tamarind Avenue and Maywood Street
3	Speed Feedback Sign	Install speed feedback sign along Maywood Street	Maywood Street between Tamarind Avenue and Alder Avenue
4	High Visibility Crosswalk	Install a high-visibility crosswalk on the west leg of the intersection	Maywood Street and Alder Avenue
5	ADA Compliant Curb Ramps	Install ADA compliant curb ramps on three corners of the intersection	Maywood Street and Alder Avenue
6	All-Way Stop Control	Replace existing RRFB with all-way stop control (*)	Maywood Street and Alder Avenue
7	Speed Feedback Sign	Install speed feedback sign along Alder Street	Alder Avenue between Maywood Street and Jurupa Avenue

8	Curb Extension	Install a curb extension at the southwest corner of the intersection	Maywood Street and Alder Avenue
9a	Sidewalk	Construct sidewalk on east side of street	Alder Avenue from Santa Ana Avenue to Jurupa Avenue
9b		Construct a sidewalk on the west side of street	Alder Avenue from Jurupa Avenue to school frontage
9с		Construct a sidewalk on the west side of street	Alder from Maywood Street to Santa Ana Avenue
9d		Construct a sidewalk on east side street	Tamarind Avenue between Maywood Street and Santa Ana Avenue
9e		Construct a sidewalk on the north side of street	Maywood Street between Tamarind Avenue and 250' east of Tamarind Avenue
10	Class II Bike lanes (SBCTA Planned)	Coordinate with SBCTA to construct Class II Bike Lanes per SBCTA planned bikeways	Jurupa Avenue between Alder Avenue and Sierra Avenue
			Alder Avenue between Jurupa Avenue to San Bernardino Avenue
11	Class I Multi-Use Trail (SBCTA Planned)	Coordinate with SBCTA to construct Class I Multi Use Trail per SBCTA planned bikeways	Dirt road south of Jurupa Avenue

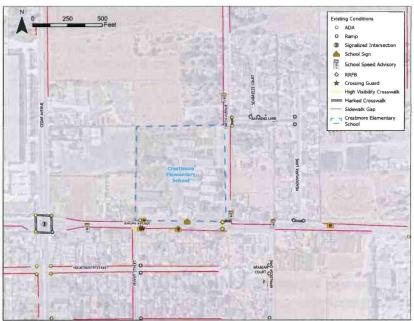
Figure 4.5.7 Existing Pedestrian Conditions

Figure 4.5.7 provides an overview of the existing pedestrian network and challenges observed during the mobility assessment site visit. The sidewalk network surrounding Crestmore Elementary School is incomplete. During the site visit, it was observed that there were no sidewalks on the south side of Jurupa Avenue and the east side of Larch Avenue. Sidewalks obstructions were also observed along the existing sidewalks on the west side of Larch Avenue including plant remnants and cracked concrete.

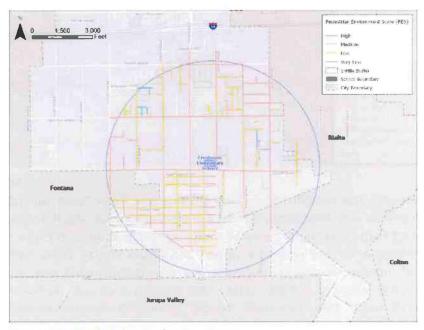
Figure 4.5.8 Pedestrian Evaluation Score

Challenges to walking were evaluated using the Pedestrian Evaluation Score (PES) developed by CR Associates. Based on the physical environment, surrounding land uses, and the street environment, a PES score was developed for nearby roadways. Figure 4.5.8 shows the results of the PES scoring. A sidewalk network with medium and high PES scores indicates low stress for walking, whereas low or very low PES scores can be considered stressful walking environments. The roadways near Crestmore Elementary School show primarily low PES scores, with very low scores on Larch Avenue, Cedar Avenue, and Jurupa Avenue. This indicates a stressful walking environment near the school along these roadways and may create an access barrier for students walking to school.
