## 4.5 CRESTMORE ELEMENTARY SCHOOL

18870 Jurupa Ave, Bloomington, CA 92316  
Colton Joint Unified School District

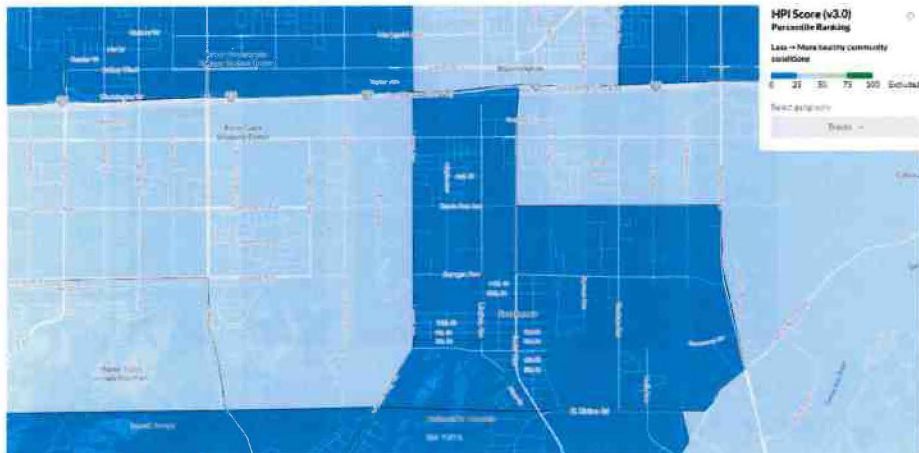
**Figure 4.4.8 Healthy Place Index Score - Ruth O. Harris Middle School**

The California Healthy Places Index (HPI), developed by the Public Health Alliance of Southern California, is a tool used to explore the community conditions that impact life expectancy. The HPI tool helps prioritize public and private investments, resources, and programs in neighborhoods where they are needed the most. The HPI tool combines 23 community characteristics such as access to healthcare, housing, education, and more. The tool produces a score ranging from 0-100 with a higher score representing a healthier community. The tool's indicators reflect widely recognized thematic areas of the social determinants of health and are consistent with those described by the Centers for Disease Control (CDC). Figure 4.4.8 illustrates the HPI scores for the census tract Ruth O. Harris Middle School is located within. The HPI score of 34.6 indicates less healthy conditions surrounding the school.

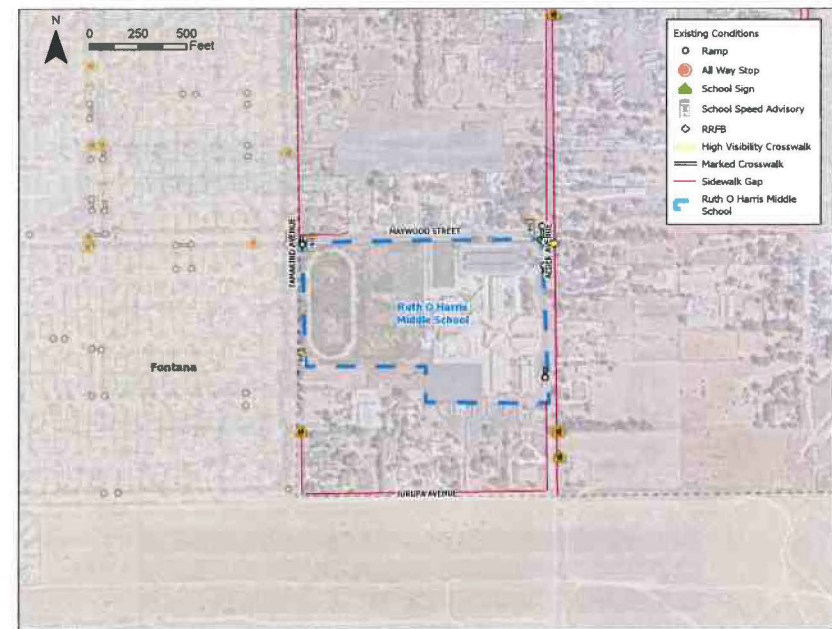
**Figure 4.4.9 Existing Pedestrian Conditions**

Figure 4.4.9 provides an overview of the existing pedestrian network and challenges observed during the mobility assessment. The sidewalk network surrounding Ruth O. Harris Middle School is incomplete. There are no sidewalks on the east side of Alder Avenue, the north side of Maywood Avenue and parts of Tamarind Avenue. There is currently an existing Rectangular Rapid Flashing Beacon (RRFB) on the south leg of Alder Avenue and Maywood Street with a high-visibility crosswalk. The walk audit observed that the RRFB works well and is functional.

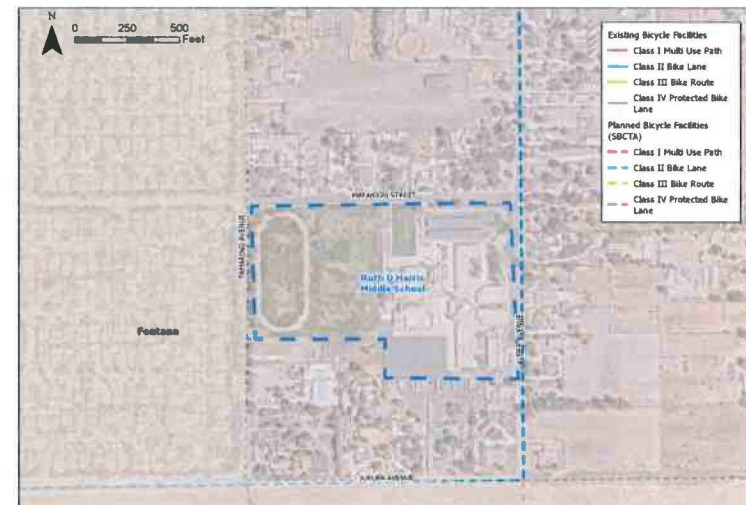
**Figure 4.4.12 Existing and Planned Bicycle Conditions**

Currently, there are no bicycle facilities surrounding Ruth O. Harris Middle School. There are plans to implement a Class II Bike Lane along Jurupa Avenue and Cedar Avenue through San Bernardino County Transportation Authority (SBCTA) (Figure 4.4.12).

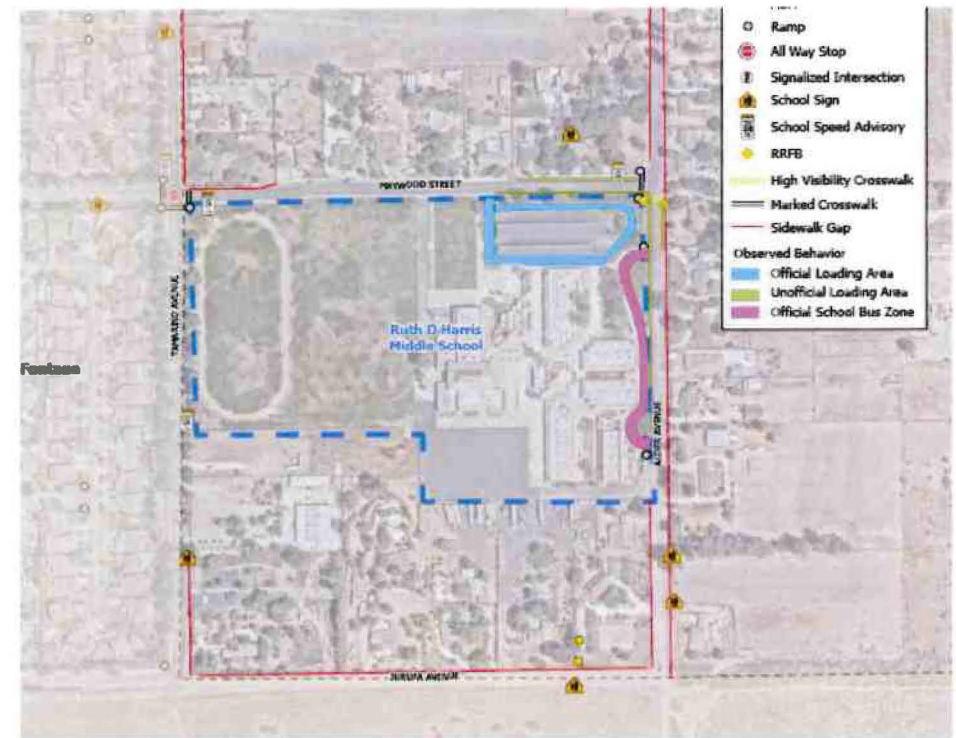
Figure 4.4.15 Existing Pick-Up and Drop-Off Vehicle Behavior

Ruth O. Harris Middle School is accessed via Alder Avenue, a two-lane road with parking along both sides, and Maywood Street, a two-lane road. Figure 4.4.15 illustrates the existing pick-up and drop-off conditions, and the behaviors observed during the mobility assessment.

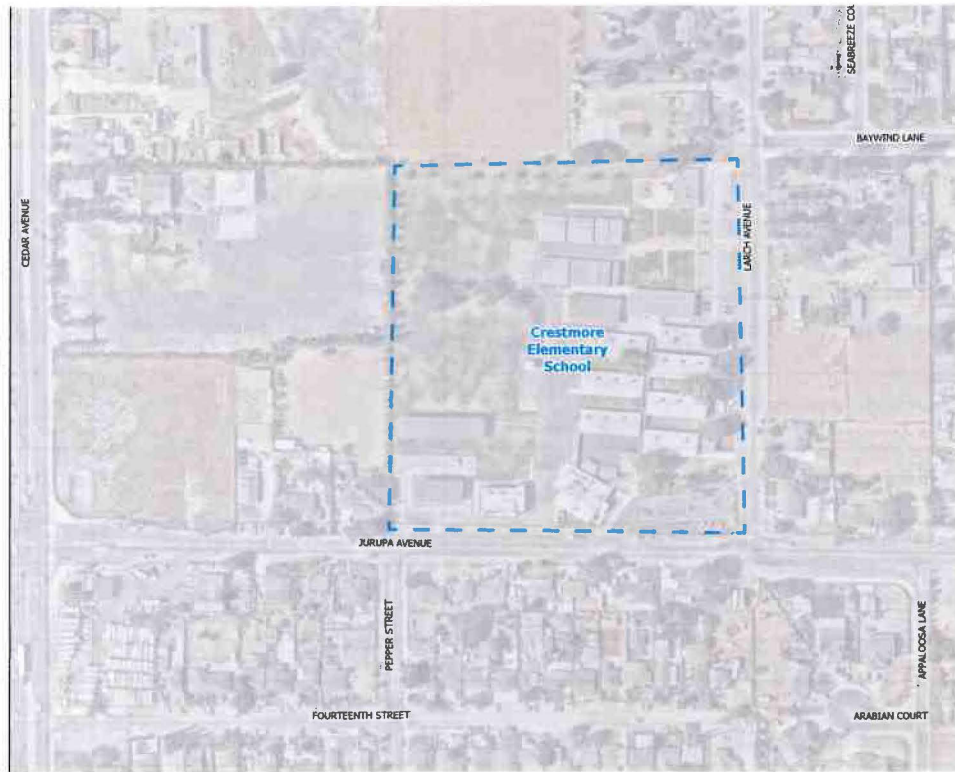
**Figure 4.5.1 Context Map**

Crestmore Elementary School is in southern Bloomington on the northwest corner of the intersection of Jurupa Avenue and Larch Avenue. The school is located approximately 1.5 miles south of Interstate 10 (I-10) and approximately 0.7 miles from Kessler Park. The land use surrounding Crestmore Elementary School is primarily residential with some industrial and vacant land. Figure 4.5.1 shows the school area and the overall context of the school site.

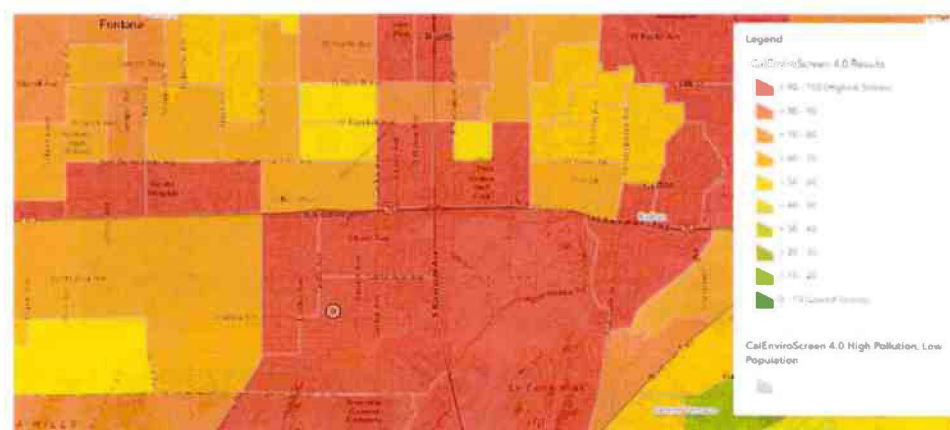
**Figure 4.5.5 CalEnviroScreen 4.0 Score - Crestmore Elementary School**

CalEnviroScreen (CES) is a tool developed by the California Office of Environmental Health Hazard Assessment (OEHHA) that identifies communities that are disproportionately burdened by pollutants. Indicators used to identify communities include exposures (traffic, pesticides, and drinking water), environmental effects (cleanup sites, solid waste), sensitive populations (Asthma, low birth weight), and socioeconomic factors (education, poverty, unemployment). Scores range from 0-100 with a higher score indicating a higher effect of pollutants for the area. Figure 4.5.5 illustrates the CES scores for Crestmore Elementary School and its surrounding area, scoring in the 95th to 100th percentile which indicates the area is disproportionately burdened by pollutants.

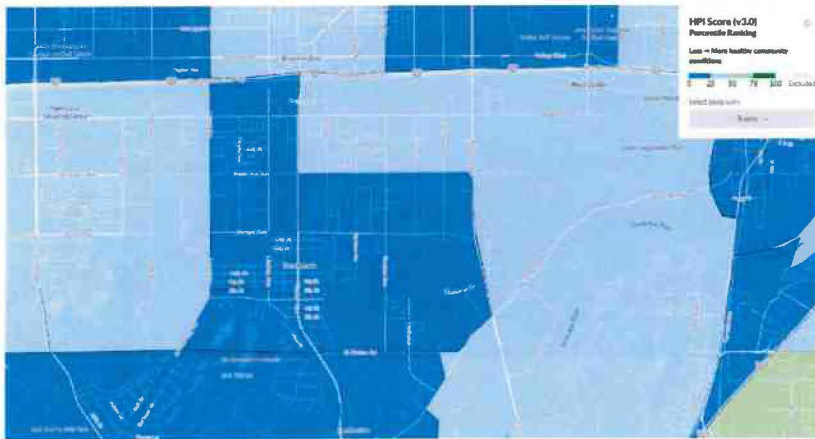
**Figure 4.5.6 Healthy Place Index Score - Crestmore Elementary School**

The California Healthy Places Index (HPI), developed by the Public Health Alliance of Southern California, is a tool used to explore the community conditions that impact life expectancy. The HPI tool helps prioritize public and private investments, resources, and programs in neighborhoods where they are needed the most. The HPI tool combines 23 community characteristics such as access to healthcare, housing, education, and more. The tool produces a score ranging from 0-100 with a higher score representing a healthier community. The tool's indicators reflect widely recognized thematic areas of the social determinants of health and are consistent with those described by the Centers for Disease Control (CDC). Figure 4.5.6 illustrates the area surrounding Crestmore Elementary School, which shows an HPI score of 13.9 indicating less healthy conditions surrounding the school.

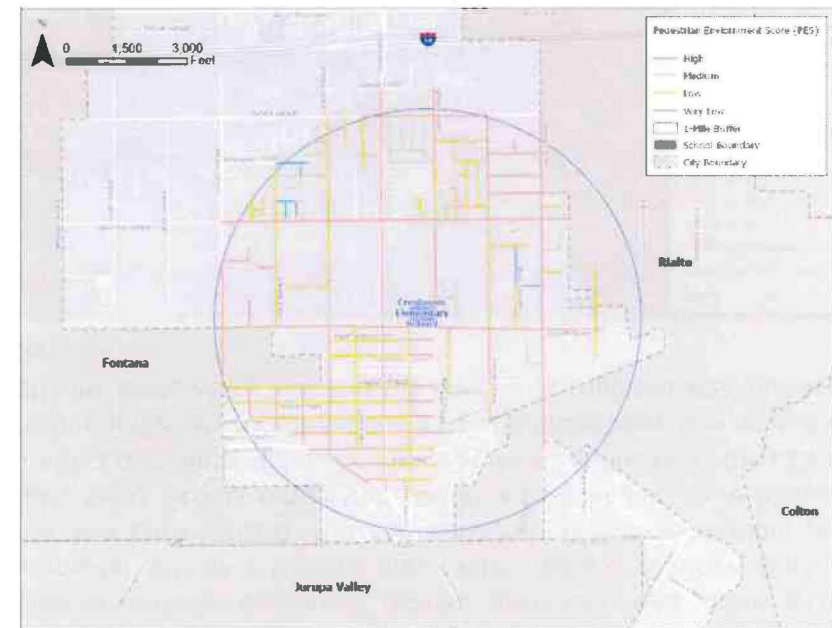
**Figure 4.5.8 Pedestrian Evaluation Score**

Challenges to walking were evaluated using the Pedestrian Evaluation Score (PES) developed by CR Associates. Based on the physical environment, surrounding land uses, and the street environment, a PES score was developed for nearby roadways. Figure 4.5.8 shows the results of the PES scoring. A sidewalk network with medium and high PES scores indicates low stress for walking, whereas low or very low PES scores can be considered stressful walking environments. The roadways near Crestmore Elementary School show primarily low PES scores, with very low scores on Larch Avenue, Cedar Avenue, and Jurupa Avenue. This indicates a stressful walking environment near the school along these roadways and may create an access barrier for students walking to school.
