SCHOOL RECOMMENDATIONS

# 4.6 KIMBARK ELEMENTARY SCHOOL

18021 Kenwood Ave, San Bernardino, CA 92407  
San Bernardino City Unified School District

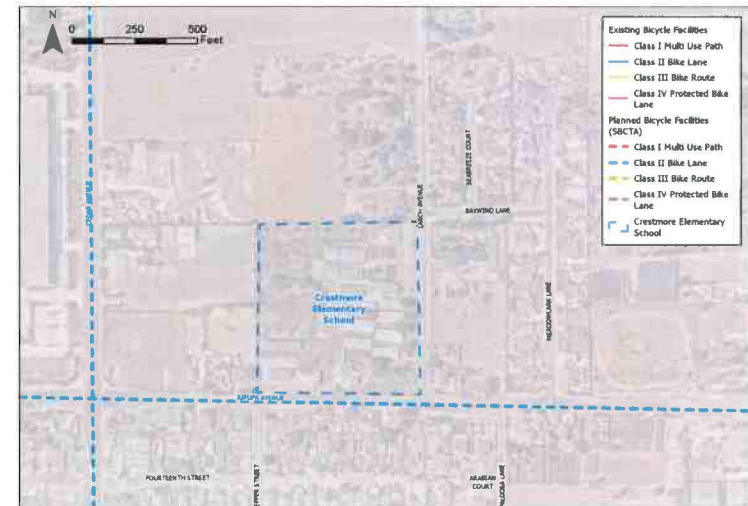
Figure 4.5.10 Existing and Planned Bicycle Conditions

Currently, there are no bicycle facilities surrounding Crestmore Elementary School. There are San Bernadino County Transportation Authority (SBCTA) plans to implement a Class II Bike Lane along Jurupa Avenue and Cedar Avenue (Figure 4.5.10).

| ID | Improvement | Description | Location |
|---|---|---|---|
| 15a | Class II Bike lanes (SBCTA Planned) | Coordinate with SBCTA to construct Class II Bike Lanes per SBCTA planned bikeways | Jurupa Avenue from Locust Avenue to W. Willow Avenue |
| 15b | | Coordinate with SBCTA to construct Class II Bike Lanes per SBCTA planned bikeways | Cedar Avenue from Randall Avenue to El Rivino Road |

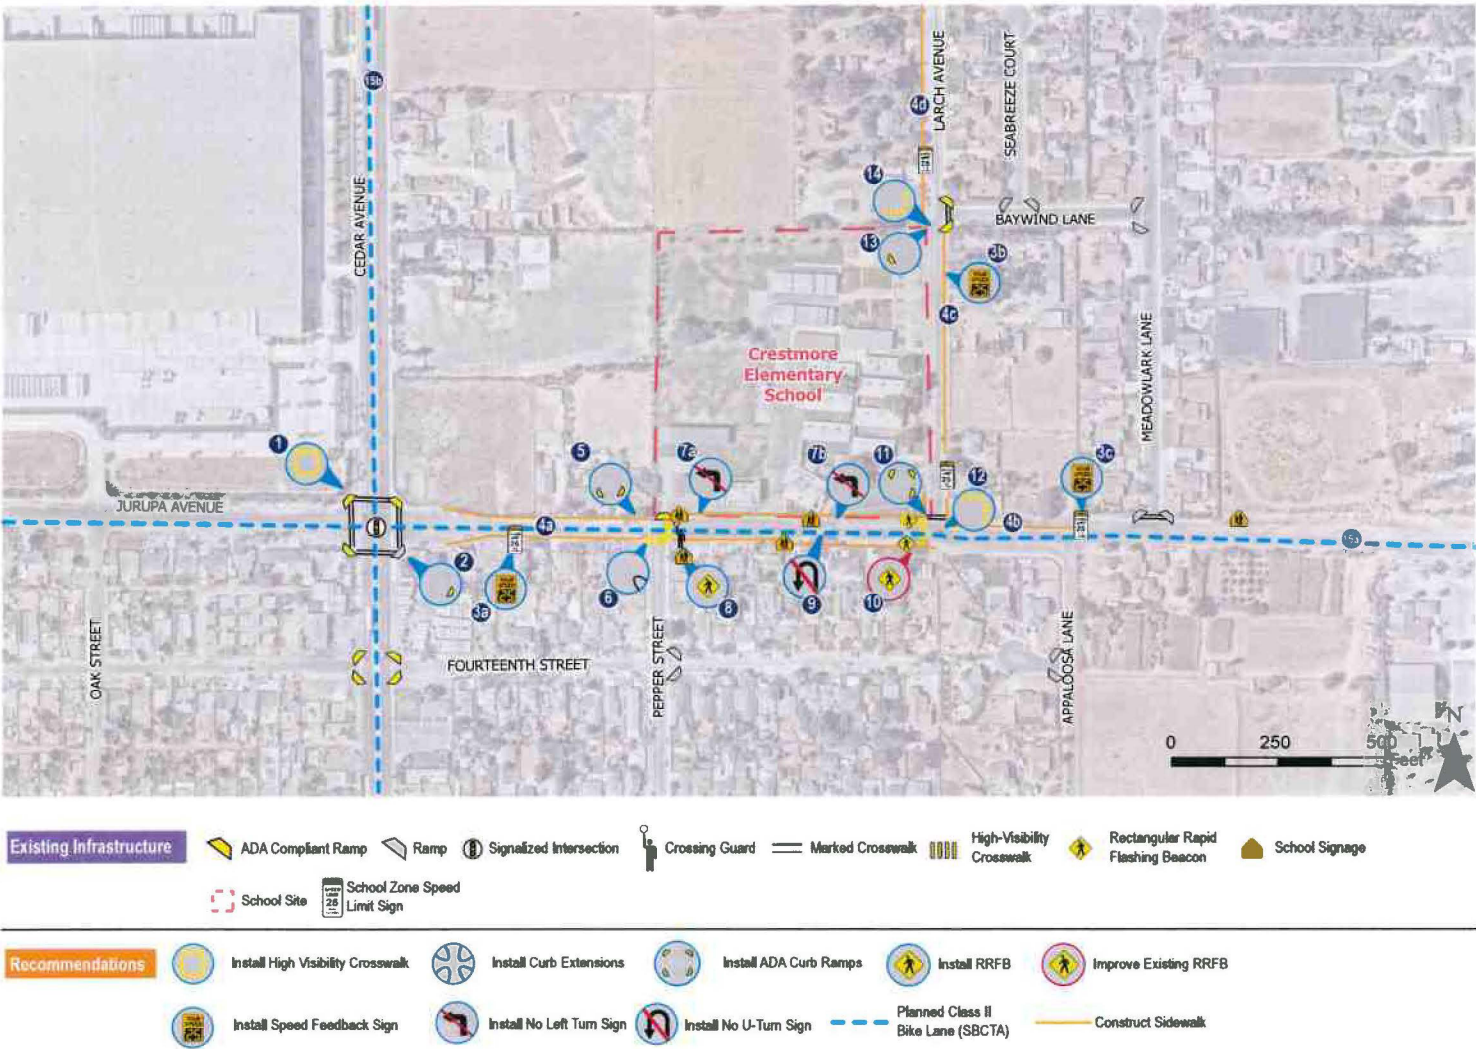
CRESTMORE ELEMENTARY SCHOOL

Several interventions to improve the SRTS experience are recommended. By improving the existing high visibility crosswalks along Jurupa Avenue and adding Rectangular Rapid Flashing Beacons (RRFBs), more opportunities will be available for students to cross the street safely. Speed feedback signs are recommended along Jurupa Avenue and Larch Avenue to discourage speeding along these streets. As part of SBCTA's Active Transportation Plan, Class II bike lanes have been planned along Jurupa Avenue and Cedar Avenue. To improve pedestrian accessibility, ADA-compliant curb ramps and sidewalks are recommended at the school frontage and surrounding intersections. These recommendations are highlighted in the graphic provided. A summary of the recommendations is provided in Table 4.5.1.

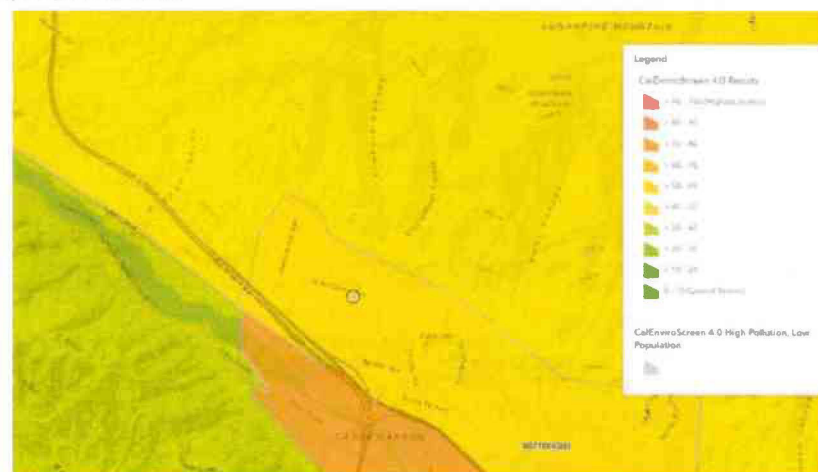
**Figure 4.6.7 CalEnviroScreen 4.0 Score - Kimbark Elementary School**

CalEnviroScreen (CES) is a tool developed by the California Office of Environmental Health Hazard Assessment (OEHHA) that identifies communities that are disproportionately burdened by pollutants. Indicators used to identify communities include exposures (traffic, pesticides, and drinking water), environmental effects (cleanup sites, solid waste), sensitive populations (Asthma, low birth weight), and socioeconomic factors (education, poverty, unemployment). Scores range from 0-100 with a higher score indicating a higher effect of pollutants for the area. Figure 4.6.7 illustrates the CES scores for the census tract where Kimbark Elementary School is located, scoring in the 50-60 percentile range which indicates the area is moderately burdened by pollutants. For this region, the highest exposures to pollutants are ozone, traffic, and drinking water, in that order.

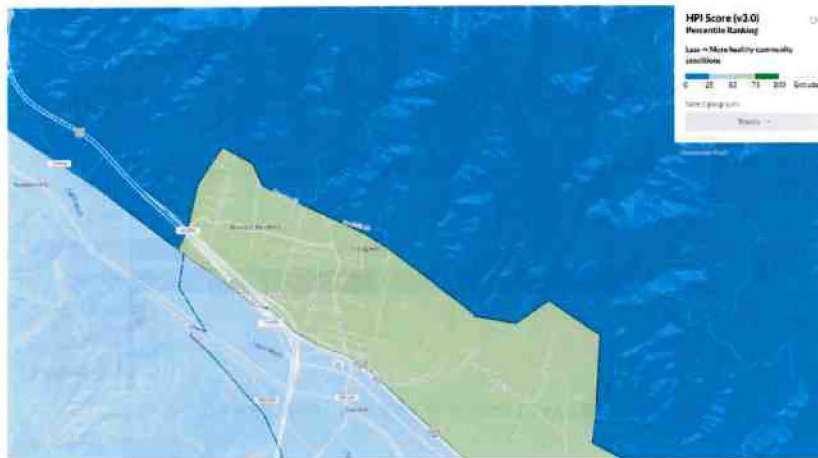
**Figure 4.6.8 Healthy Place Index Score - Kimbark Elementary School**

The California Healthy Places Index (HPI), developed by the Public Health Alliance of Southern California, is a tool used to explore the community conditions that impact life expectancy. The HPI tool helps prioritize public and private investments, resources, and programs in neighborhoods where they are needed the most. The HPI tool combines 23 community characteristics such as access to healthcare, housing, education, and more. The tool produces a score ranging from 0-100 with a higher score representing a healthier community. The tool's indicators reflect widely recognized thematic areas of the social determinants of health and are consistent with those described by the Centers for Disease Control (CDC). Figure 4.6.8 illustrates the HPI scores for the census tract Kimbark Elementary School is located within. The HPI score of 54.4 healthier conditions surrounding the school.
