#### **CRESTMORE ELEMENTARY SCHOOL**

# 4.6 KIMBARK ELEMENTARY SCHOOL

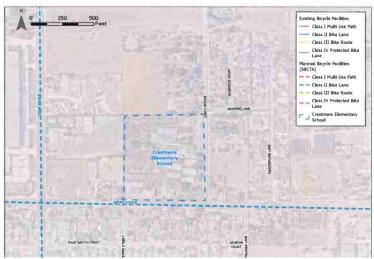
Figure 4.5.10 Existing and Planned Bicycle Conditions

Currently, there are no bicycle facilities surrounding Crestmore Elementary School. There are San Bernadino County Transportation Authority (SBCTA) plans to implement a Class II Bike Lane along Jurupa Avenue and Cedar Avenue (Figure 4.5.10).

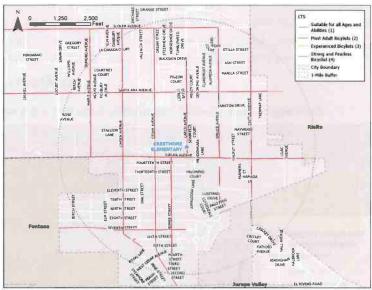
Figure 4.5.11 Bicycle Level of Traffic Stress

The bicycle environment was assessed using the bicycle Level of Traffic Stress (LTS) methodology for characterizing cycling environments, as developed by Mekuria, et al (2012) of the Mineta Transportation Institute. LTS considers a number of factors to classify the street network into categories according to the level of stress it causes cyclists. The LTS assessment conducted by MBI concluded that the roads surrounding Crestmore Elementary School have high LTS scores indicating higher stress levels for cyclists (Figure 4.5.11).

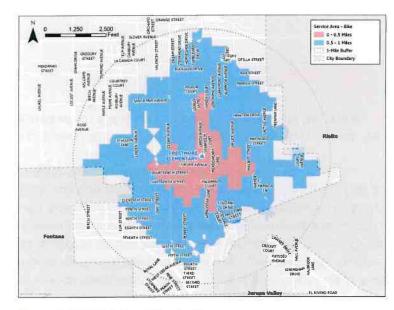
Figure 4.5.12 Existing Bikeshed

Figure 4.5.12 shows the bikeshed for Crestmore Elementary School. The bikeshed shows the area which a student can bike two miles from the school.

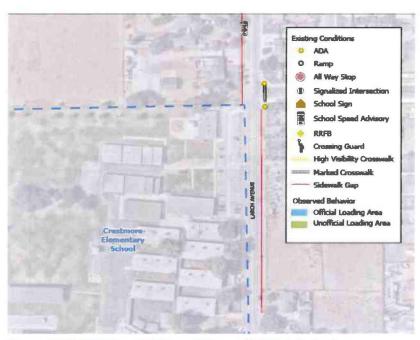
Figure 4.5.13 Existing Pick-Up and Drop-Off Vehicle Behavior

Crestmore Elementary School is accessed via Larch Avenue, a two-lane road with parking along both sides, and Jurupa Avenue, a two-lane road with parking on the west side. Figure 4.5.13 illustrates the existing pick-up and drop-off conditions, and the behaviors observed during the mobility assessment.

There is currently a crossing guard at the intersection of Jurupa Avenue and Pepper Street. This intersection has an uncontrolled crossing with a high-visibility crosswalk and signage. There are "no parking" signs along the south side of Jurupa Avenue where there are currently houses. Parents dropping off their children still park along the south side of Jurupa Avenue and cross the street into the middle of traffic with their children.

Official drop-off currently occurs at the Crestmore Elementary School parking lot just at the school's official front entrance. During the site visit, parents were observed arriving 30 minutes prior to the first bell. Many parents were seen dropping off students at the official unloading area right in front of the school, while other parents were seen forming a second drop-off line on the southern side of the parking lot and had students walk through the parking lot. Staff members were seen blocking off the main drop-off line by stepping in front of cars to make sure students cross the parking lot safely. School staff recognize that vehicles use unofficial spots to drop off students at the south end of parking lot along Jurupa Avenue.

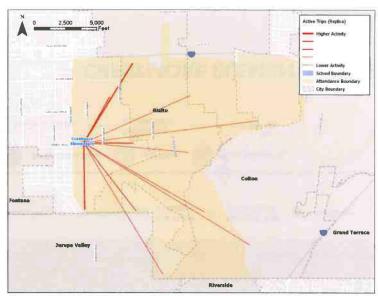
**Figure 4.5.15 Active Travel Pattern**

For each neighborhood, the number of trips made by each travel type was shown using lines on a map (Figure 4.5.15 and 4.5.16). A thicker line means more people are estimated to travel using that mode from that TAZ. Line thickness can be compared within the same mode of travel, such as comparing two walking routes from two different TAZs. One can also get a general sense of how walking and driving compare by looking at both sets of lines from the same TAZ side by side. For example, a thicker line for auto, compared to active for a particular TAZ indicates more of an interest to drive compared to walking or biking. It should be noted the lines are scaled differently with regards to trips for each mode of travel (auto and active), so they should not be compared directly. This data helps reveal how people tend to travel based on several factors, such as the existing walking or biking environment, land uses, physical barriers, population densities, and the layout of the roadway network.

A travel pattern analysis was conducted for Crestmore Elementary School to understand how students may be traveling to the campus. Origin-Destination data was downloaded from the Replica Big Data platform, and ArcGIS and Python were used to process the data. Featuring the school site as the destination, the analysis provides insights into the magnitude of trips made to-and-from the surrounding neighborhoods. The neighborhoods are defined by Traffic Analysis Zones (TAZs) that fall within the school's attendance boundary. The analysis is performed by travel mode for both active travel, which includes walking and biking, and auto travel. The resulting maps display the number of trips by these two modes between the neighborhood TAZs and the TAZ where the school is located.

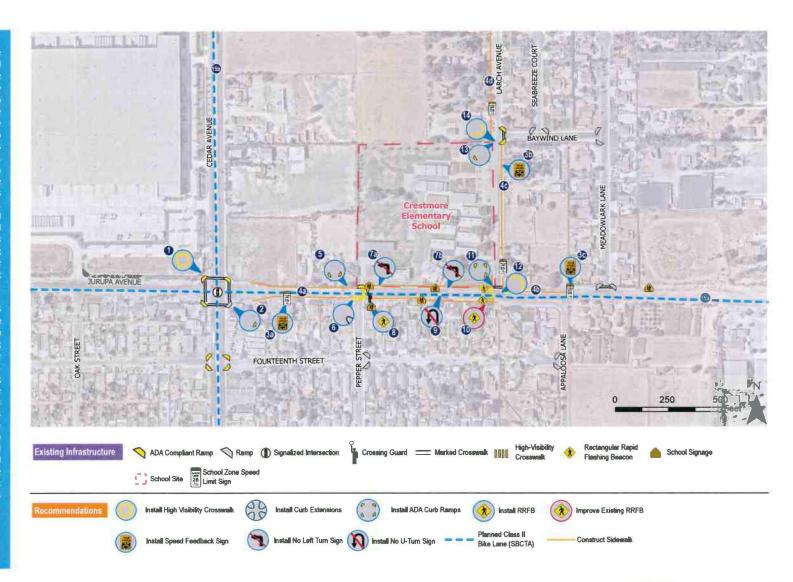
experience are recommended. By improving the existing high visibility crosswalks along Jurupa Avenue and adding Rectangular Rapid Flashing Beacons (RRFBs), more opportunities will be available for students to cross the street safely. Speed feedback signs are recommended along Jurupa Avenue and Larch Avenue to discourage speeding along these streets. As part of SBCTA's Active Transportation Plan, Class II bike lanes have been planned along Jurupa Avenue and Cedar Avenue. To improve pedestrian accessibility, ADA-compliant curb ramps and sidewalks are recommended at the school frontage and surrounding intersections. These recommendations are highlighted in the graphic provided. A summary of the recommendations is provided in Table 4.5.1.

Several improvement opportunities were identified in the mobility assessment conducted for Crestmore Elementary School. Through the student tallies, it was found that the primary mode of travel for most students commuting to and from Crestmore Elementary School was the use of the family vehicle. During the mobility assessment, parents explained this was due to the pedestrian environment, as they felt it was unsafe with a lack of crossings and sidewalks. There are two uncontrolled crossings across Jurupa Avenue at the school frontage. One crossing has a crossing guard, but vehicles were seen not observing the cross guards. There is no bicycle infrastructure and limited school signage directly surrounding the school entrance, along with several missing sidewalks along the adjacent roads. Further, speeding was cited as a main concern for parents in the areas surrounding the school, specifically along Jurupa Avenue.

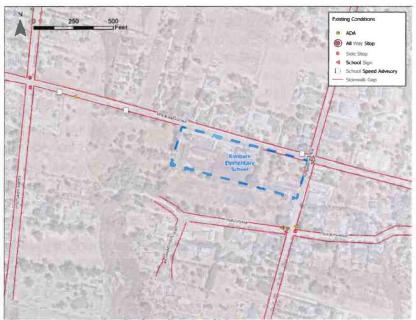
Figure 4.6.9 Existing Pedestrian Conditions

Figure 4.6.9 provides an overview of the existing pedestrian network and challenges observed and analyzed. Kimbark Elementary School is located within a rural community, with limited sidewalks around the school.

There is an existing sidewalk directly in front of the school along Kenwood Avenue with a small amount of parking spaces. There is also a dirt path on the north side of Kenwood Avenue where parents were observed to parking and then cross the street toward the front of the school with their children.

During the principal interview and walk audit, it was noted that the intersection at Kimbark Avenue and Kenwood Avenue is dangerous at night during after school events. Parents have been observed parking at the Moms store on the northeast corner of the intersection and cross to get to the school. Since this a rural community, street lights are limited, making it very dark during after school programs.

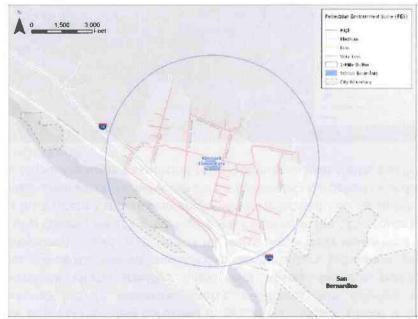
Figure 4.6.10 Pedestrian Evaluation Score

Challenges to walking were evaluated using the Pedestrian Evaluation Score (PES) developed by CR Associates. Based on the physical environment, surrounding land uses, and the street environment, a PES score was developed for nearby roadways. Figure 4.6.10 shows the results of the PES scoring. A sidewalk network with medium and high PES scores indicates low stress for walking, whereas a low or very low PES score can be considered a stressful walking environment. The roadways near Kimbark Elementary School show primarily low PES scores. This indicates a stressful walking environment near the school along these roadways and may create an access barrier to walking.
