SCHOOL RECOMMENDATIONS

## 4.12 WEST RANDALL ELEMENTARY SCHOOL

15620 Randall Ave, Fontana, CA 92335  
Fontana Unified School District

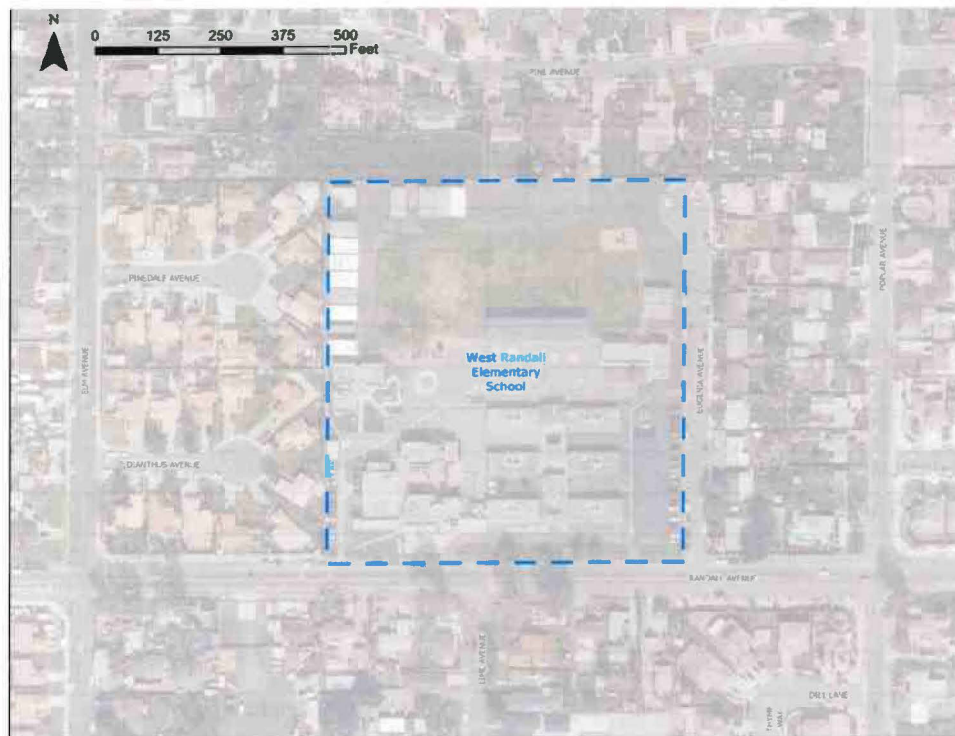
Figure 4.12.1 Context Map

West Randall Elementary School is located in unincorporated San Bernadino County, California, within the City of Fontana Sphere of Influence, west of the city boundary. West Randall Elementary School is located north of Randall Avenue, between Elm Avenue and Poplar Avenue. The school is located approximately 1.5 miles north of the Interstate 10 (I-10) freeway and approximately 2.0 miles east of Auto Club Speedway, a Nascar racing track. The land uses surrounding West Randall Elementary School are primarily residential. Figure 4.12.1 shows the school area and the overall context of the school site.

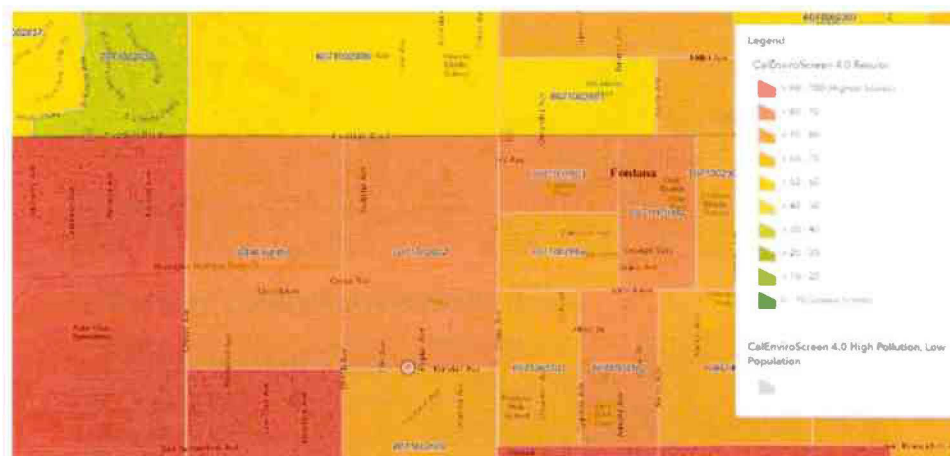
**Figure 4.12.5 CalEnviroScreen 4.0 Score - West Randall Elementary School**

CalEnviroScreen (CES) is a tool developed by the California Office of Environmental Health Hazard Assessment (OEHHA) that identifies communities that are disproportionately burdened by pollutants. Factors used to identify communities include exposures (traffic, pesticides, and drinking water), environmental effects (cleanup sites, solid waste), sensitive populations (asthma, low birth weight) and socioeconomic factors (education, poverty, unemployment). Scores range from 0-100 with a higher score indicating a higher effect of pollutants for a particular area. Figure 4.12.5 illustrates the CES scores for West Randall Elementary School and its surrounding area, scoring in the 80th to 90th percentile, which indicates the area is significantly burdened by pollutants.

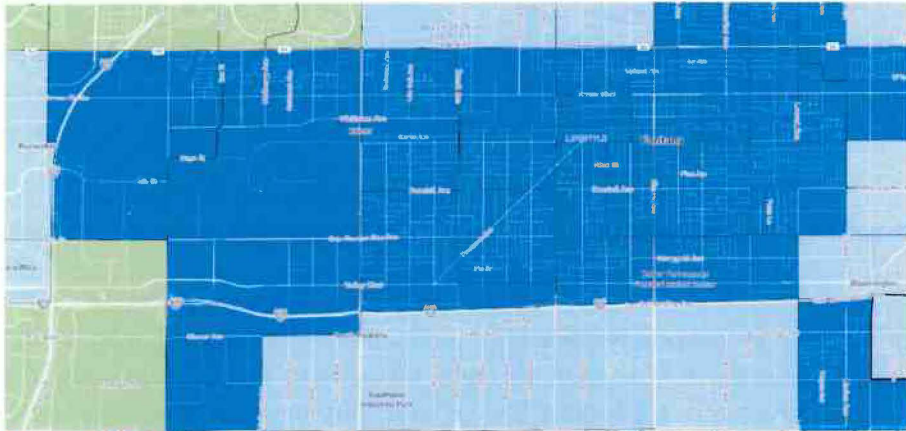
**Figure 4.12.6 Healthy Place Index Score - West Randall Elementary High School**

The California Healthy Places Index (HPI), developed by the Public Health Alliance of Southern California, is a tool used to explore the community conditions that impact life expectancy. The HPI tool helps prioritize public and private investments, resources, and programs in neighborhoods where they are needed the most. The HPI tool combines 23 community characteristics such as access to healthcare, housing, education, and more. The tool produces a score ranging from 0-100 with a higher score representing a healthier community. The tool's indicators reflect widely recognized thematic areas of the social determinants of health and are consistent with those described by the Centers for Disease Control (CDC). Figure 4.12.6 illustrates the area surrounding West Randall Elementary School, which shows an HPI score of 13.9, indicating less healthy conditions surrounding the school.

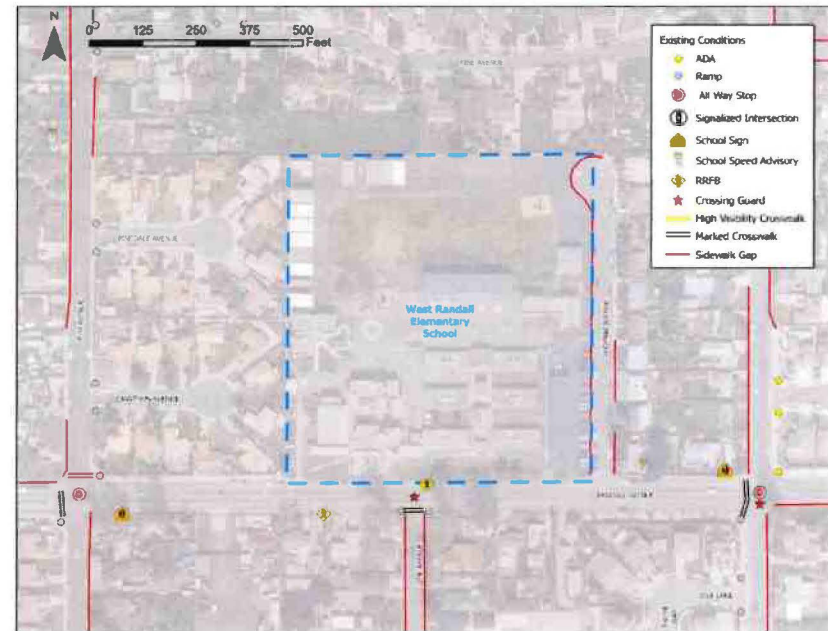
**Figure 4.12.7 Existing Pedestrian Conditions**

Figure 4.12.7 provides an overview of the existing pedestrian network and challenges observed and analyzed. The sidewalk network surrounding West Randall Elementary School is incomplete. During the site visit, missing sidewalks were observed on portions of Randall Avenue, Poplar Avenue, Lime Avenue, and Elm Avenue. A large portion of the sidewalk area is paved with asphalt instead of concrete on the north and south sides of Randall Avenue, containing cracks, bumps and irregular slopes throughout. Curb ramps are also missing on the north side of Randall Avenue at the Rectangular Rapid Flashing Beacon (RRFB) crossing at the intersection of Randall Avenue and Lime Avenue. It should be noted that the RRFB is only activatable on the north side of Randall Avenue along the school frontage and is not activatable on the south side of Randall Avenue where the crossing guard is located. During rainy days, water collects in the curb areas, pooling in some areas of sidewalk and on school property, which also disrupts walking. Two mailboxes were observed on the south side of Randall Avenue across from the school that created a path of travel that was less than 4 feet in width, which would cause potential ADA concerns. At the intersection of Elm Avenue and Randall Avenue, the east and south legs are missing.

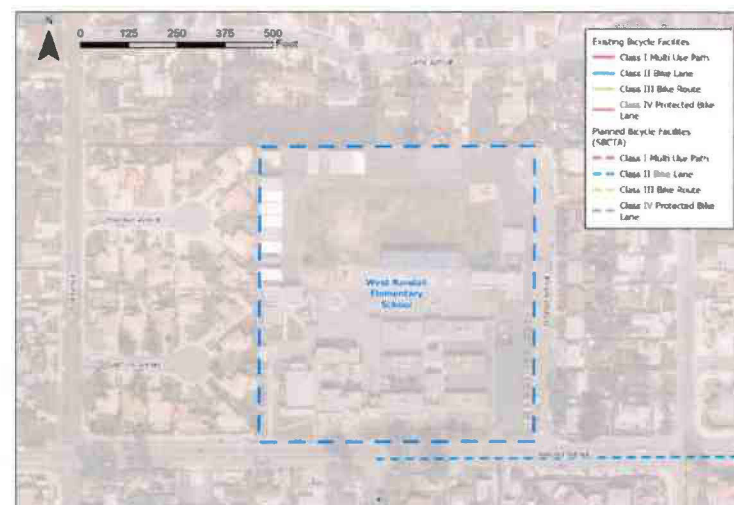
Figure 4.12.10 Existing and Planned Bicycle Condition

Currently, there are no bicycle facilities surrounding West Randall Elementary School. The San Bernadino County Transportation Authority (SBCTA) plans to implement a Class II Bike Lane along Randall Avenue east of Lime Avenue (Figure 4.12.10).

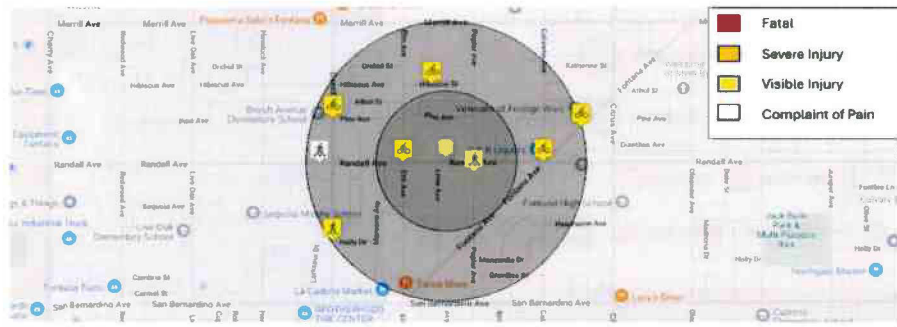
**Figure 4.12.14 Bicycle and Pedestrian Involved Collisions (2019-2023)**

Between 2019 and 2023, there were nine bicycle and pedestrian collisions within a one-half mile radius of West Randall Elementary School (Figure 4.12.14). Of the nine collisions, there were no collisions where a pedestrian or bicyclist sustained severe injuries.
