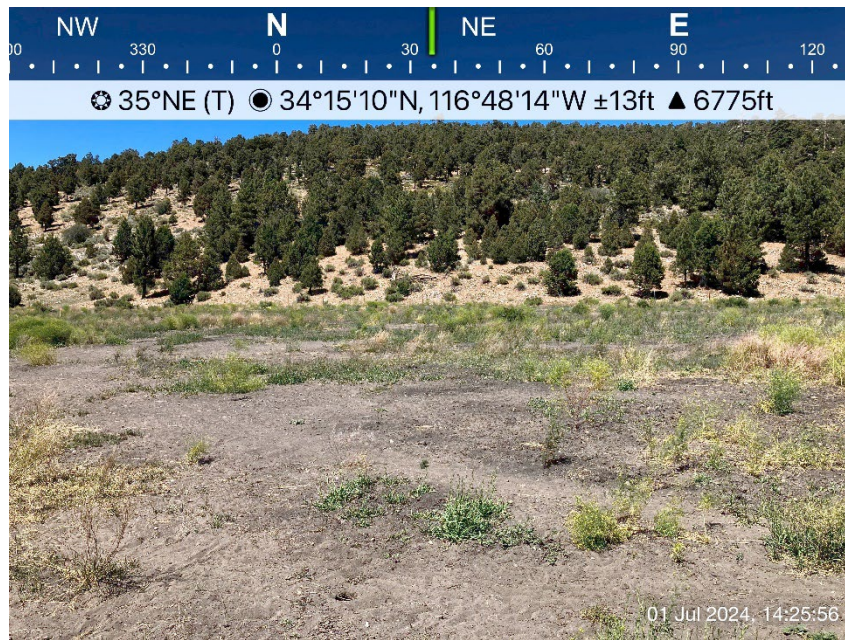
**Photograph 3.** Representative overview of the sparsely vegetated area in the minor topographic depression of the northwestern to north central section of the Project Area facing northeast.

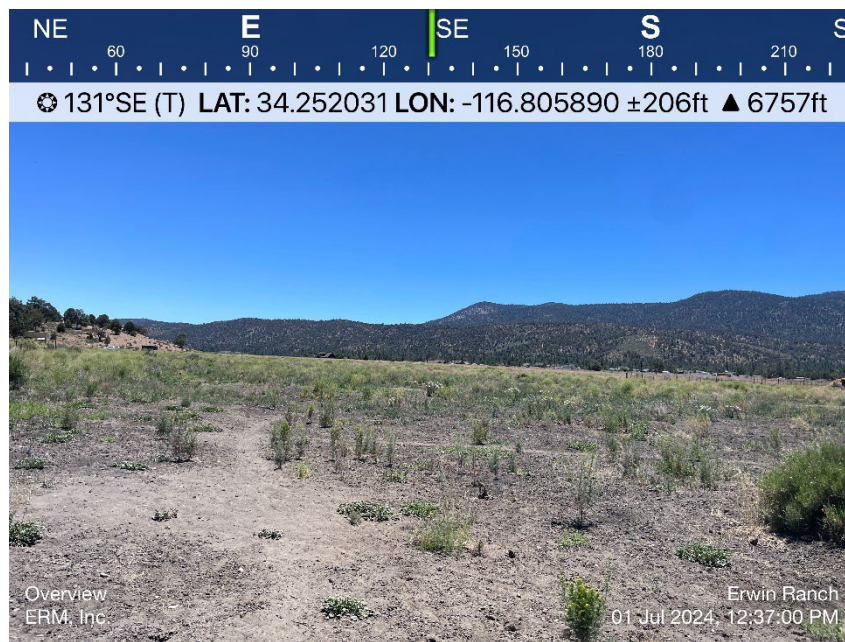
**Photograph 4.** Representative overview of the sparsely vegetated area in the minor topographic depression of the northwestern to north central section of the Project Area facing southeast.

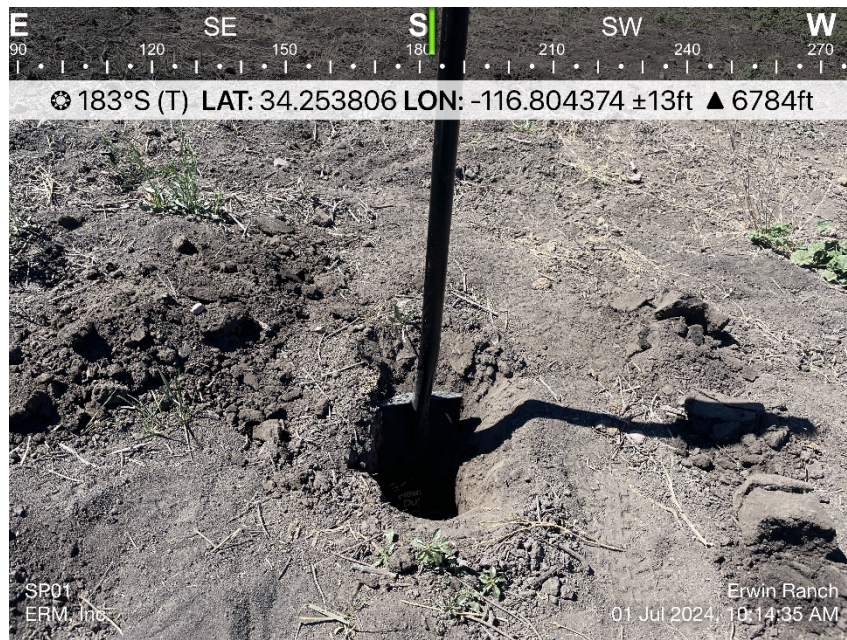
**Photograph 5.** Overview of Sample Point 01 (SP01) soil pit in the sparsely vegetated topographic depression facing south.

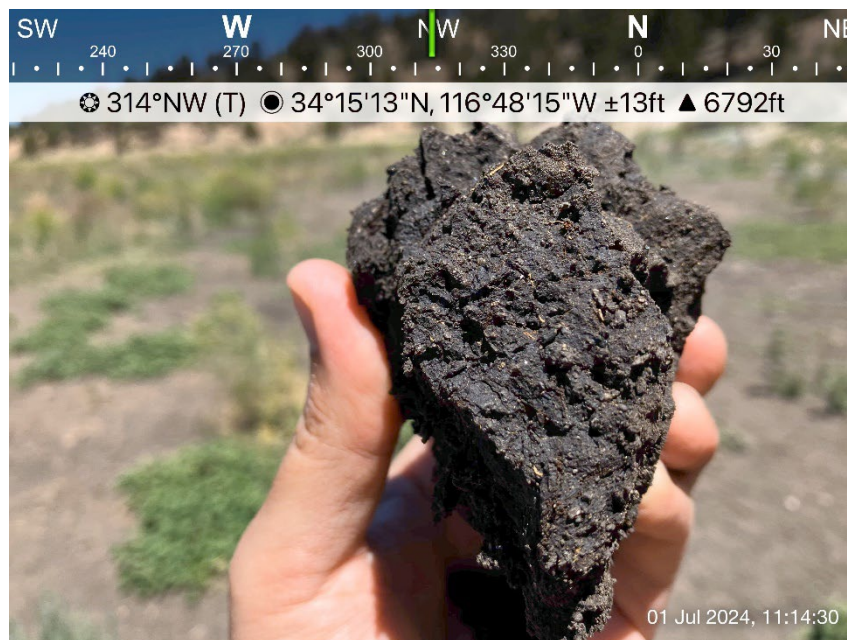
**Photograph 6.** Close-up of upper 6 inches of soil from Sample Point (SP01) facing northwest.

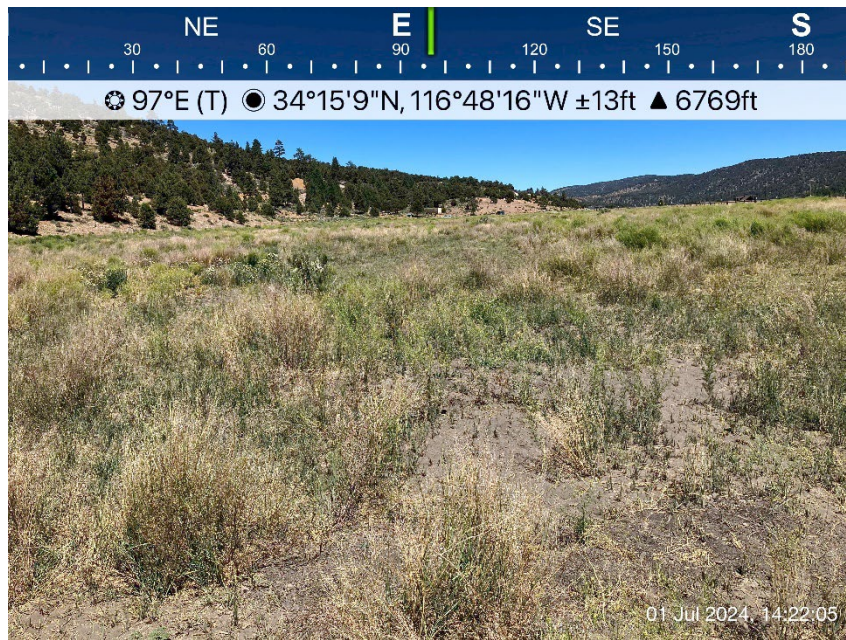
**Photograph 7.** Overview of the outer boundary of the minor topographic depression, indicating higher non-native upland mustard cover facing east.

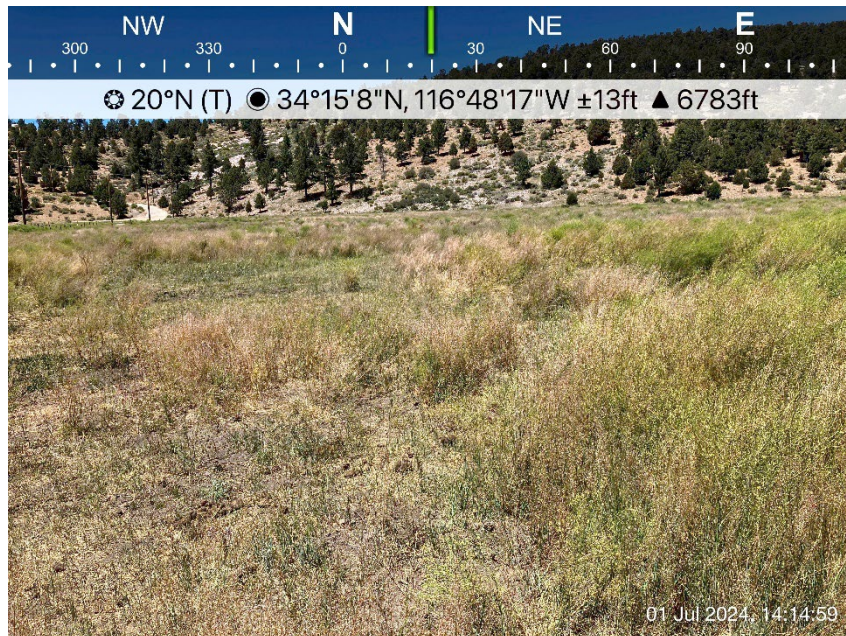
**Photograph 8.** Overview of the transitional zone between the sparsely vegetated minor topographic depression and higher non-native upland mustard cover facing north.

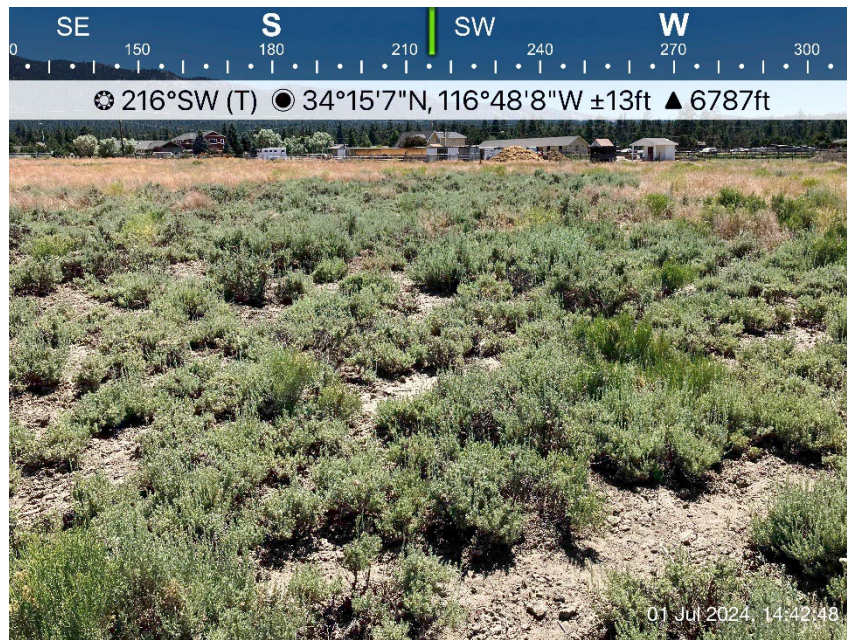
**Photograph 9.** Representative overview of the flat big sagebrush area of the southern section of the Project Area with the neighboring equestrian facility in the background facing southwest.

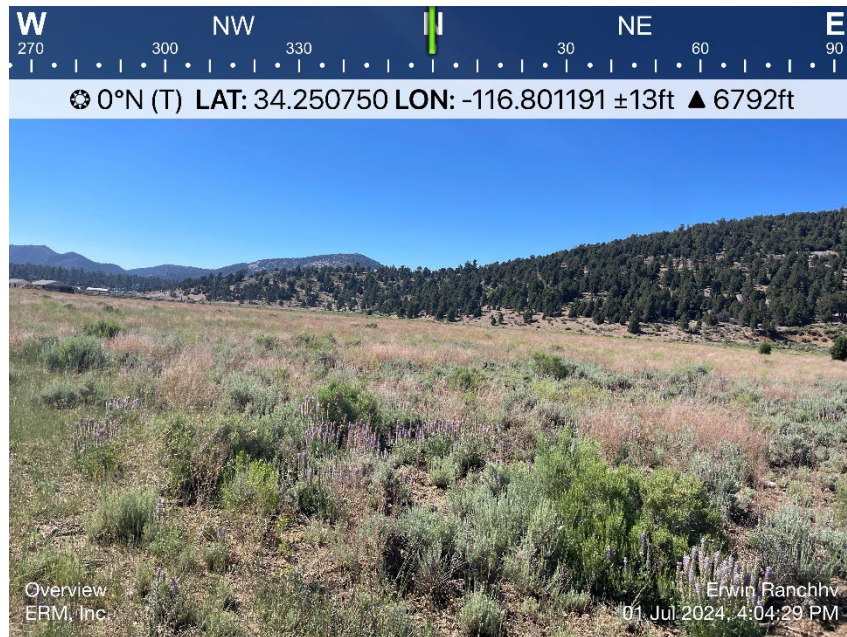
**Photograph 10.** Representative overview of the flat big sagebrush area of the southern section of the Project Area facing north.

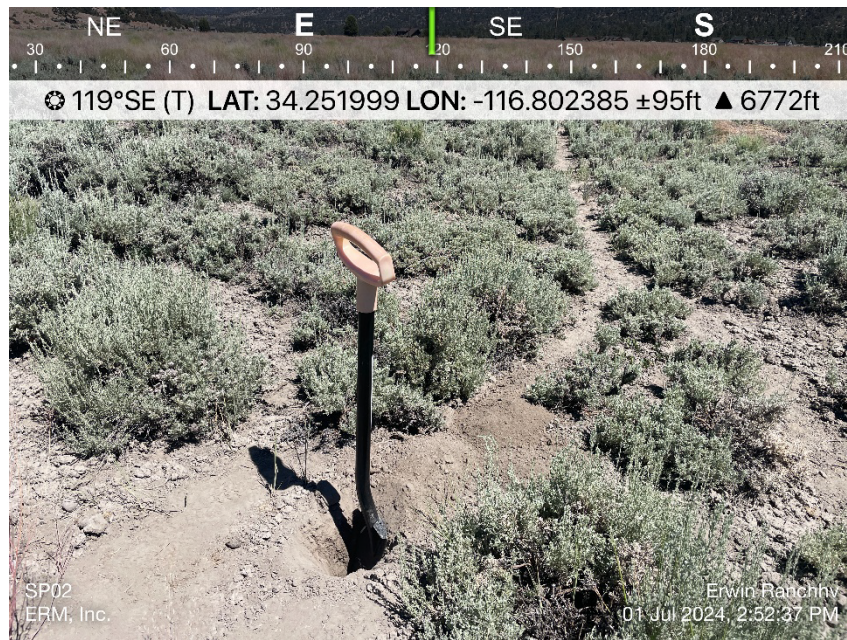
**Photograph 11.** Overview of Sample Point 02 (SP01) soil pit in the flat big sagebrush area of the southern section of the Project Area facing east.

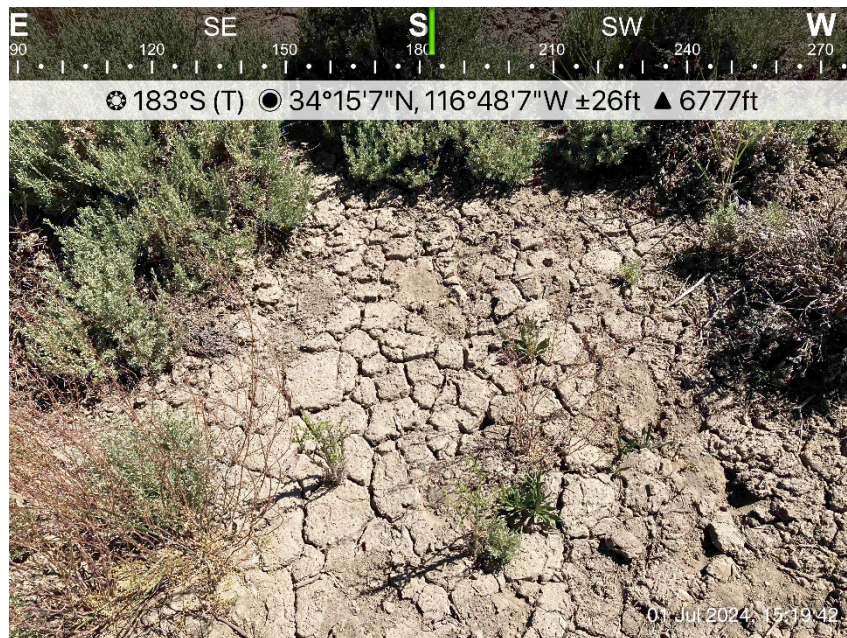
**Photograph 12.** Soil surface cracks from the flat big sagebrush region of the southern section of the Project Area facing south.

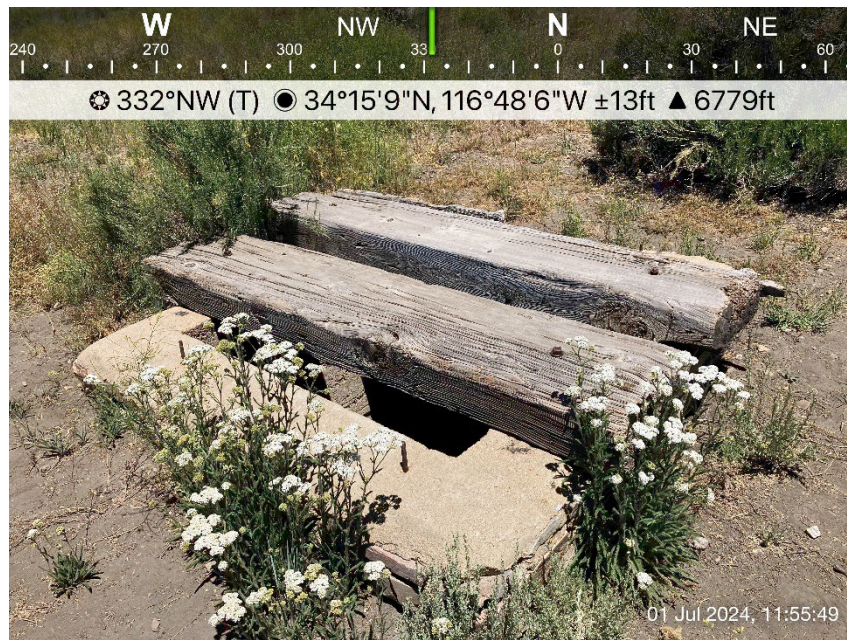
**Photograph 13.** Abandoned mineshaft containing standing water at a depth of 10 to 15 feet at the time of the field investigation facing northwest.

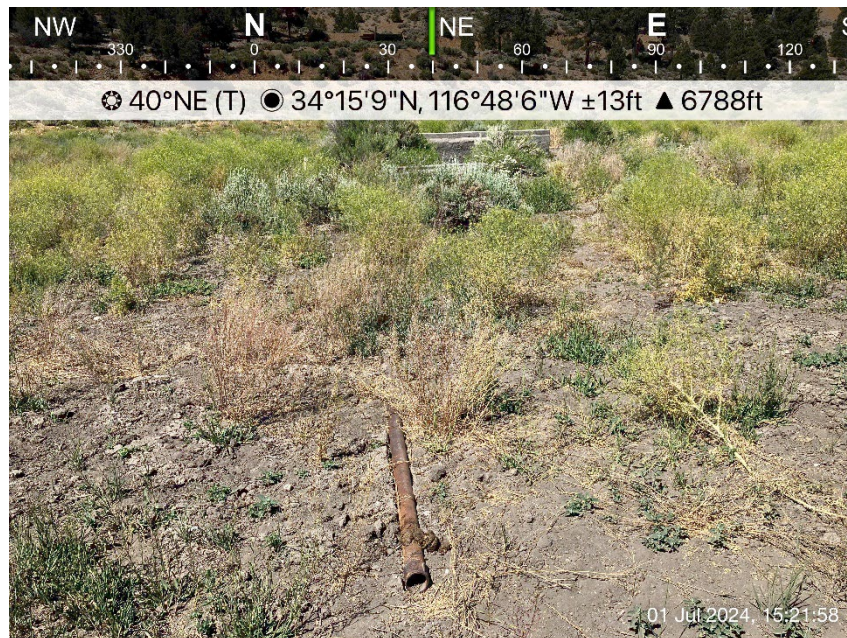
**Photograph 14.** Drainpipe (foreground) emerging from the abandoned mineshaft (midground) in front of a concrete barrier (background) in the north central section of the Project Area facing northeast.
