# SCHOOL RECOMMENDATIONS

# NEWMARK ELEMENTARY SCHOOL

## 4.10 REDLANDS EAST VALLEY HIGH SCHOOL

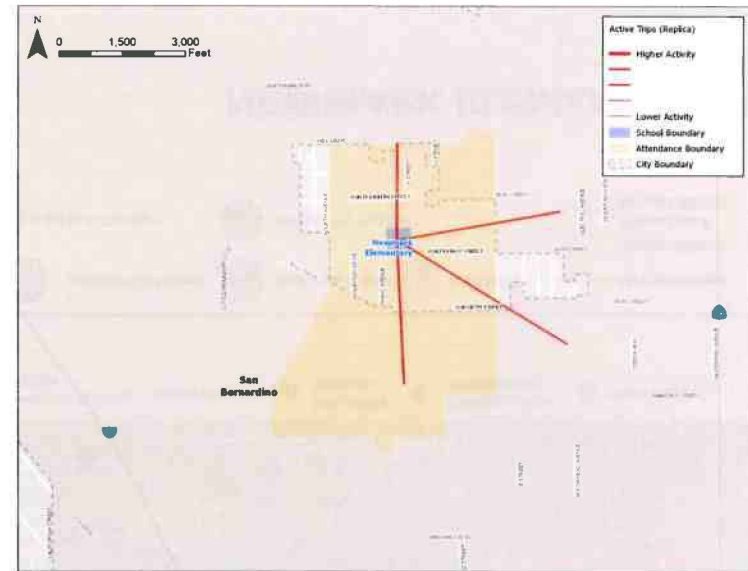
Figure 4.9.15 Active Travel Pattern

For each neighborhood, the number of trips made by each travel type was shown using lines on a map (Figure 4.9.15 and 4.9.16). A thicker line means more people are estimated to travel using that mode from that TAZ. Line thickness can be compared within the same mode of travel, such as comparing two walking routes from two different TAZs. One can also get a general sense of how walking and driving compare by looking at both sets of lines from the same TAZ side by side. For example, a thicker line for auto, compared to active for a particular TAZ indicates more of an interest to drive compared to walking or biking. It should be noted the lines are scaled differently with regards to trips for each mode of travel (auto and active), so they should not be compared directly. This data helps reveal how people tend to travel based on several factors, such as the existing walking or biking environment, land uses, physical barriers, population densities, and the layout of the roadway network.

A travel pattern analysis was conducted for Newmark Elementary School to understand how students may be traveling to the campus. Origin-Destination data was downloaded from the Replica Big Data platform, and ArcGIS and Python were used to process the data. Featuring the school site as the destination, the analysis provides insights into the magnitude of trips made to-and-from the surrounding neighborhoods. The neighborhoods are defined by Traffic Analysis Zones (TAZs) that fall within the school's attendance boundary. The analysis is performed by travel mode for both active travel, which includes walking and biking, and auto travel. The resulting maps display the number of trips by these two modes between the neighborhood TAZs and the TAZ where the school is located.

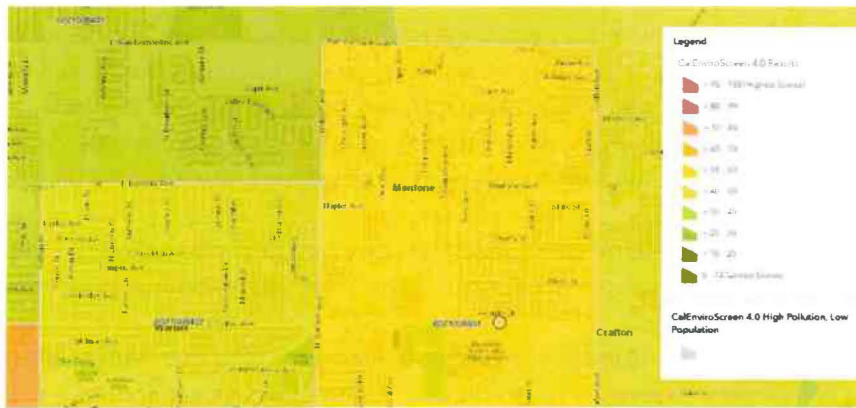
CalEnviroScreen (CES) is a tool developed by the California Office of Environmental Health Hazard Assessment (OEHHA) that identifies communities that are disproportionately burdened by pollutants. Indicators used to identify communities include exposures (traffic, pesticides, and drinking water), environmental effects (cleanup sites, solid waste), sensitive populations (Asthma, low birth weight), and socioeconomic factors (education, poverty, unemployment). Scores range from 0-100 with a higher score indicating a higher effect of pollutants for the area. Figure 4.10.7 illustrates the CES scores for the census tract where Redlands East Valley High is located, scoring in the 50th to 60th percentile range which indicates the area is moderately burdened by pollutants. For this region, the highest exposures to pollutants are ozone, pesticides, and drinking water, in that order.

**Figure 4.10.7 CalEnviroScreen 4.0 Score - Redlands East Valley High School**

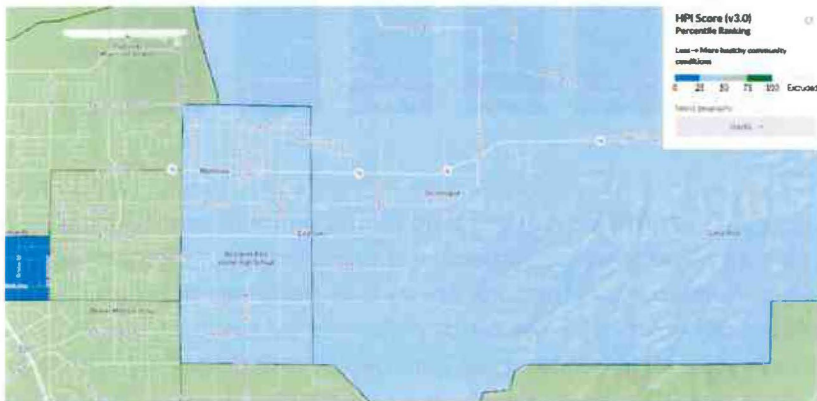
The California Healthy Places Index (HPI), developed by the Public Health Alliance of Southern California, is a tool used to explore the community conditions that impact life expectancy. The HPI tool helps prioritize public and private investments, resources, and programs in neighborhoods where they are needed the most. The HPI tool combines 23 community characteristics such as access to healthcare, housing, education, and more. The tool produces a score ranging from 0-100 with a higher score representing a healthier community. The tool's indicators reflect widely recognized thematic areas of the social determinants of health and are consistent with those described by the Centers for Disease Control (CDC). Figure 4.10.8 illustrates the HPI scores for the census tract Newmark Elementary is located within. The HPI score of 45.5 indicates less than healthy conditions surrounding the school.

**Figure 4.10.8 Healthy Place Index Score - Redlands East Valley High School**

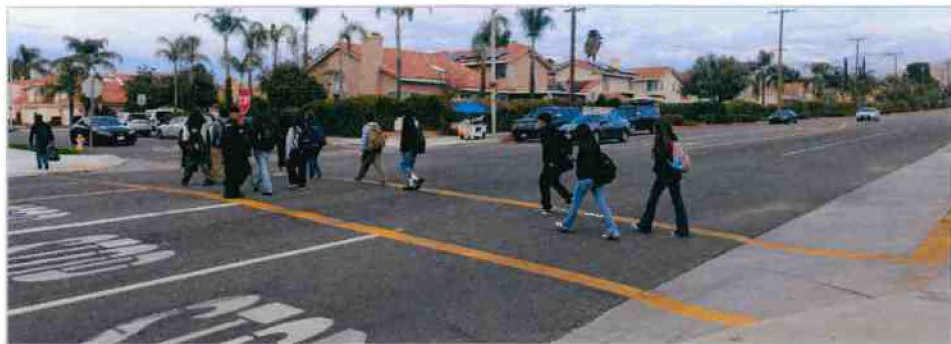
**Figure 4.10.14 Existing Pick-Up and Drop-Off Vehicle Behavior**

Redlands East Valley High School is accessed via Colton Avenue, a four-lane road with centerline delineators. Figure 4.10.14 illustrates the existing conditions, and the behaviors observed during the mobility assessment.

Vehicles were seen parking on both sides of Colton Avenue, creating a backup vehicles along the road. Many students were seen using the all-way stop sign at the front of the school to cross the street and meet with parked vehicles in the neighborhood north of the school.

One of the biggest concerns the school noted was that the intersection of Colton Avenue and Opal Avenue has seen some collisions between vehicles and pedestrians and feel like the intersection is not safe.
