# 4.10 REDLANDS EAST VALLEY HIGH SCHOOL

31000 E Colton Ave, Redlands, CA 92374 Redlands Unified School District

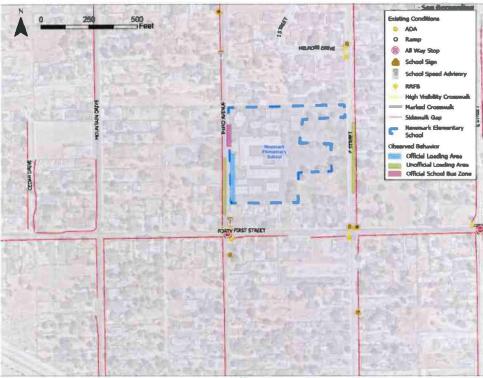
Figure 4.9.13 Existing Pick-Up and Drop-Off Vehicle Behavior

Newmark Elementary School is accessed via 3rd Avenue and F Street, both twolane roads. Figure 4.9.13 illustrates the existing conditions, and the behaviors observed during the mobility assessment.

Vehicles were seen parking on both sides of 3rd Avenue, creating a backup vehicles along the road. Those who parked on the west side of 3rd Avenue were seen crossing the street into oncoming traffic. Parents were seen double parking behind vehicles perpendicularly parked in the small lot in front of the school, creating backups and delays.

There is also a gate at the back of the school on F Street, where a staff member is located to greet the students. Similar to the front of the school, vehicles were observed parking on both sides of the street and crossing the street into oncoming traffic.

One of the biggest concerns that was mentioned during the walk audit was students who are dropped off on the west side of 3rd Avenue and the east side of F Street and cross the street toward the school into oncoming traffic to access the school.

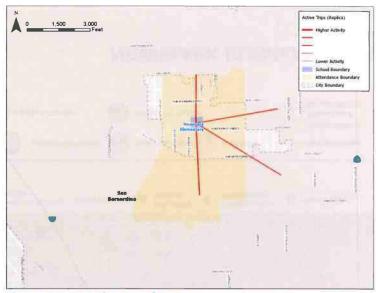
**Figure 4.9.15 Active Travel Pattern**

For each neighborhood, the number of trips made by each travel type was shown using lines on a map (Figure 4.9.15 and 4.9.16). A thicker line means more people are estimated to travel using that mode from that TAZ. Line thickness can be compared within the same mode of travel, such as comparing two walking routes from two different TAZs. One can also get a general sense of how walking and driving compare by looking at both sets of lines from the same TAZ side by side. For example, a thicker line for auto, compared to active for a particular TAZ indicates more of an interest to drive compared to walking or biking. It should be noted the lines are scaled differently with regards to trips for each mode of travel (auto and active), so they should not be compared directly. This data helps reveal how people tend to travel based on several factors, such as the existing walking or biking environment, land uses, physical barriers, population densities, and the layout of the roadway network.

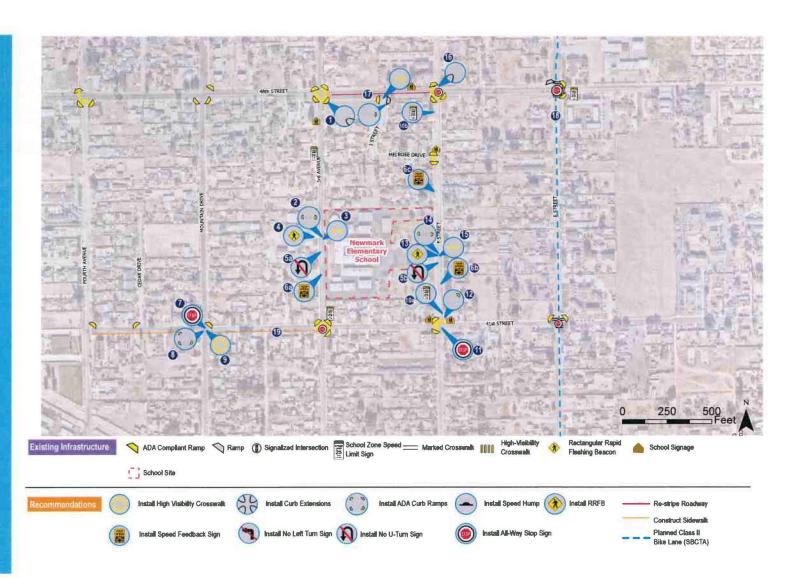
**TABLE 4.9.1 NEWMARK ELEMENTARY SCHOOL RECOMMENDATIONS**

To combat some of these challenges, a series of improvements are recommended around the school. To add to the newlyconstructed sidewalk, a mid-block crosswalk and Rectangular Rapid Flashing Beacon (RRFB) are recommended along 3rd Avenue, providing students a safe way to cross the street. An all-way stop is recommended at the intersections on 41st Street and F Street and Mountain Drive. This will allow for vehicles to stop more frequently within the school zone. To enhance the pedestrian experience, ADA compliant curb ramps and high-visibility crosswalks are recommended at intersections surrounding the school. Speed feedback signs are also recommended along 3rd Avenue and F Street to function as additional traffic calming measures.

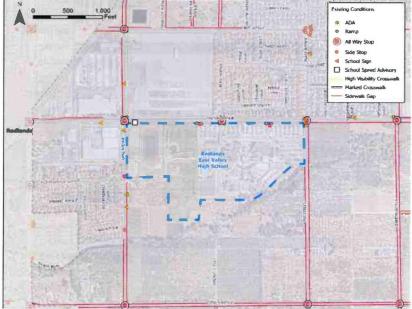
**Figure 4.10.9 Existing Pedestrian Conditions**

Figure 4.10.9 provides an overview of the existing pedestrian network and challenges observed and analyzed. There are also sidewalks on both sides of Opal Avenue from Colton Avenue to Independence Avenue. Many students were observed walking west on Colton Avenue using the sidewalk. Many parents were observed parking their car on both sides of Colton as they waited for students to walk to their car.

During the field observations, many students were seen crossing Colton Avenue at one of the three all-way stop signs in front of the school. This created a lot of congestion along Colton Avenue, but overall rant smoothly.

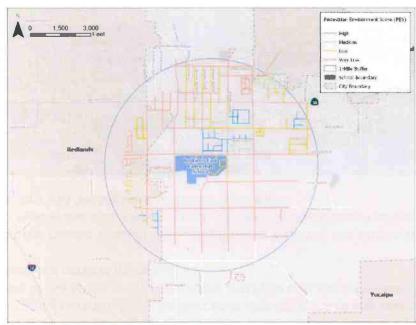
**Figure 4.10.10 Pedestrian Evaluation Score**

Challenges to walking were evaluated using the Pedestrian Evaluation Score (PES) developed by CR Associates. Based on the physical environment, surrounding land uses, and the street environment, a PES score was developed for nearby roadways. Figure 4.10.10 shows the results of the PES scoring. A sidewalk network with medium and high PES scores indicates low stress for walking, whereas a low or very low PES score can be considered a stressful walking environment. Crafton Avenue and Opal Avenue are shown to have a very low PES score, indicating a stressful walking environment. This indicates a stressful walking environment near the school along these roadways and may create an access barrier to walking.

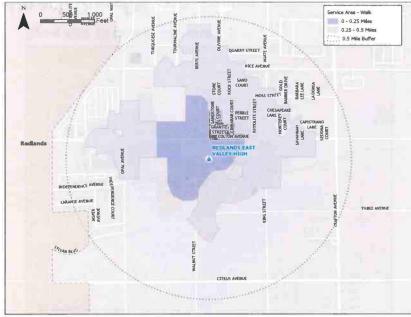
Figure 4.10.11 Existing Pedestrian Walkshed

Figure 4.10.11 shows the walkshed for Redlands East Valley High School. The walkshed shows the area which a student can walk a half mile from the school. The walkshed has been reviewed for sidewalk connectivity and accessibility.

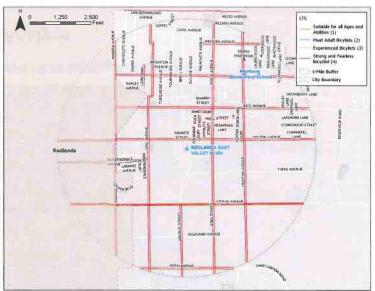
Figure 4.10.12 Bicycle Level of Traffic Stress

The bicycle environment was assessed using the bicycle Level of Traffic Stress (LTS) methodology for characterizing cycling environments, as developed by Mekuria, et al (2012) of the Mineta Transportation Institute. LTS considers a number of factors to classify the street network into categories according to the level of stress it causes cyclists. The LTS assessment conducted by MBI concluded that the roads immediately surrounding Redlands East Valley High have high LTS scores indicating higher stress levels for cyclists (Figure 4.10.12).

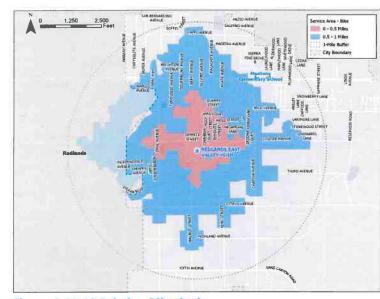
Figure 4.10.13 Existing Bikeshed

Figure 4.10.13 shows the bikeshed for Redlands East Valley High School. The bikeshed shows the area which a student can bike one mile from the school.

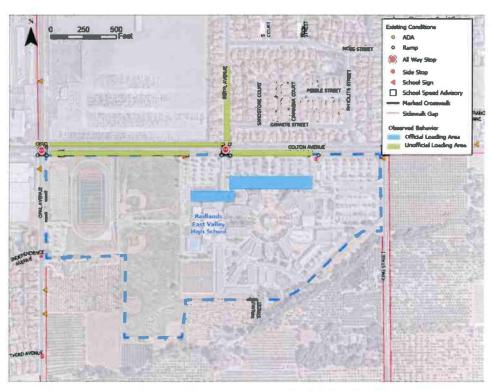
Figure 4.10.14 Existing Pick-Up and Drop-Off Vehicle Behavior

Redlands East Valley High School is accessed via Colton Avenue, a four-lane road with centerline delineators. Figure 4.10.14 illustrates the existing conditions, and the behaviors observed during the mobility assessment.

Vehicles were seen parking on both sides of Colton Avenue, creating a backup vehicles along the road. Many students were seen using the all-way stop sign at the front of the school to cross the street and meet with parked vehicles in the neighborhood north of the school.

One of the biggest concerns the school noted was that the intersection of Colton Avenue and Opal Avenue has seen some collisions between vehicles and pedestrians and feel like the intersection is not safe.
