## 4.16 REDWOOD ELEMENTARY SCHOOL

8570 Redwood Avenue, Fontana CA 92335  
Fontana Unified School District

SCHOOL RECOMMENDATIONS

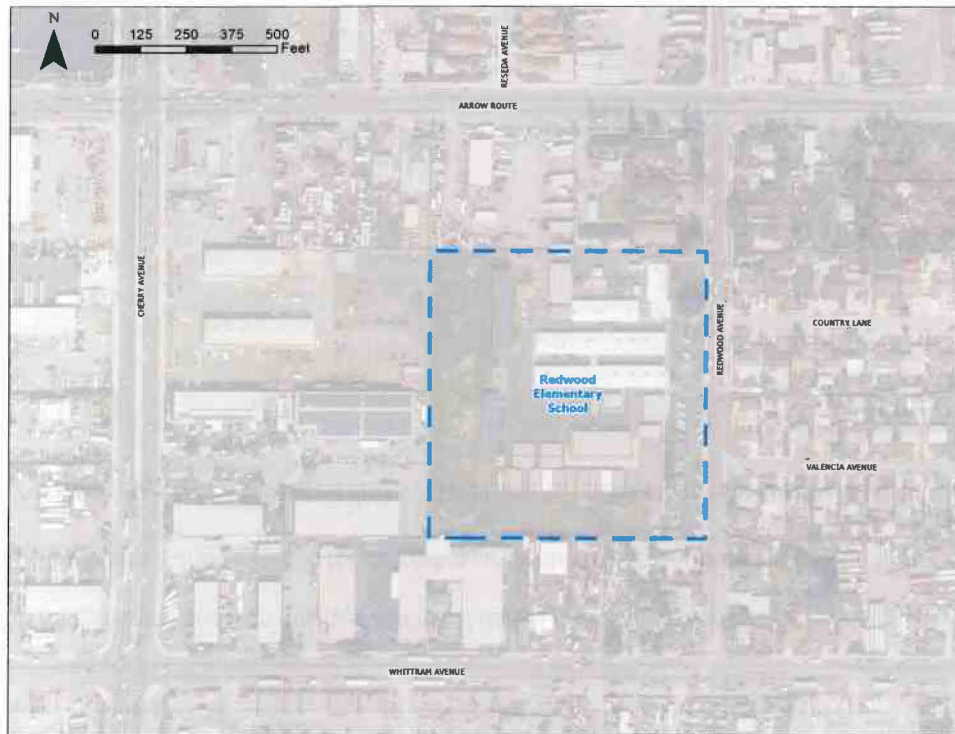
Figure 4.16.1 Context Map

Redwood Elementary School is located in unincorporated San Bernardino County, California, within the Fontana Sphere of Influence, west of the city boundary. Redwood Elementary School is located west of Redwood Avenue, between Arrow Route and Whittram Avenue. The school is located approximately 2.0 miles north of the Interstate 10 (I-10) freeway and approximately 0.5 miles northeast of Auto Club Speedway, a Nascar racing track. The land use surrounding Redwood Elementary School is primarily residential and industrial land uses. Figure 4.16.1 shows the school area and the overall context of the school site.

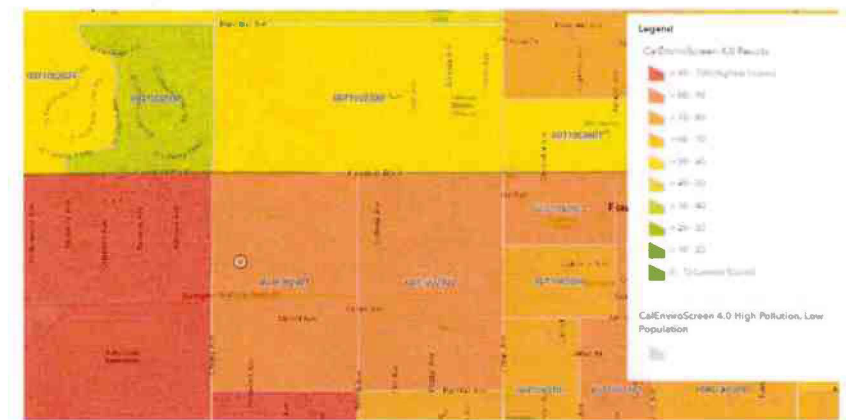
**Figure 4.16.4 CalEnviroScreen 4.0 Score - Redwood Elementary School**

CalEnviroScreen (CES) is a tool developed by the California Office of Environmental Health Hazard Assessment (OEHHA) that identifies communities that are disproportionately burdened by pollutants. Indicators used to identify communities include exposures (traffic, pesticides, and drinking water), environmental effects (cleanup sites, solid waste), sensitive populations (asthma, low birth weight) and socioeconomic factors (education, poverty, unemployment). Scores range from 0-100 with a higher score indicating a higher effect of pollutants for a particular area. Figure 4.16.4 illustrates the CES scores for Redwood Elementary School and its surrounding area scoring in the 80th to 90th percentile, which indicates the area is significantly burdened by pollutants.

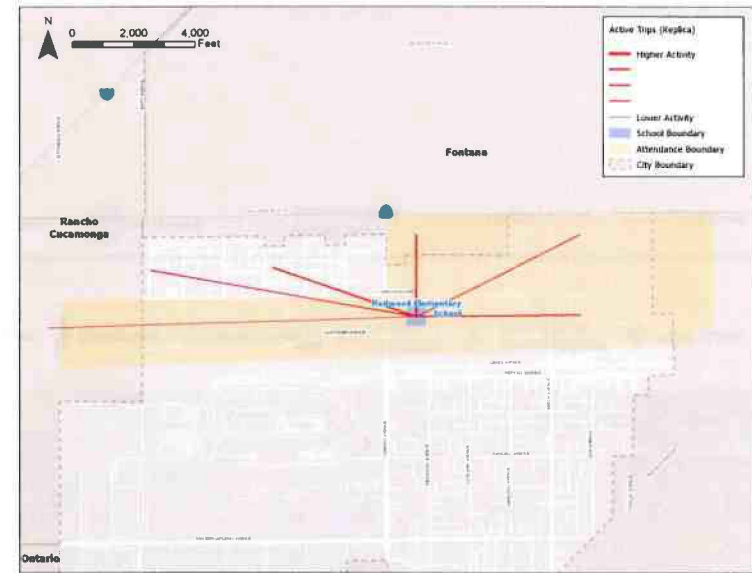
**Figure 4.16.14 Active Travel Pattern**

For each neighborhood, the number of trips made by each travel type was shown using lines on a map (see Figure 4.16.14 and Figure 4.16.15 for active trip and auto trip maps, respectively). A thicker line means more people are estimated to travel using that mode of transportation from that neighborhood. Line thickness can be compared within the same type of travel, such as comparing two walking routes. One can also get a general sense of how walking and driving compare by looking at both sets of lines side by side. However, the lines are scaled differently for each mode of travel, so they should not be compared directly. This data helps reveal how people tend to travel based on several factors, such as the existing walking or biking environment, land uses, physical barriers, population densities, and the layout of the roadway network.

For Redwood Elementary School, auto and active modes have relatively similar magnitudes for each respective mode from each TAZ.
