Phase I Environmental Site Assessment

St. John of God Medical Facility

13333 Palmdale Road

April 27, 2023 | Terracon Project No. LA237038

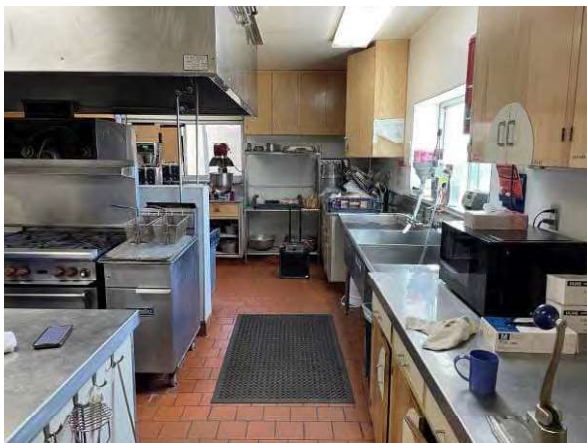
Photo #5 View of kitchen in southern building of complex.

One ventilation hood was observed in the kitchen area of the southeastern building during the site reconnaissance. The hood is used for food preparation and appeared to be in good condition at the time of the site reconnaissance.

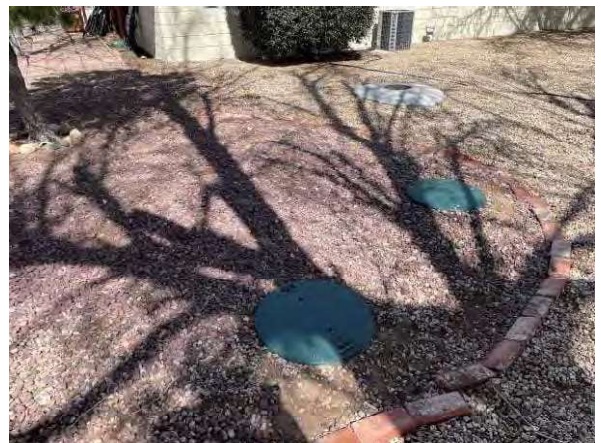
Photo #6 View of subgrade grease trap system, located in the central portion of the complex to the north of the kitchen area.

One grease trap was observed during the site reconnaissance. This equipment was located between the buildings on the eastern portion of the complex and was associated with the kitchen for the cafeteria. Staining and/or evidence of a release was not observed in this area. According to the site contact, Mr. Donchig, the grease traps are serviced biannually by A & A Septic. Based on site observations and contact-provided information, the on-site grease trap did not appear to represent a REC to the site.

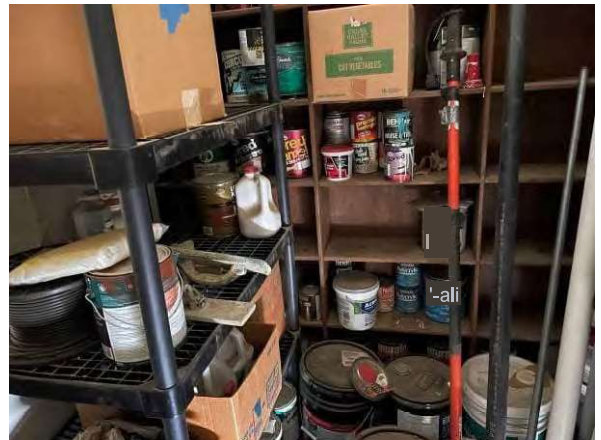
Photo #12 Additional view of cleaning and maintenance product storage in maintenance garage on southeastern portion of complex.

Two 55-gallon steel barrels containing grease waste, approximately 25 5-gallon buckets of paint were observed in the maintenance shed on the southern portion of the facility. The 55-gallon barrels were observed to be stored within secondary containment. Floor drains or sumps were not observed in the vicinity of the 55-gallon barrels or 5-gallon buckets. According to Mr. Donchig, the grease waste barrels are removed from the site by A & A Septic biannually. Surficial staining was not observed in the vicinity of the barrels or the 5-gallon buckets. Based on visual observations, the 55-gallon grease waste barrels and 5-gallon buckets do not represent a REC to the site.

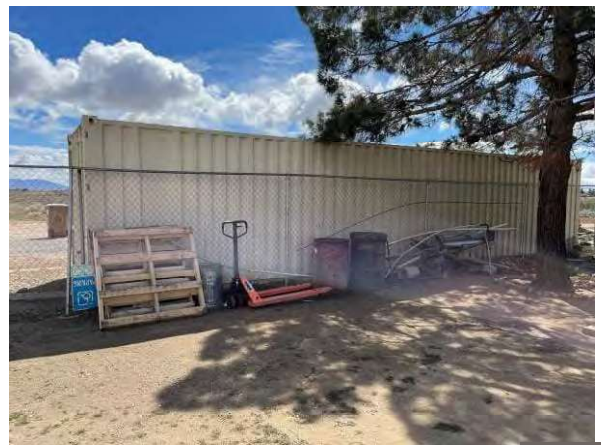
Photo #18 View of storage area on eastern portion of complex, with 55-gallon steel grease waste barrels pictured.

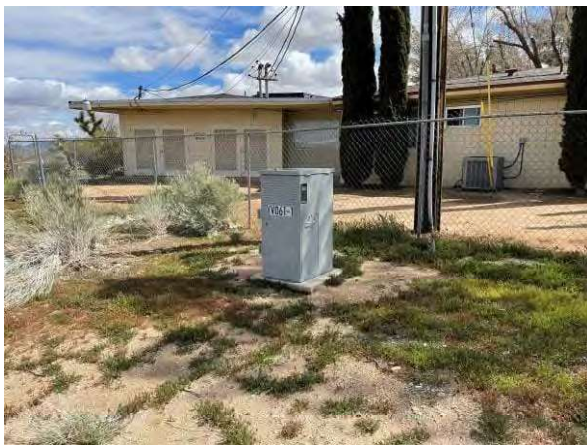
Photo #23 View of pad-mounted transformer on northwestern portion of complex.

During Terracon’s site visit, one pad-mounted transformer, owned and serviced by Southern California Edison, was observed on the northwestern portion of the complex in the central portion of the site. No information with regard to PCB content of the transformer fluids was observed. Some transformers contain mineral oil which may contain PCBs.

Southern California Edison maintains responsibility for the transformers, and if the transformers were “PCB contaminated,” Southern California Edison is not required to replace the transformer fluids until a release is identified. However, evidence of current or prior releases was not observed in the vicinity of the electrical equipment during the site reconnaissance.

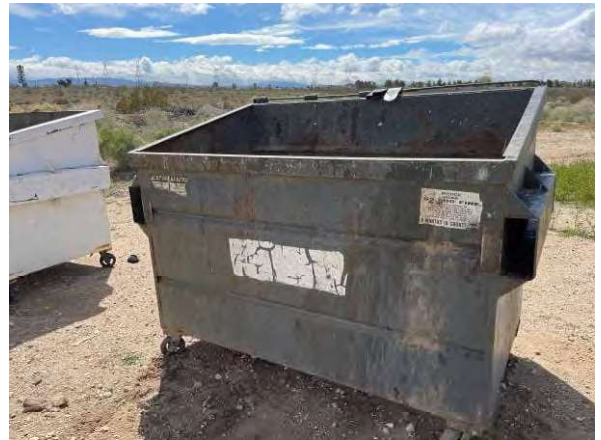
Photo #28 View of the solid waste dumpsters on the southeastern portion of the site.

Two solid waste disposal dumpsters, serviced by BurrTec were observed on the southeastern portion of the complex in the central area of the site. No evidence of staining, noxious odors or hazardous waste disposal was observed within or in the vicinity of the on-site dumpsters.

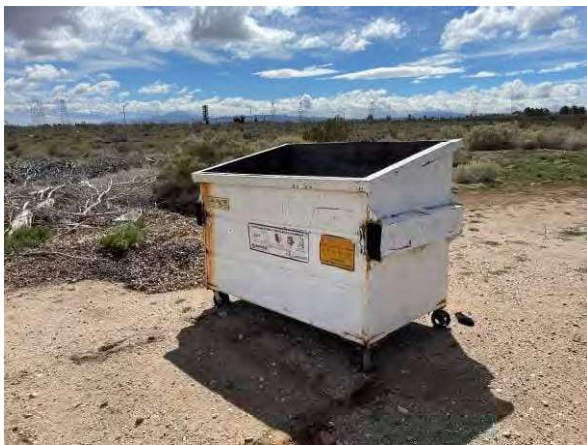
Photo #29 Additional view of the solid waste dumpsters on the southeastern portion of the site.
