# **Materials Testing Report 303 West 5th Street in San Bernardino, California**

**January 2025 (Revised)**

MTGL Project No.:  
6877A04

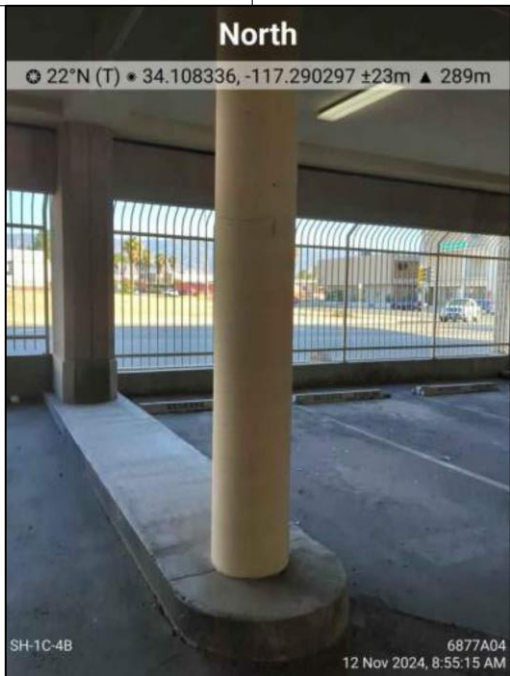
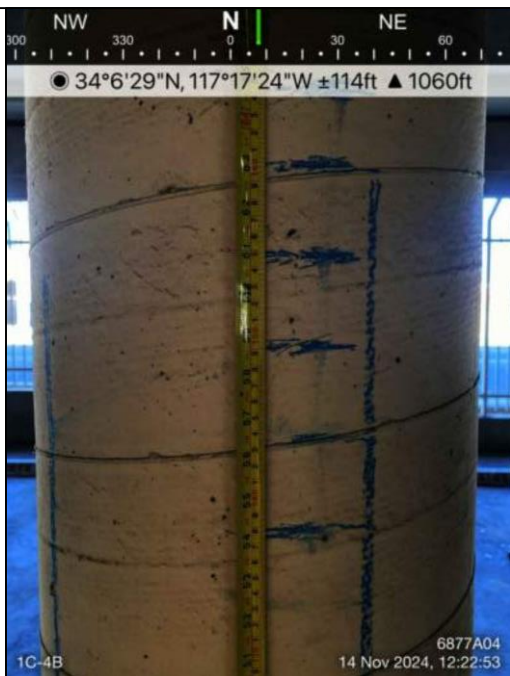
MTGL Project No.: 6877A04	Date: December, 2024	Scale: NTS	Figure No.: C-1
------------------------------	-------------------------	---------------	--------------------

**Pictures - Column 1C-4B**  
 Seismic Retrofit Analysis for SBDCB  
 San Bernardino, California

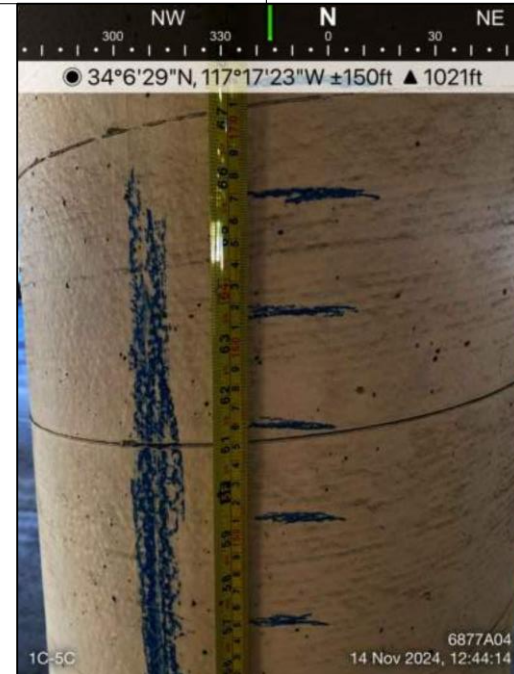
MTGL Project No.: 6877A04	Date: December, 2024	Scale: NTS	Figure No.: C-3
------------------------------	-------------------------	---------------	--------------------

**Pictures - Column 1C-5C**  
Seismic Retrofit Analysis for SBDCB  
San Bernardino, California

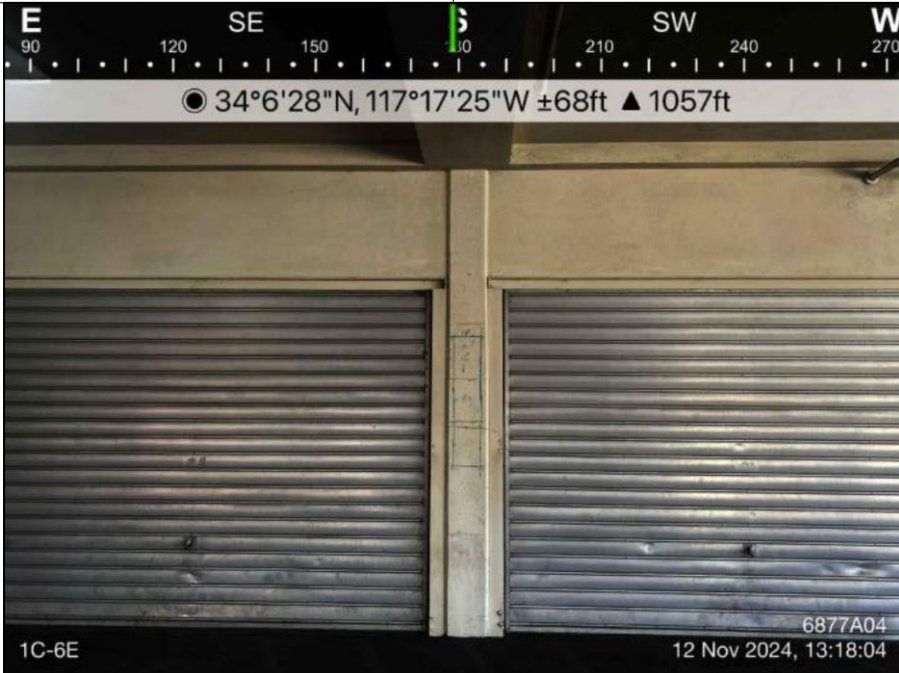
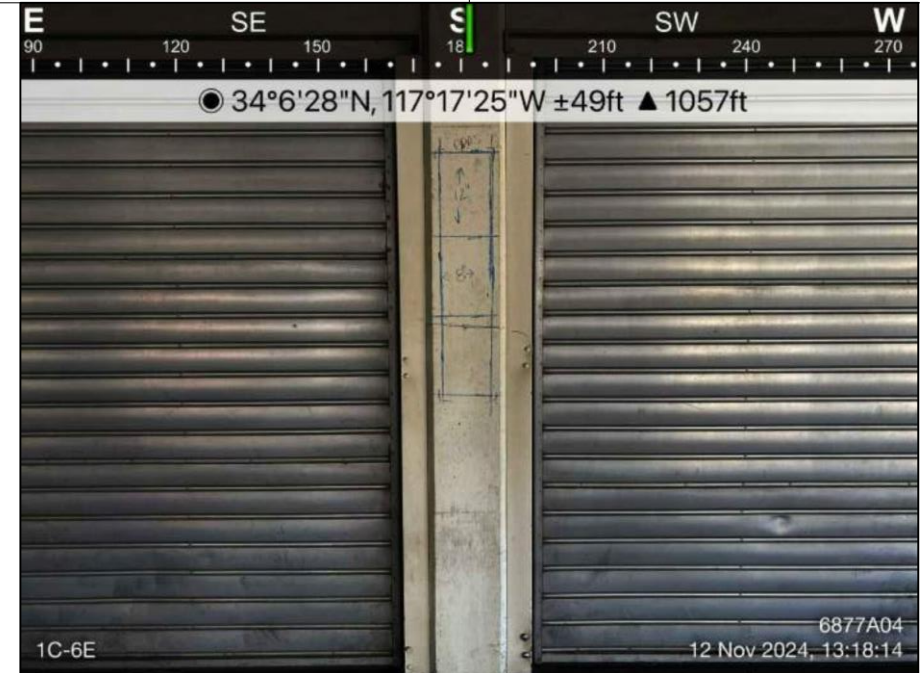
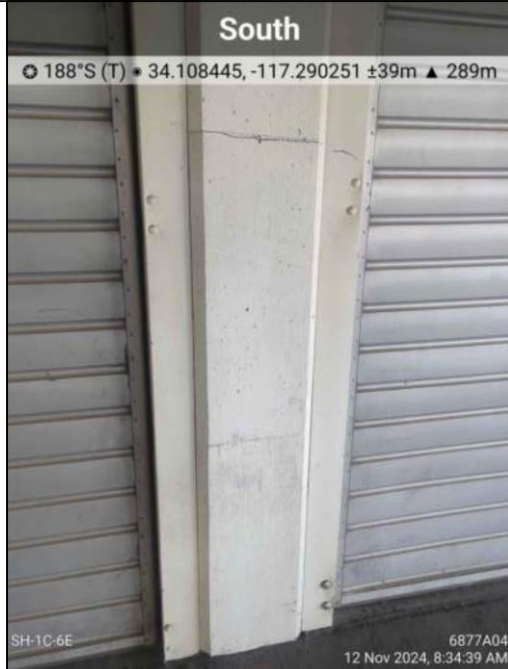
MTGL Project No.:	Date:	Scale:	Figure No.:
6877A04	December, 2024	NTS	C-5

**Pictures - Column 1C-6E**  
 Seismic Retrofit Analysis for SBDCB  
 San Bernardino, California

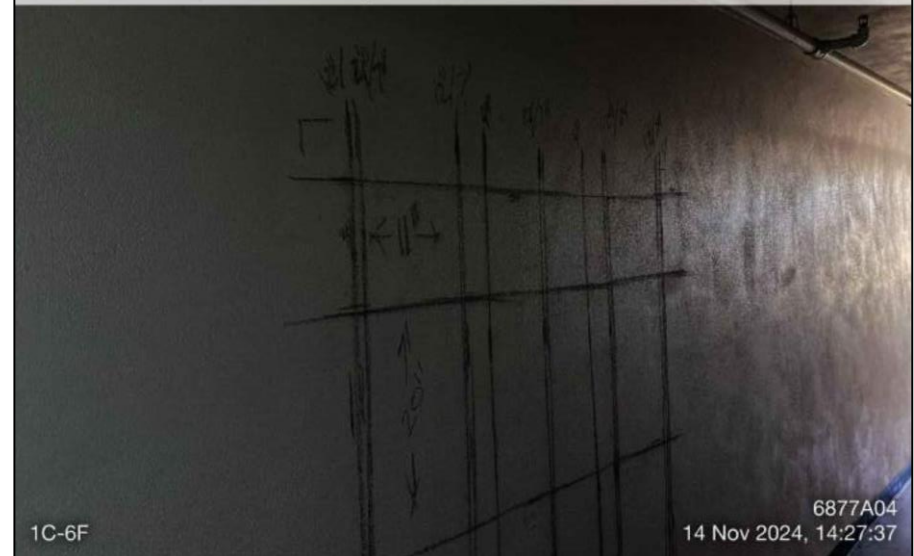
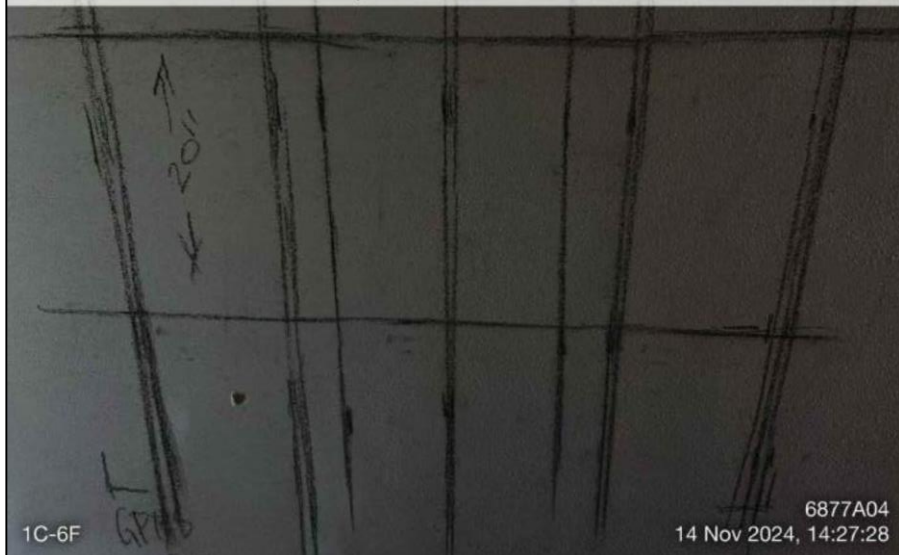
MTGL Project No.: 6877A04	Date: December, 2024	Scale: NTS	Figure No.: C-6
------------------------------	-------------------------	---------------	--------------------

**Pictures - Column 1C-6F**  
Seismic Retrofit Analysis for SBDCB  
San Bernardino, California

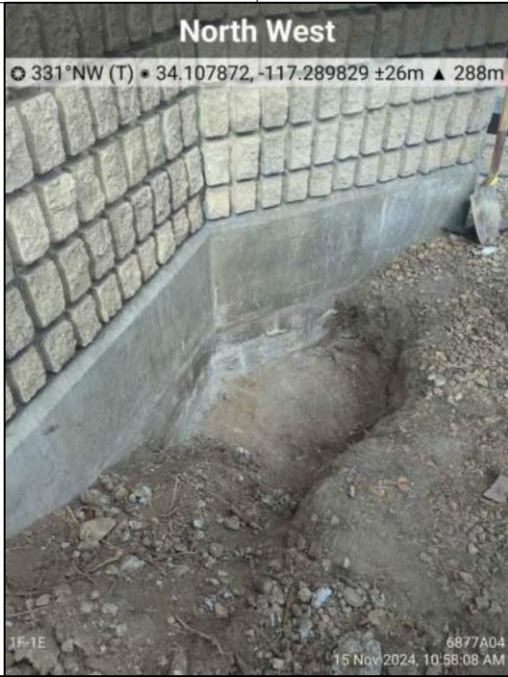
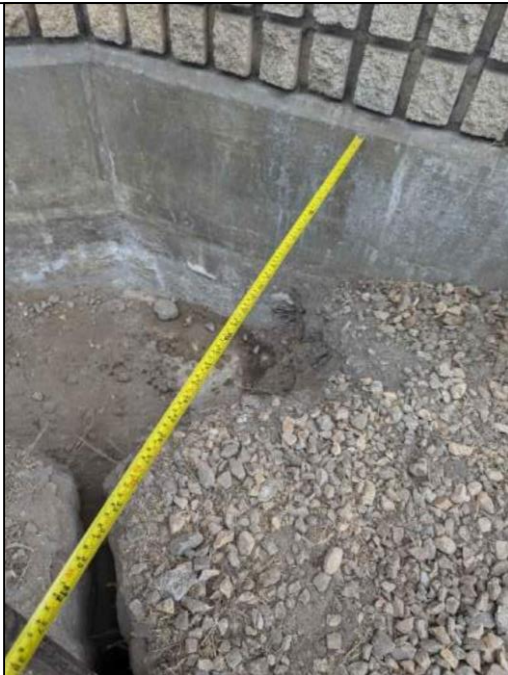
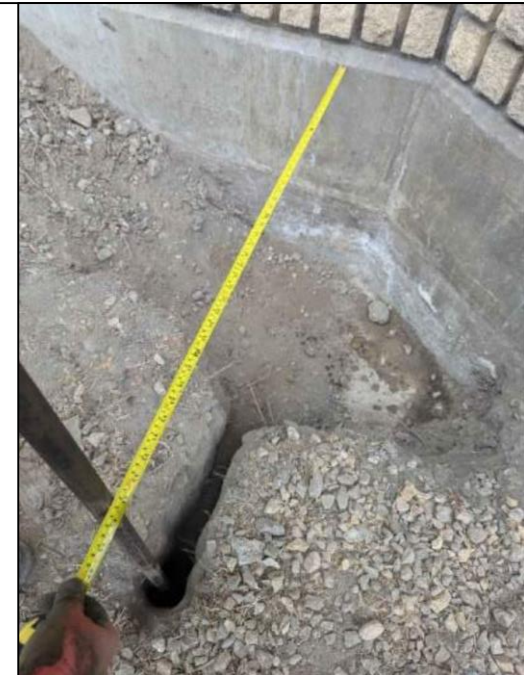
MTGL Project No.: 6877A04	Date: December, 2024	Scale: NTS	Figure No.: C-7
------------------------------	-------------------------	---------------	--------------------

**Pictures - Footing 1F-1E**  
 Seismic Retrofit Analysis for SBDCB  
 San Bernardino, California

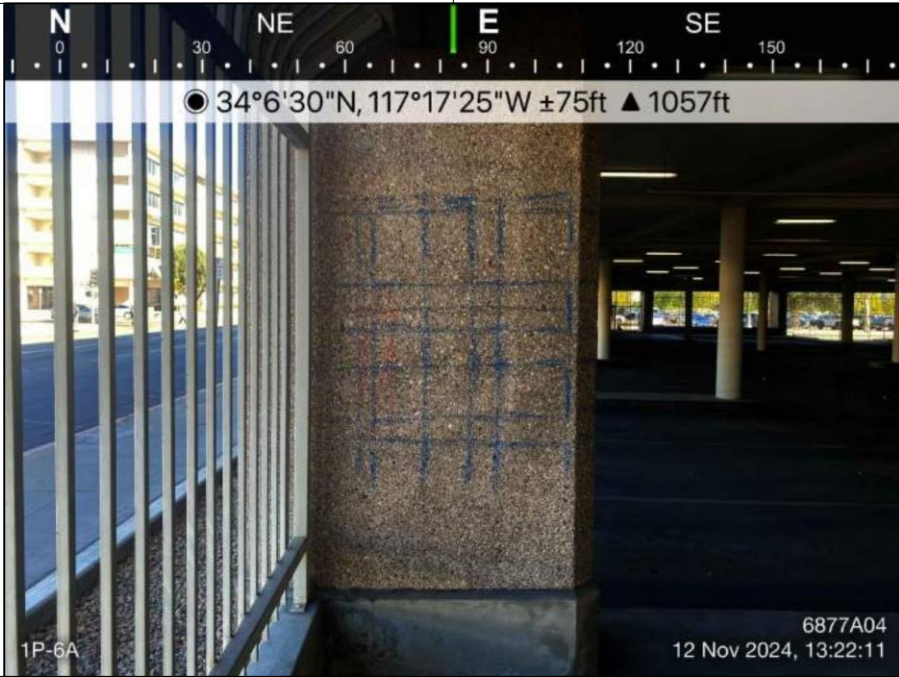
MTG: Project No.: 6877A04	Date: December, 2024	Scale: NTS	Figure No.: C-9
------------------------------	-------------------------	---------------	--------------------

**Pictures - Pier 1P-6A**  
 Seismic Retrofit Analysis for SBDCB  
 San Bernardino, California

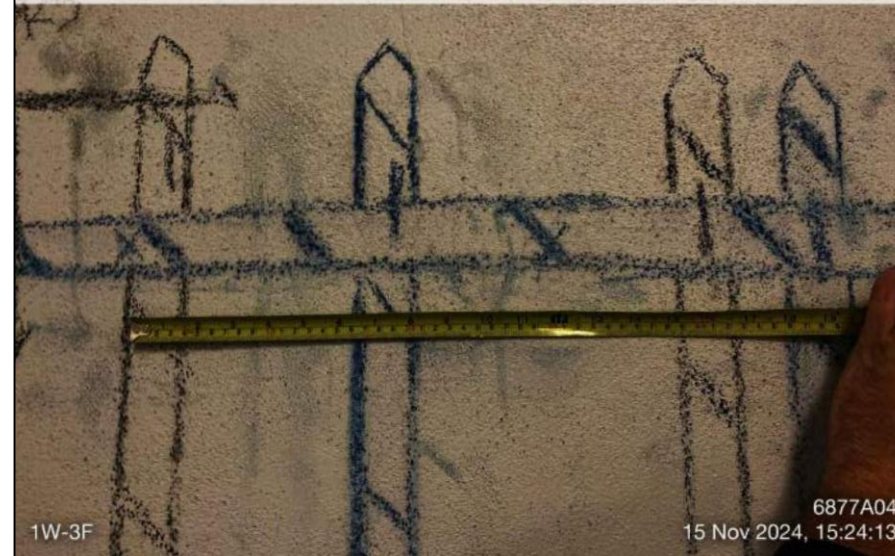
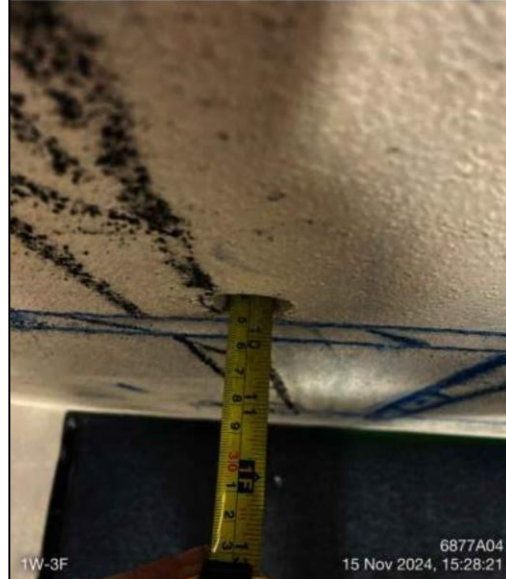
MTGL Project No.: 6877A04	Date: December, 2024	Scale: NTS	Figure No.: C-13
------------------------------	-------------------------	---------------	---------------------

**Pictures - Wall 1W-3F**  
Seismic Retrofit Analysis for SBDCB  
San Bernardino, California

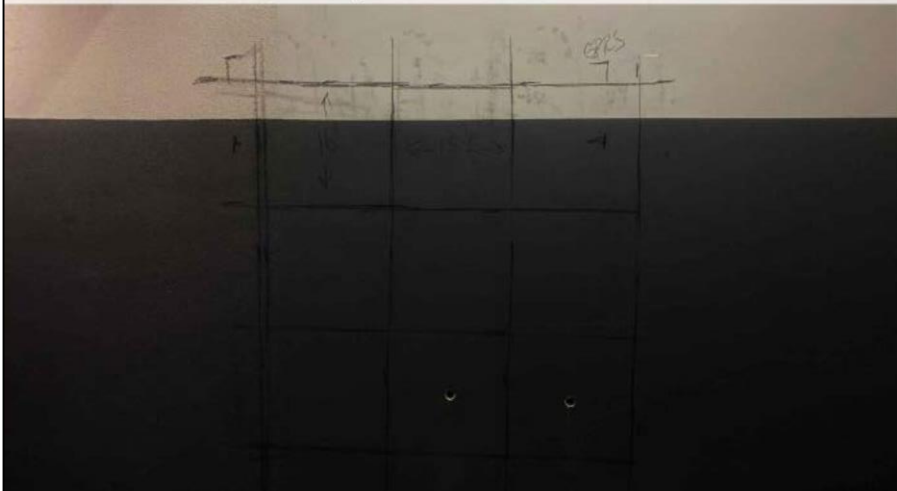
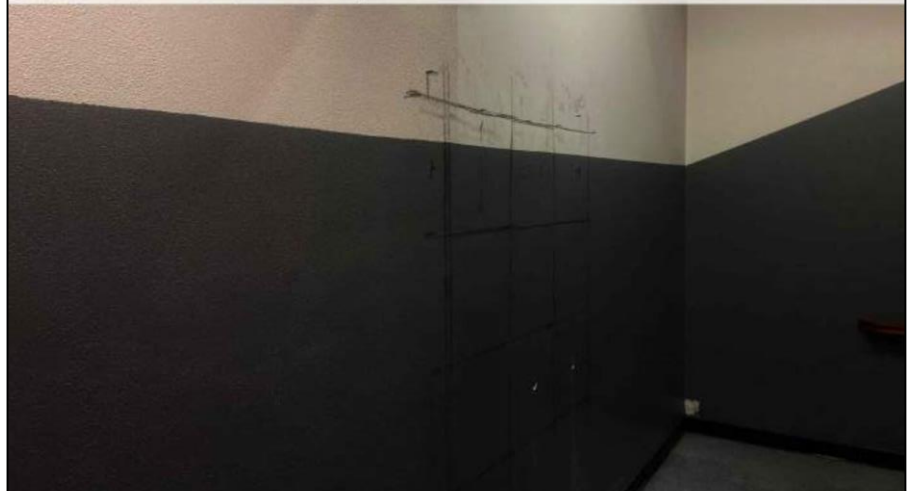
MTGL Project No.: 6877A04	Date: December, 2024	Scale: NTS	Figure No.: C-15
------------------------------	-------------------------	---------------	---------------------

**Pictures - Wall 1W-5EF**  
Seismic Retrofit Analysis for SBDCB  
San Bernardino, California

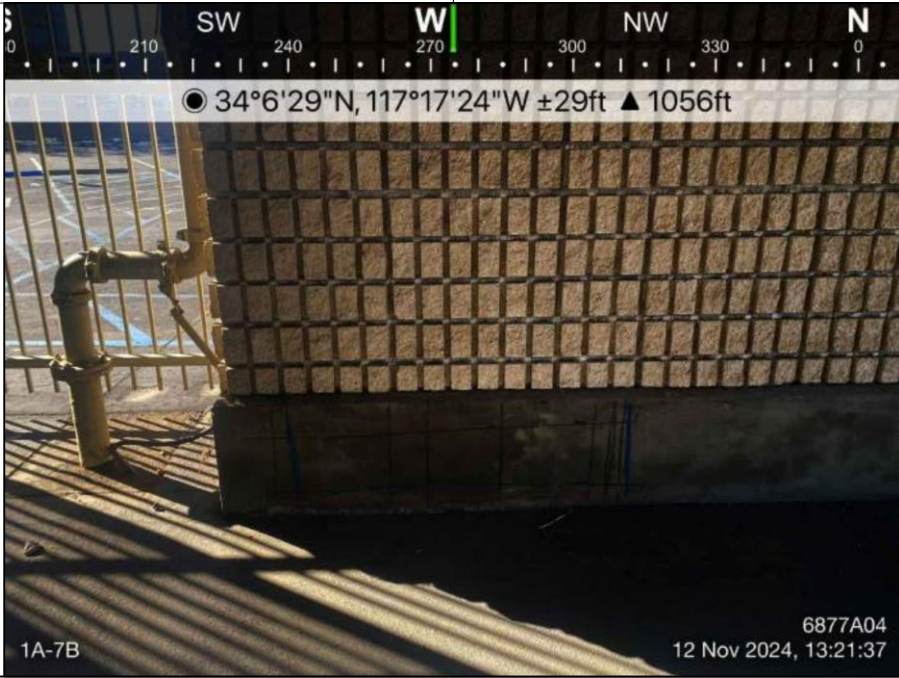
MTGL Project No.:	Date:	Scale:	Figure No.:
6877A04	December, 2024	NTS	C-16

**Pictures - Wall 1W-7B**  
Seismic Retrofit Analysis for SBDCB  
San Bernardino, California

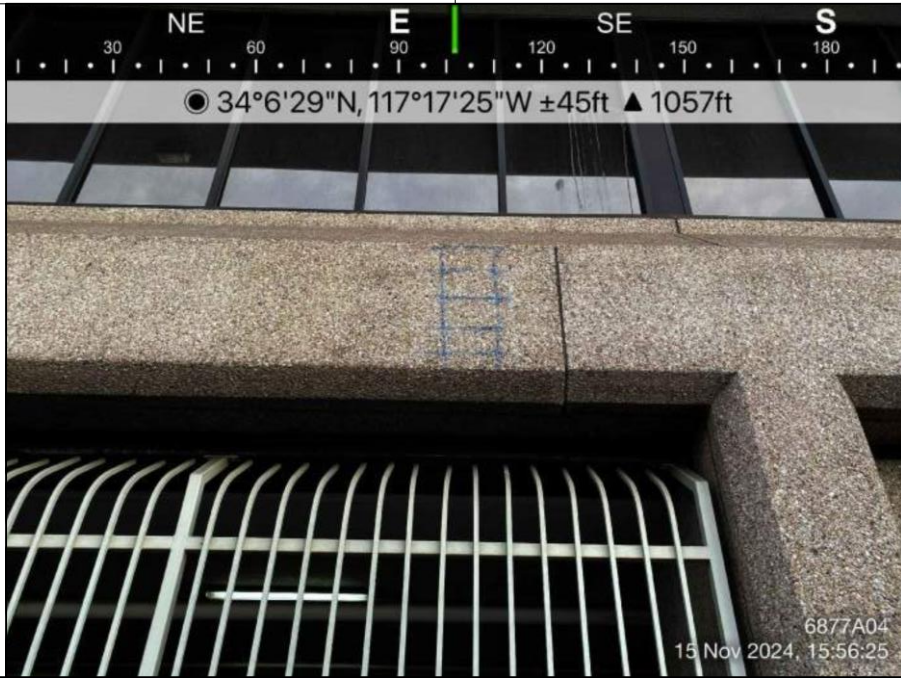
MTGL Project No.:	Date:	Scale:	Figure No.:
6877A04	December, 2024	NTS	C-17

**Pictures - Beam 2HB-7BC**  
Seismic Retrofit Analysis for SBDCB  
San Bernardino, California

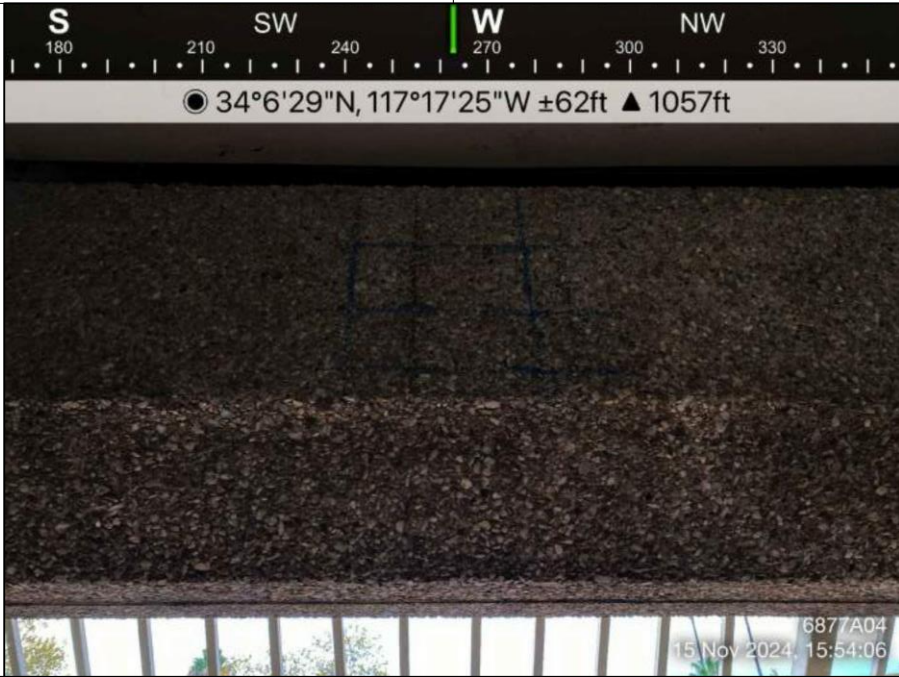
MTG: Project No.:	Date:	Scale:	Figure No.:
6877A04	December, 2024	NTS	C-18

**Pictures - Beam 2LB-7CD**  
Seismic Retrofit Analysis for SBDCB  
San Bernardino, California

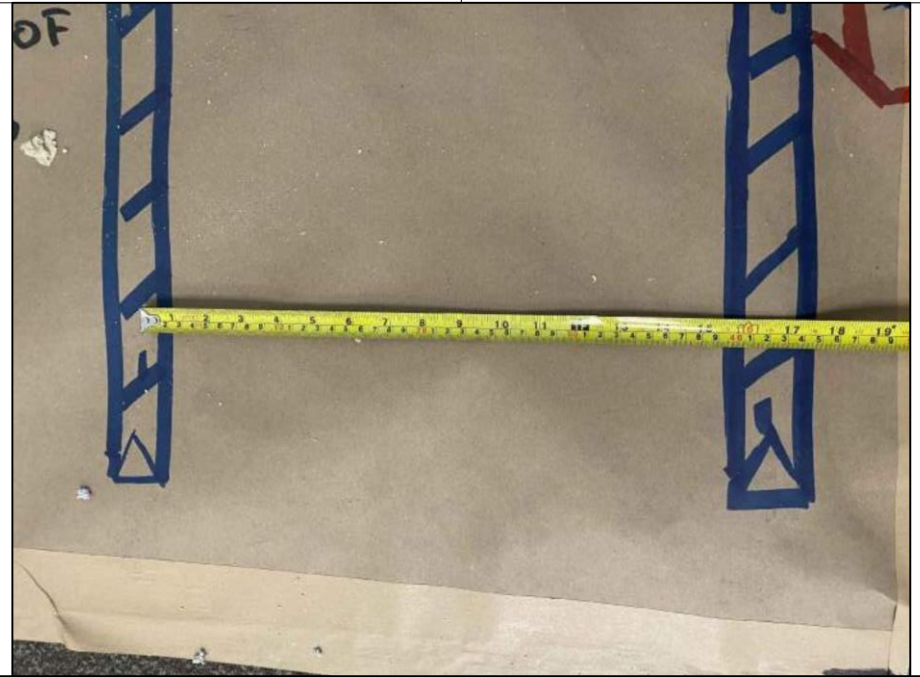
MTGL Project No.: 6877A04	Date: December, 2024	Scale: NTS	Figure No.: C-20
------------------------------	-------------------------	---------------	---------------------

**Pictures - 2nd Floor Slab Connection to 2HB**  
Seismic Retrofit Analysis for SBDCB  
San Bernardino, California

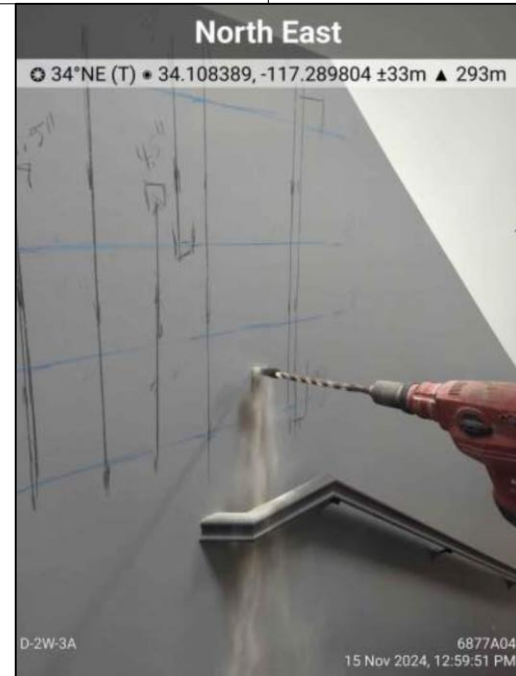
MTGL Project No.: 6877A04	Date: December, 2024	Scale: NTS	Figure No.: C-21
------------------------------	-------------------------	---------------	---------------------

**Pictures - Wall 2W-3A**  
Seismic Retrofit Analysis for SBDCB  
San Bernardino, California

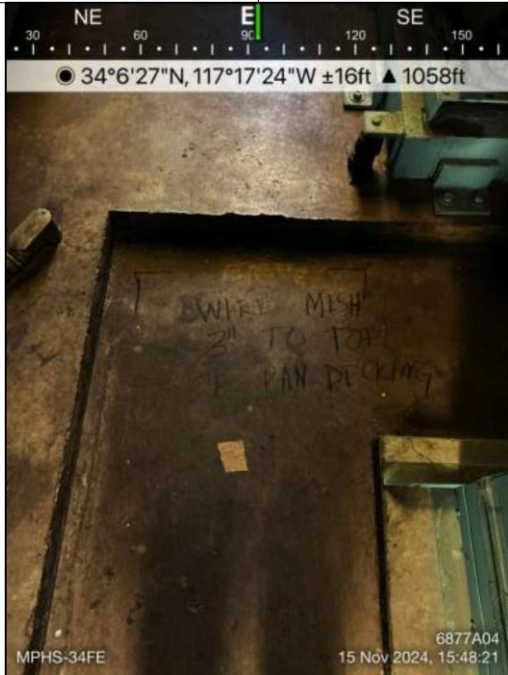
MTGL Project No.: 6877A04	Date: December, 2024	Scale: NTS	Figure No.: C-24
------------------------------	-------------------------	---------------	---------------------

**Pictures - MPH Slab**  
**Seismic Retrofit Analysis for SBDCB**  
**San Bernardino, California**

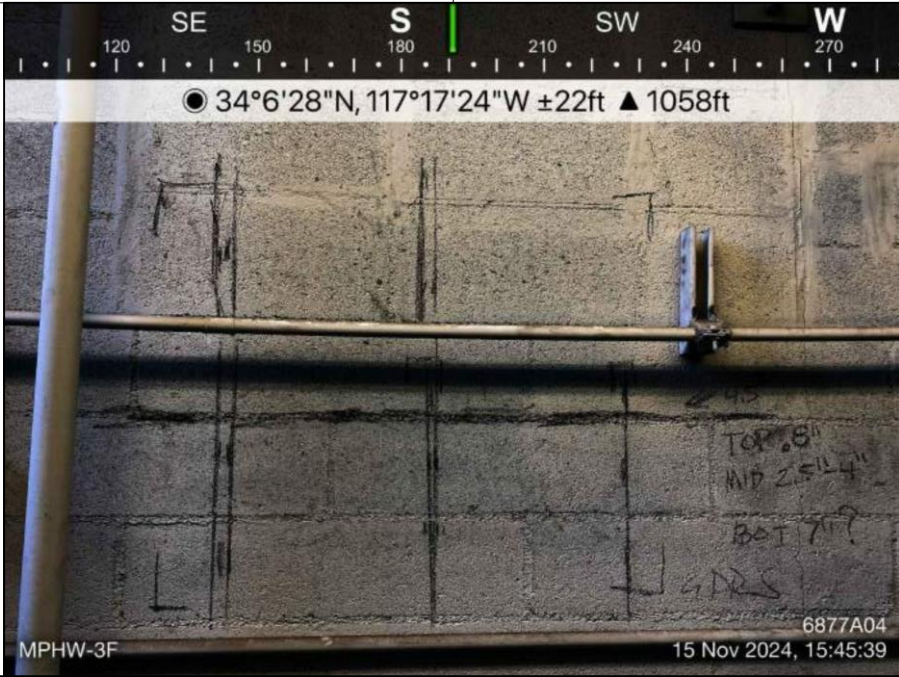
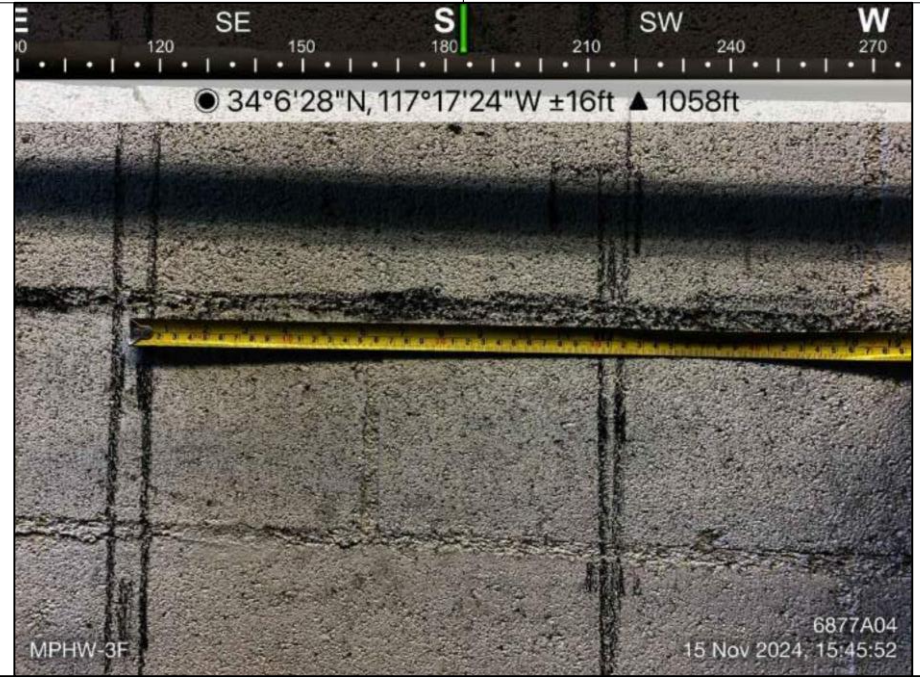
MTGL Project No.:	Date:	Scale:	Figure No.:
6877A04	December, 2024	NTS	C-25

**Pictures - MPH Wall 3F**  
 Seismic Retrofit Analysis for SBDCB  
 San Bernardino, California

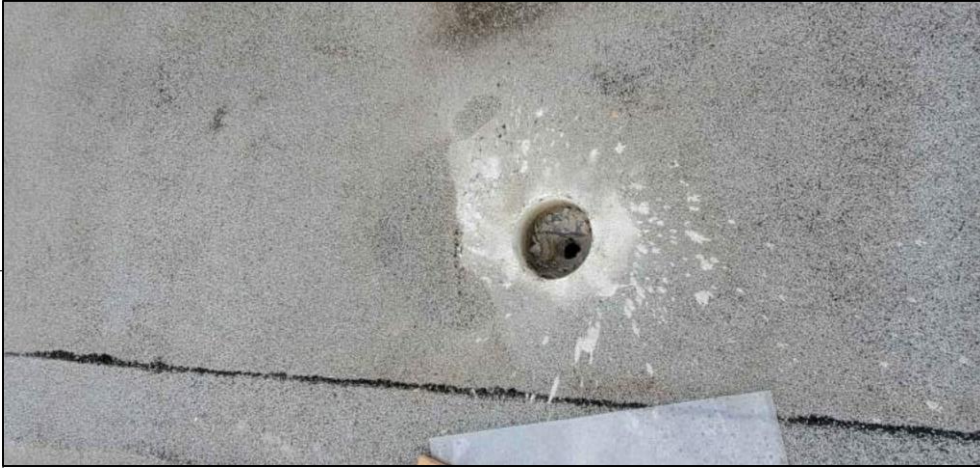
MTGL Project No.:	Date:	Scale:	Figure No.:
6877A04	December, 2024	NTS	C-26

**Pictures - Roof Slab**  
Seismic Retrofit Analysis for SBDCB  
San Bernardino, California

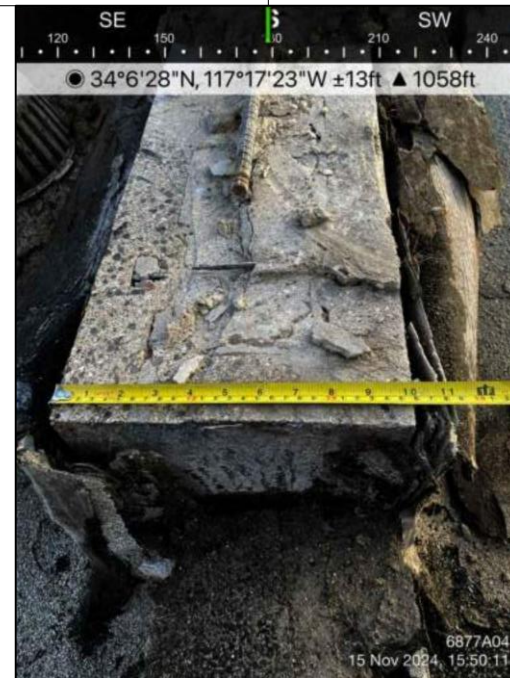
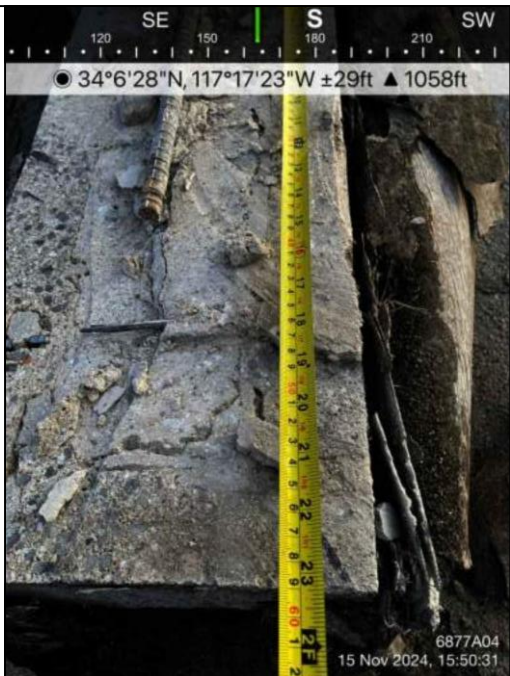
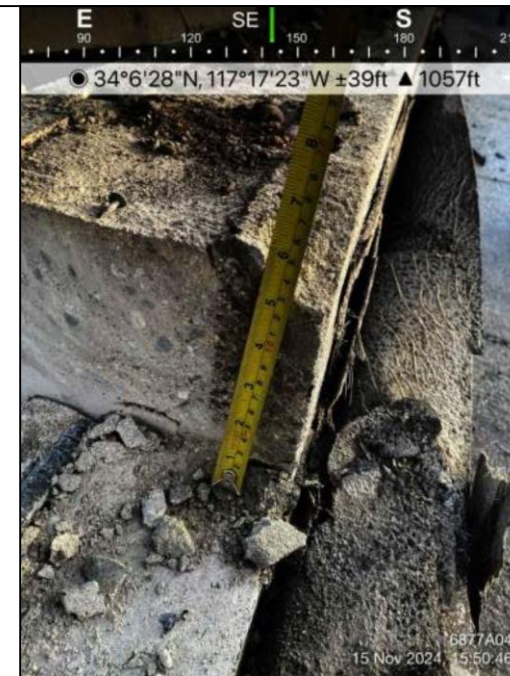
MTGL Project No.:	Date:	Scale:	Figure No.:
6877A04	December, 2024	NTS	C-27

**Pictures - High Roof Slab**  
Seismic Retrofit Analysis for SBDCB  
San Bernardino, California
