## TRAFFIC INVESTIGATION RECORD

<b>SUBJECT: REQUEST FOR SIGHT DISTANCE REMEDIATION</b>	
<b>ROAD NAME: SANTINA STREET</b>	<b>LOCATION: SNOWDROP ROAD</b>

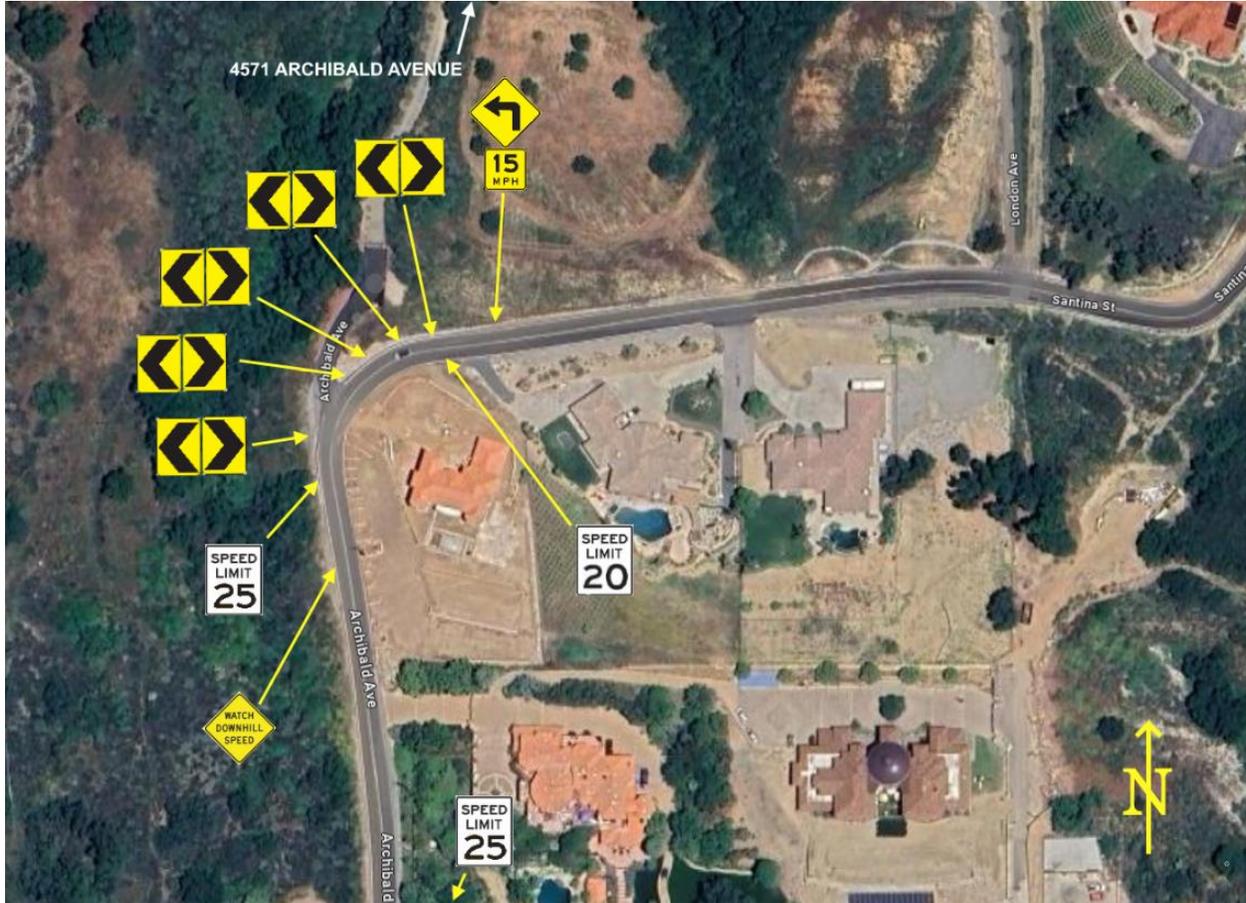
Figure 2: Existing traffic control devices at Location #1.

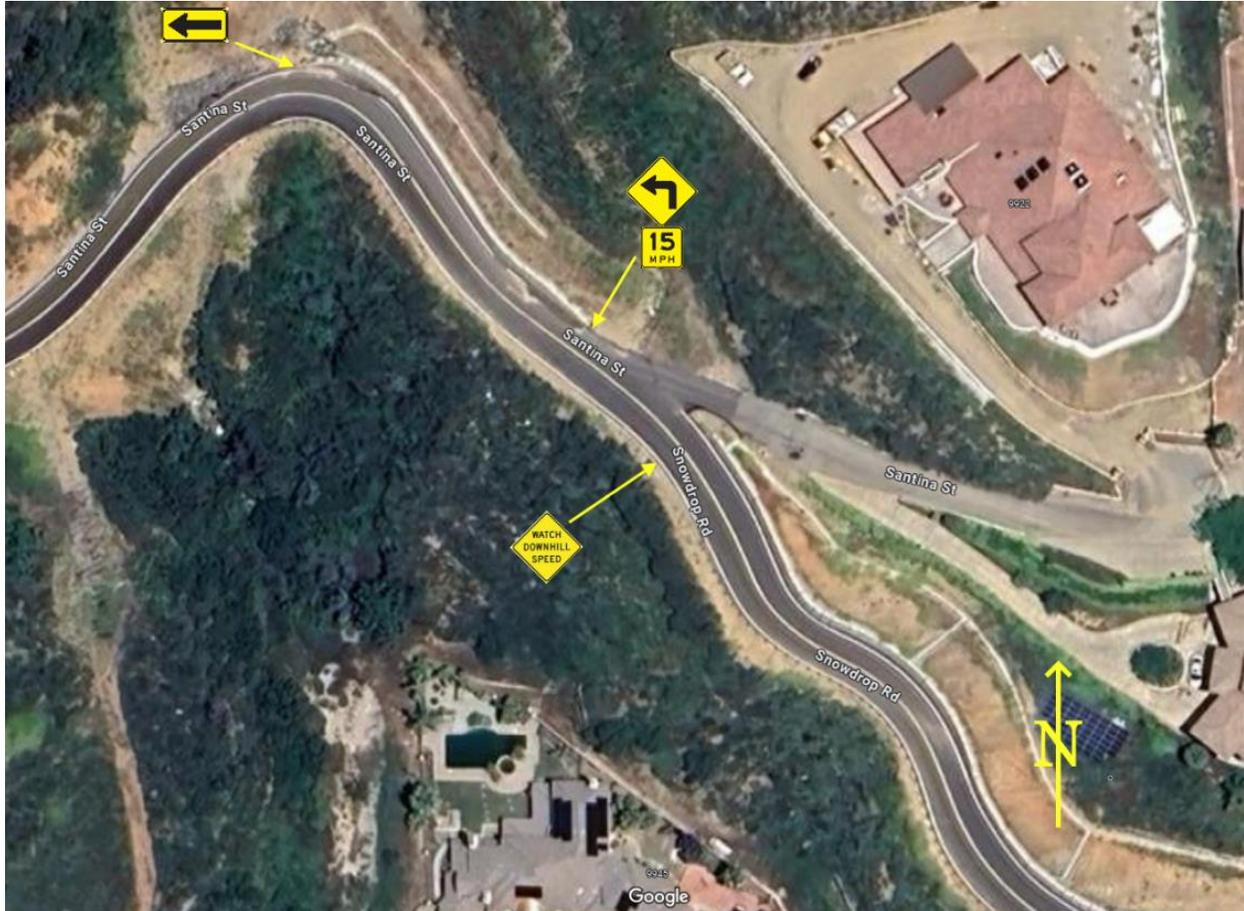
Figure 3: Existing Traffic control devices at Location #2.

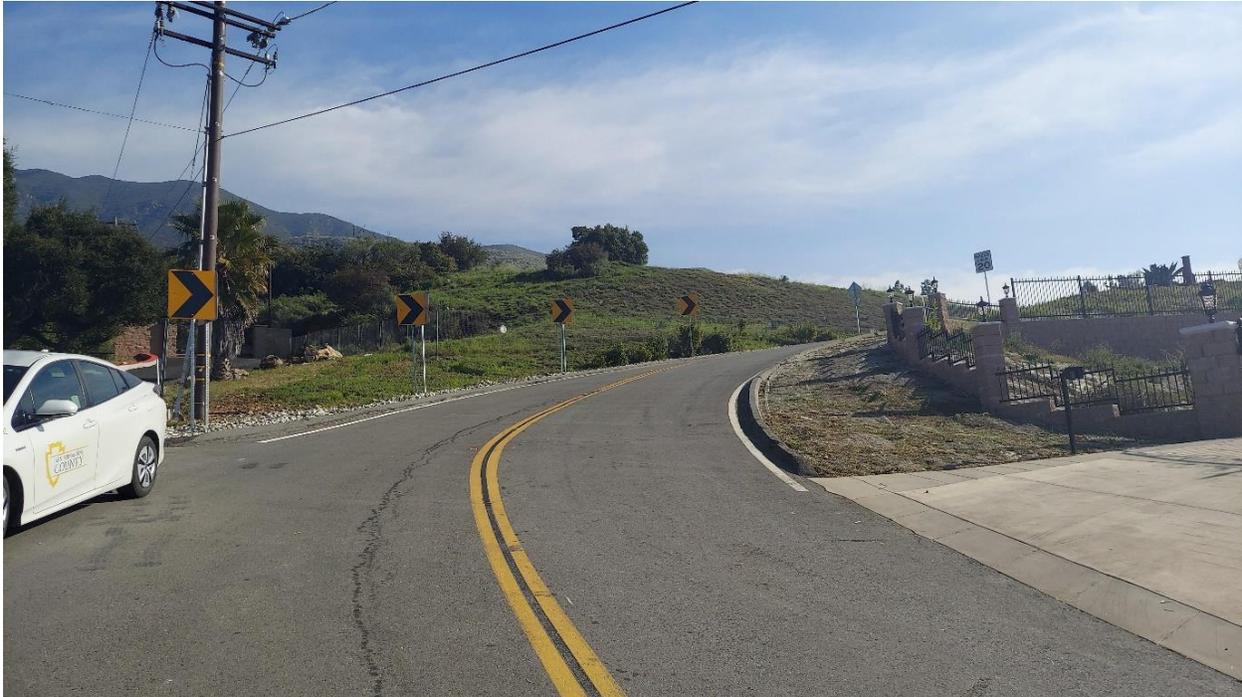
Figure 4: (Location #1) Santina Street looking north from 4571 Archibald Avenue driveway. Vertical and horizontal curves limiting sight distance are noted.

- Location #1:
  - Place rumble strips in advance of crest to warn motorists of the approaching curve, place the rumble strips at 4 locations as shown in Figure 11 below;
  - Remove the existing W1-1 sign and W13-1P (15-mph) signs;
  - Install W1-10 signs and W13-1P (15-mph) signs near said proposed rumble strips, approximately 350 feet from the curve and intersection, as shown in Figure 11.

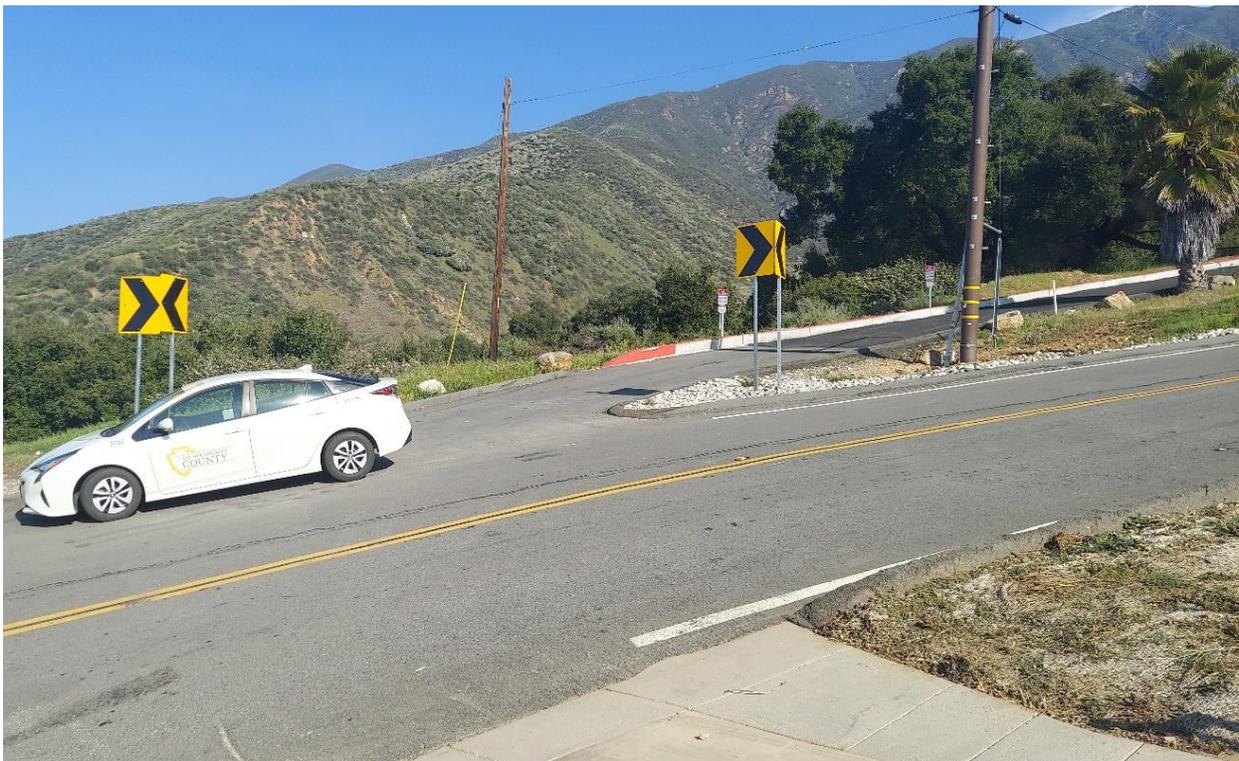
Figure 5: (Location #1) Santina Street at Archibald Avenue looking north at 4571 Archibald Avenue driveway, at turning curve.

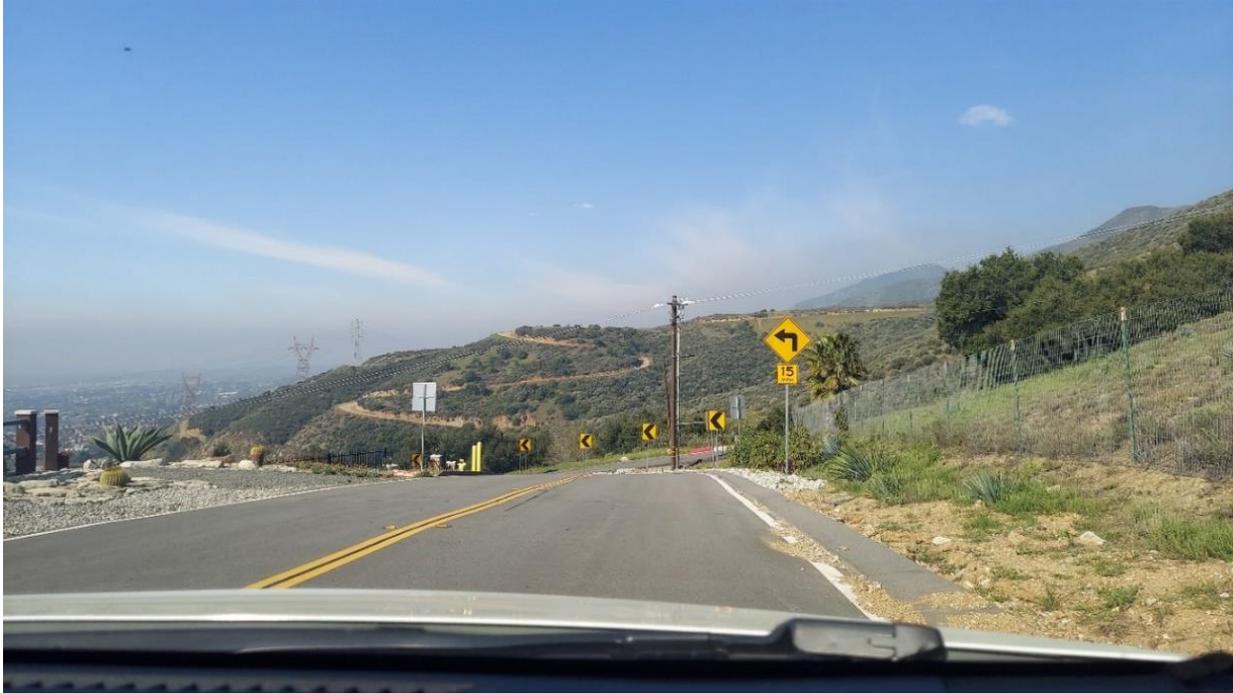
Figure 6: (Location #1) Santina Street looking west at 4571 Archibald Avenue driveway, at turning curve.

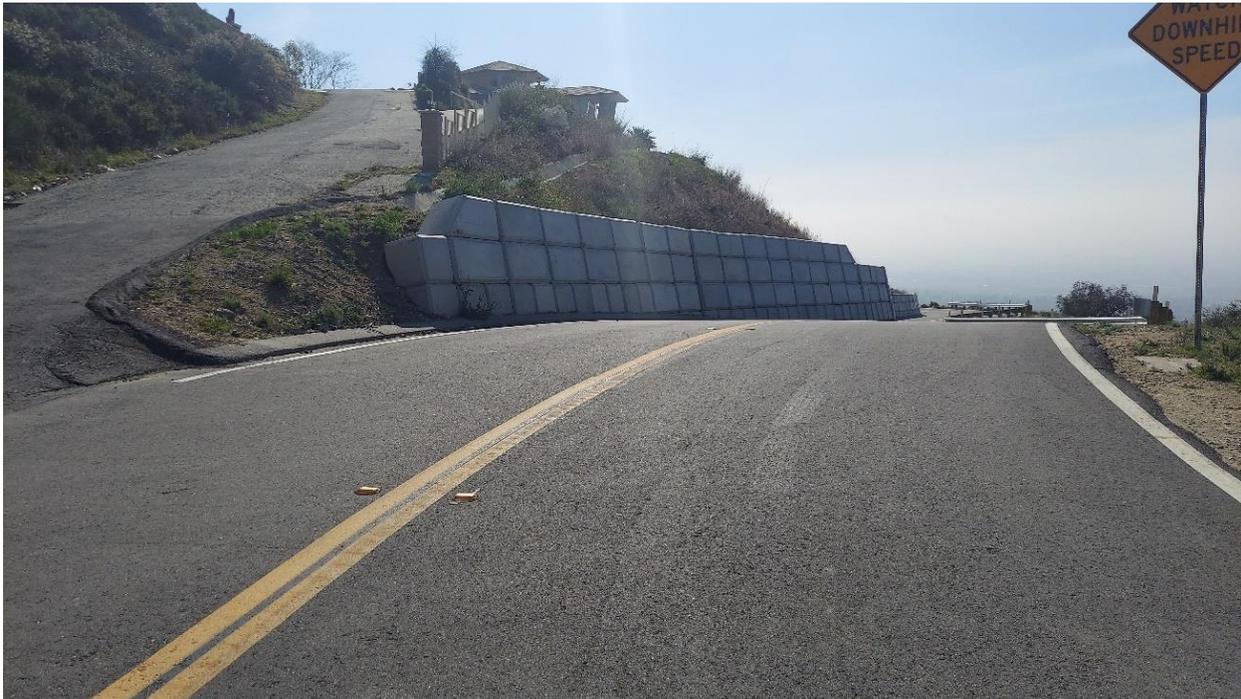
Figure 7: (Location #2) Snowdrop Road looking east from 9922 Santina Street driveway (Santina Street). Wall limiting sight distance is noted.

- Location #2: Install two traffic mirrors to improve view of oncoming vehicles. See Figure

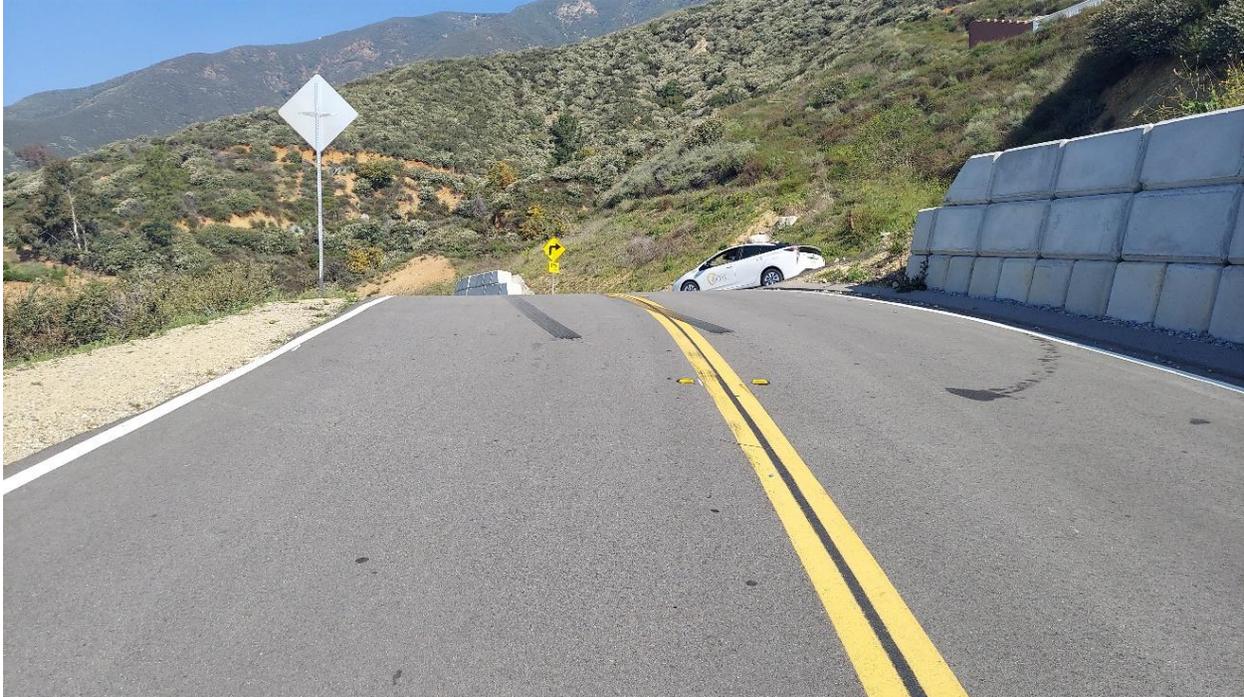
Also, Susan claims the horizontal curve radius is not large enough to make a safe turn onto the uphill portion of Santina Street. This, it is also claimed, is compounded by a vertical crest that may prevent motorists seeing the centerline when driving over the hill, possibly evidenced by skid marks located over the painted centerline for eastbound traffic.

Figure 8: Snowdrop Road looking west from 9922 Santina Street driveway (Santina Street). Vertical curve limiting sight distance and skid marks are noted.

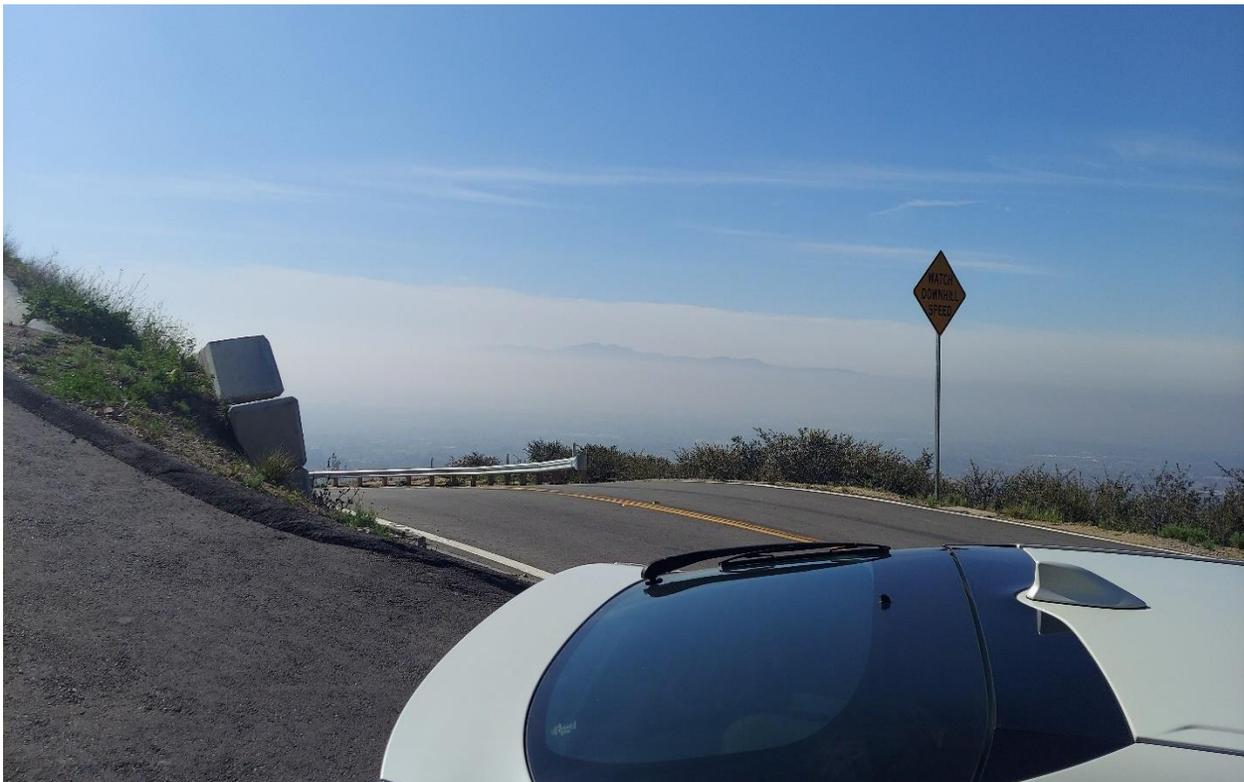
Figure 9: (Location #2) Santina Street driveway looking east at Snowdrop Road. Block wall and horizontal curve limiting sight distance are noted.

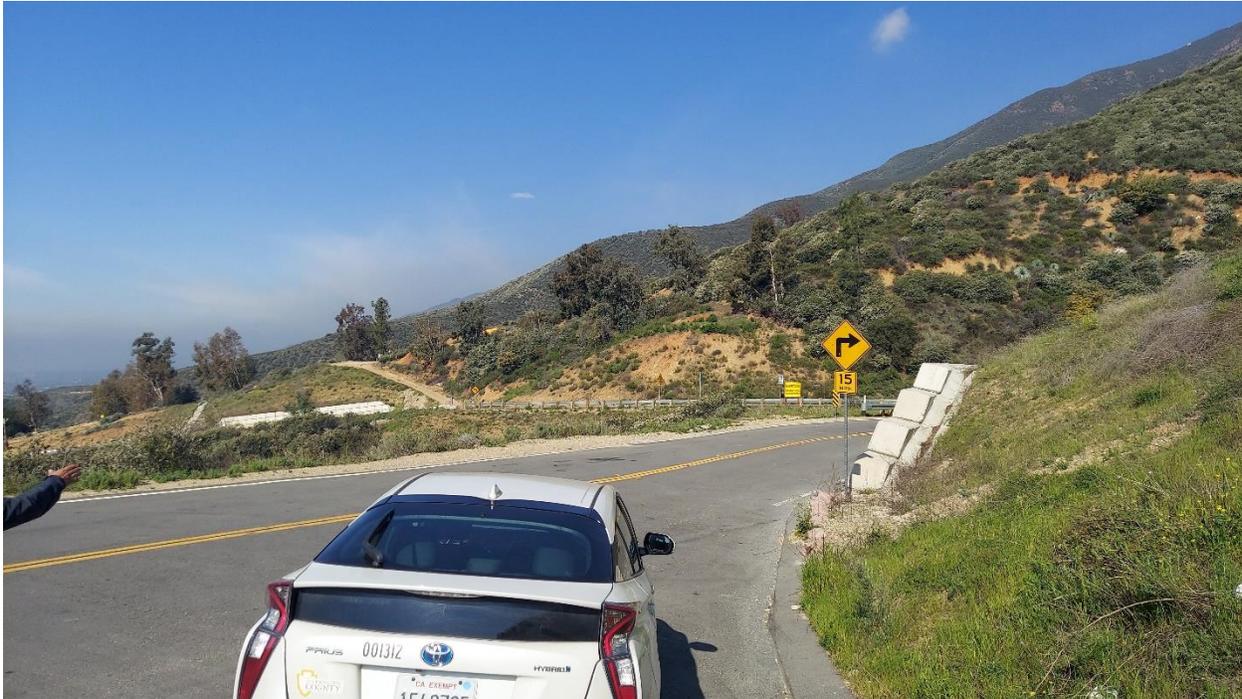
Figure 10: Santina Street driveway looking west at Snowdrop Road. Block wall and horizontal curve limiting sight distance are noted.

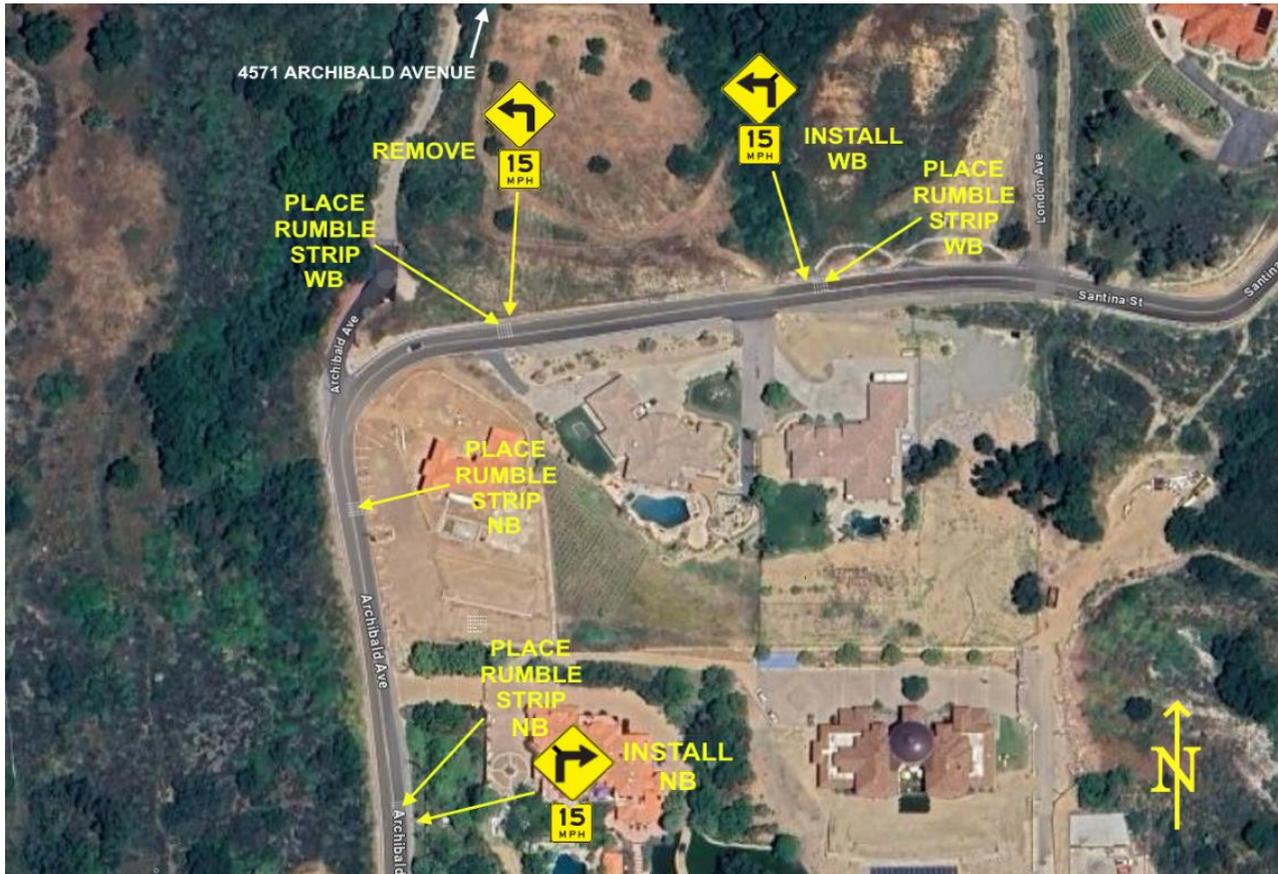
Figure 11: Proposed TCD devices for Location #1.

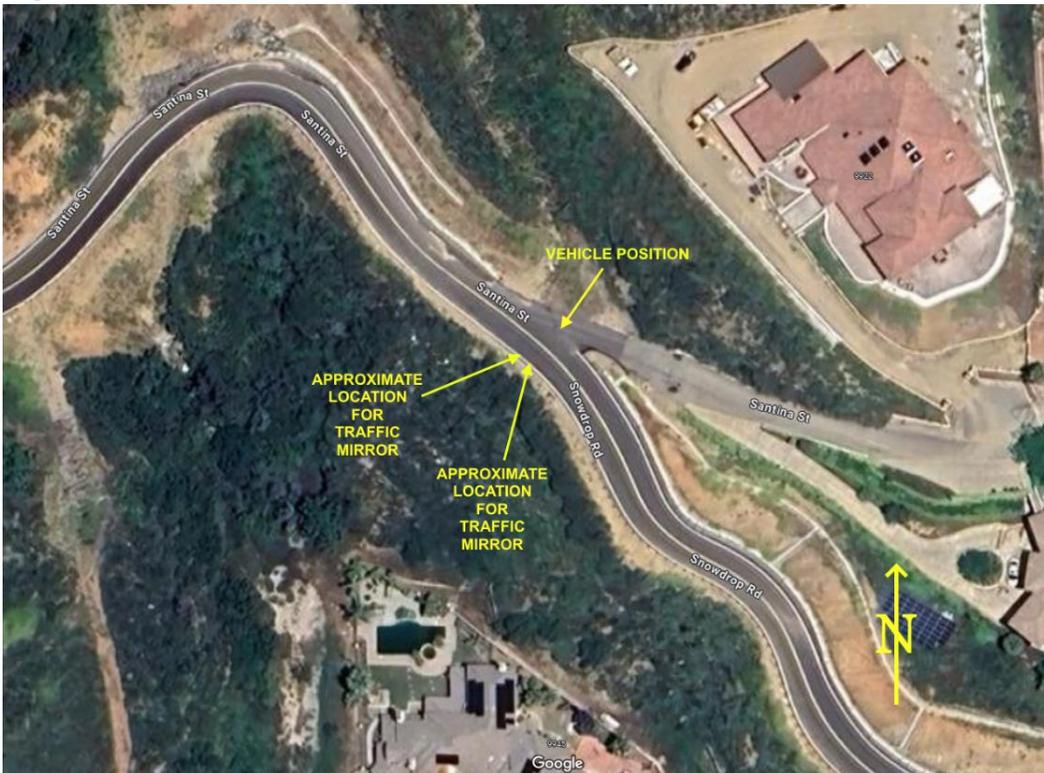
**Figure 12: Proposed TCD devices for location #2.**
