Initial Study for County of San Bernardino PROJ-2019-00032
Titan Industrial Metal Corporation Equipment Rental and Large Collection/Light Processing Facility – Conditional Use Permit,
General Plan Amendment, and Zone Change
APN: 0235-031-04, 0235-041-14, 0235-041-13, 0235-041-021, 0235-041-20
September 2023

PHASE I ENVIRONMENTAL SITE ASSESSMENT

9995, 10011, 10017 Live Oak Avenue and 14930 Valley Boulevard Fontana, California 92335

Project Number 202111-9198

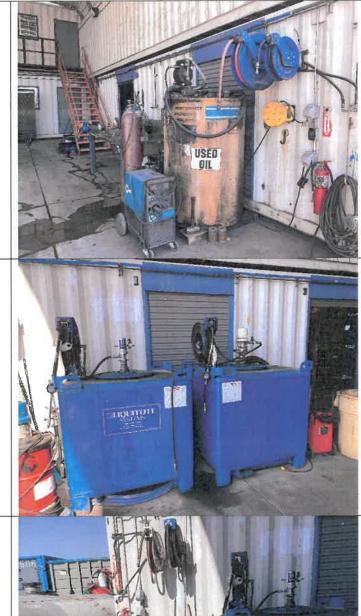
Photo 11. View of two 250-gallon ASTs, containing motor oil and hydraulic oil, located in the maintenance and storage area. Staining pictured.
