# 4.9 NEWMARK ELEMENTARY SCHOOL

4121 N 3rd Ave, San Bernardino, CA 92407  
San Bernardino City Unified School District

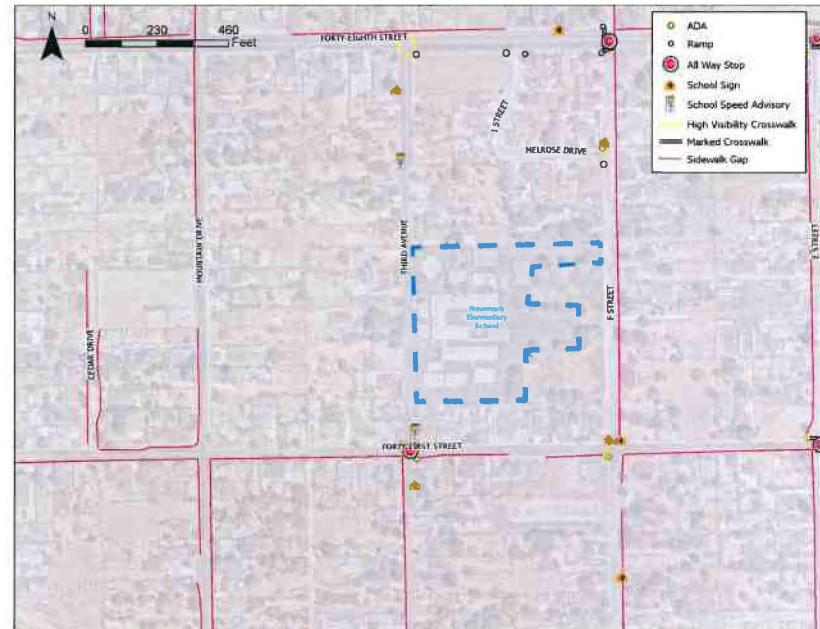
**Figure 4.9.7 Existing Pedestrian Conditions**

Figure 4.9.7 provides an overview of the existing pedestrian network and challenges observed and analyzed. There are existing sidewalks on both sides of 3rd Avenue in front of the school. There are also sidewalks surrounding the school along 41st Street, F Street and 48th Street. Although there is a sidewalk right in front of the school, students were observed walking along 3rd Avenue on the west side of the parking with oncoming traffic after being dropped off.

During the walk audit, speeding and pedestrian/vehicle conflicts were observed along 3rd Avenue frequently. Students trying to cross 3rd Avenue from the west side of the street were observed walking into oncoming traffic after being dropped off. This intersection is controlled by stop signs in the east-west direction only. The back of the school along F Street is also another area for pick-up and drop-off. It was noted by the principal that speeding was also a concern along this street.

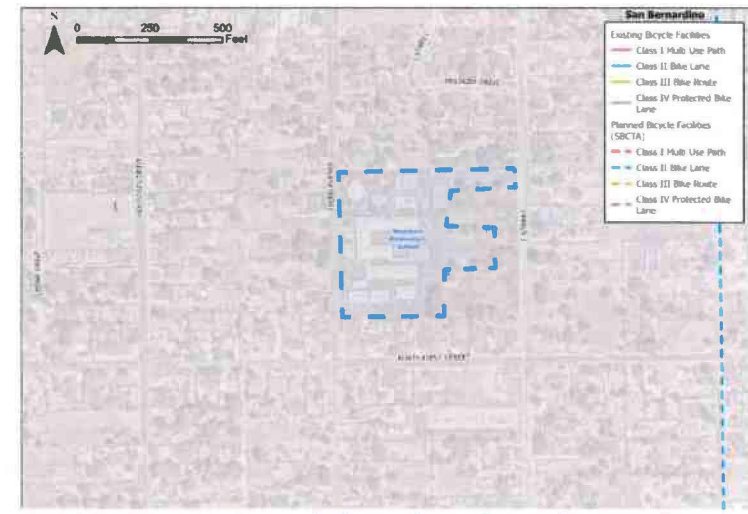
**Figure 4.9.10 Existing and Planned Bicycle Condition**

Currently, there are no bicycle facilities surrounding Newmark Elementary School. There are plans to implement a Class II Bike Lane along E Street through SBCTA (Figure 4.9.10).
