PRELIMINARY JURISDICTIONAL WATERS AND WETLANDS DELINEATION REPORT Elder Creek Channel Improvement Project

San Bernardino County Flood Control District
825 East Third Street
San Bernardino, CA 92415

Aspen Environmental Group
615 North Benson Avenue, Suite E
Upland, CA 91786

August 2019 (Revised January 2020)

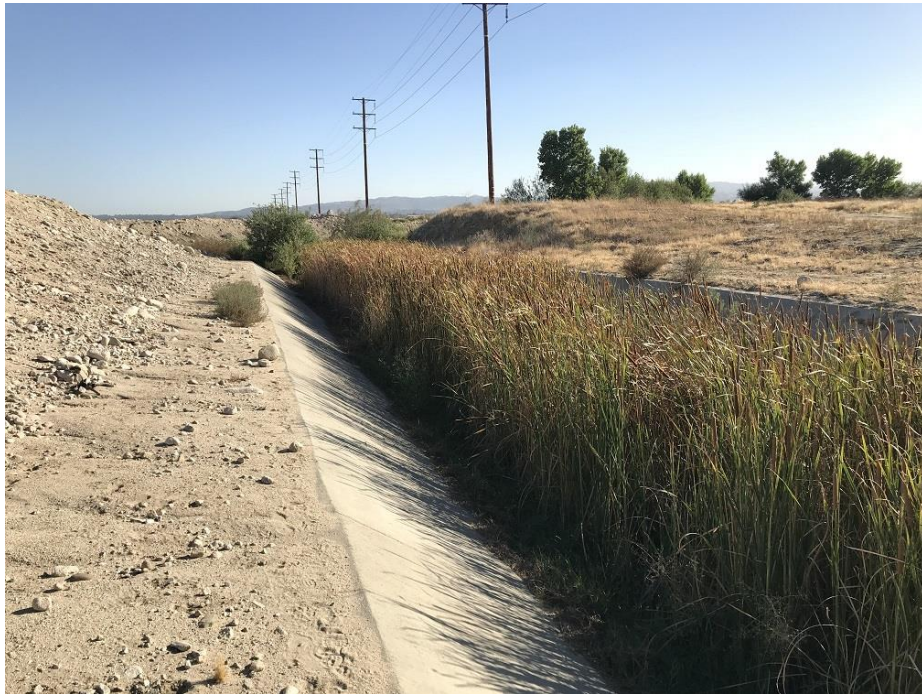
Photo 1: South-facing view of wetland vegetation within Church Channel.

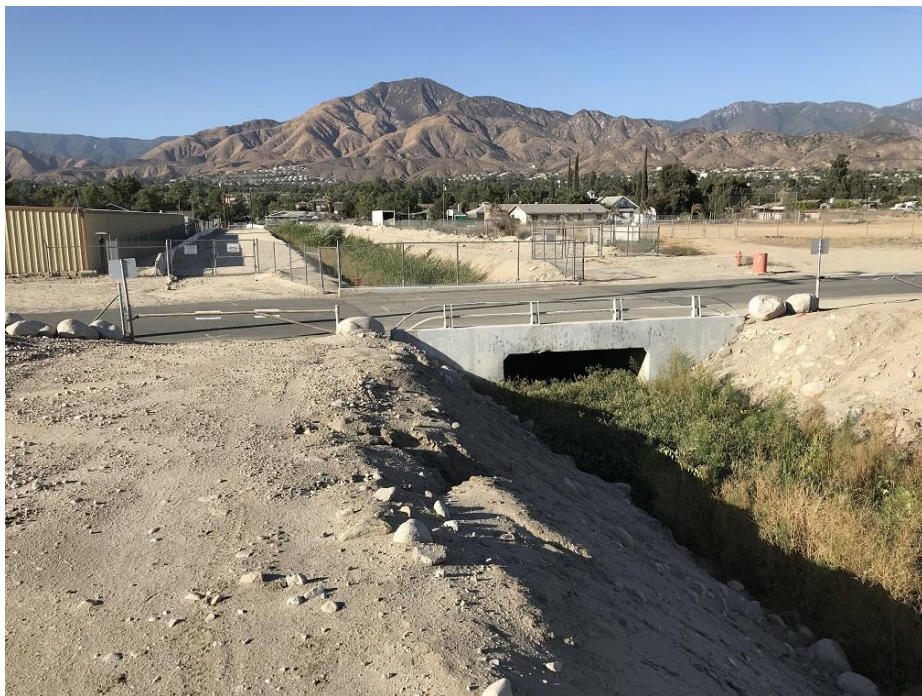
Photo 2: Northeast-facing view of wetland vegetation in Elder Channel.

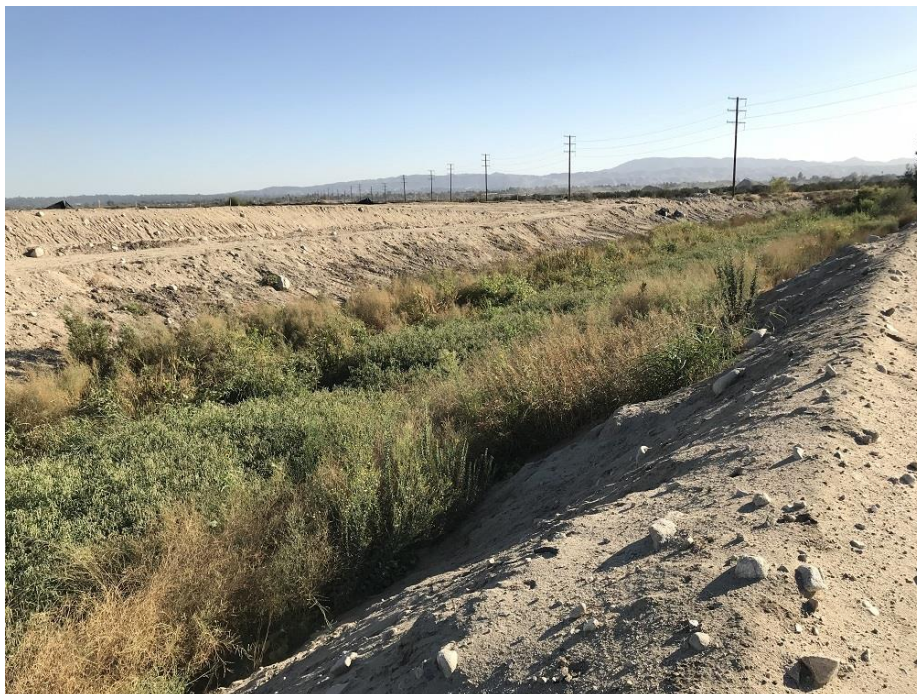
Photo 3: Southwest-facing view of wetland vegetation within the lower portion of Elder Channel.

California buckwheat scrub. California buckwheat scrub is a native upland vegetation type that is present along the southeast edge of the project site (see Photos 3 and 4 in Attachment 2). It is dominated by California buckwheat (*Eriogonum fasciculatum*), with other native species such as scalebroom (*Lepidospartum squamatum*), prickly pear (*Opuntia littoralis*), and California juniper (*Juniperus californica*) also present. Although not mapped, several patches of California juniper woodland (*Juniperus californica* Woodland Alliance) are also present just beyond the project site and are dominated by California juniper.

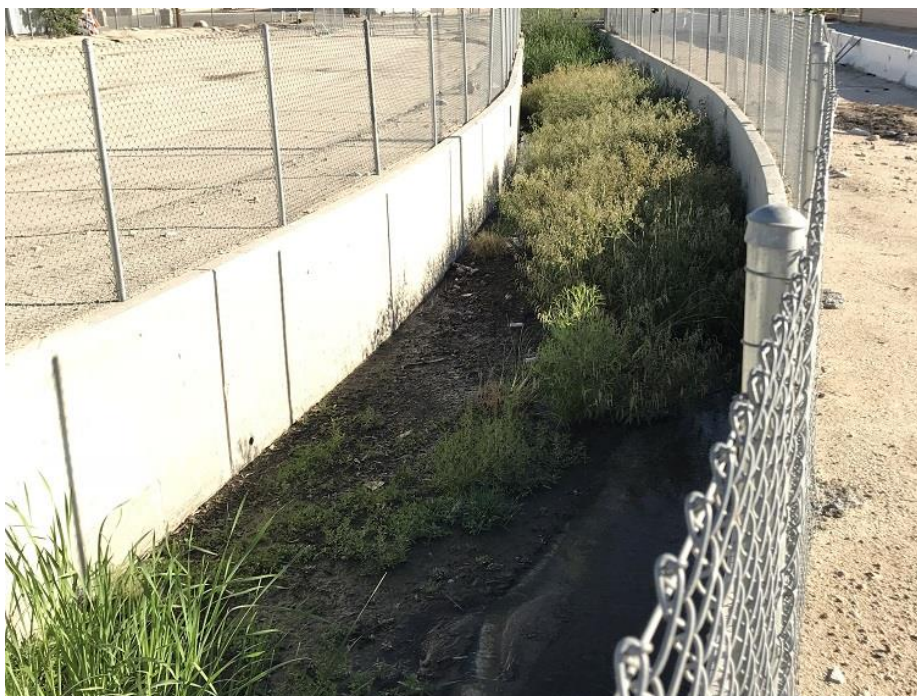
Photo 4: South-facing view of wetland vegetation in the upper portion of Elder Channel.
