# **WELL REPORT**

# PRADO EAST WELL PROJECT

SAN BERNARDINO COUNTY CHINO, CALIFORNIA

## Well Service Report

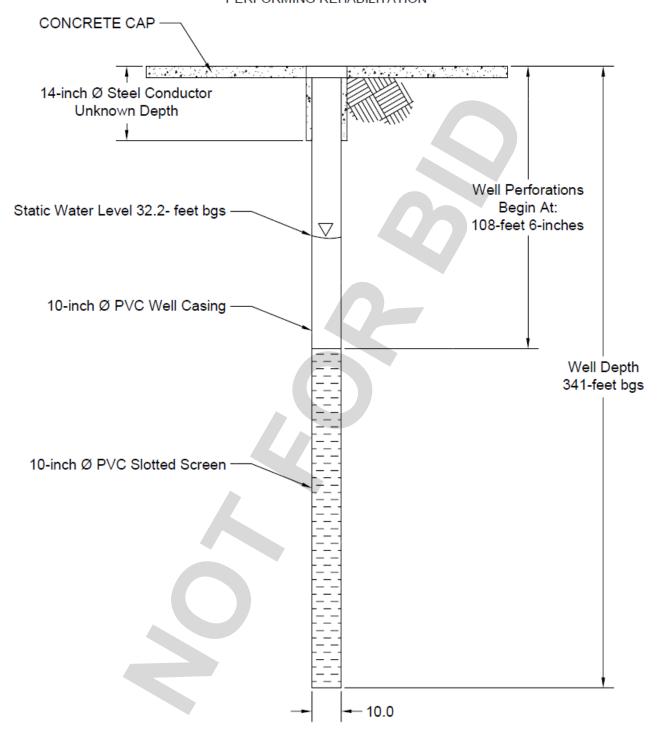
#### VIDEO LOG REPORT

After completing the brush and bail of Well #3, a video log was done to show if the brush and bail was successful in removing build-up and debris from the well. The video showed the well has a 14-inch steel conductor casing and a 10-inch PVC liner to a depth of 335 feet. Mill slotted perforations were found to begin at a depth of 111 feet and extended to a depth of 335 feet below the ground surface. The static water level was at a depth of 31 feet.

Date: March 18, 2024				
Depth: 335				
Water Level: 31' Oil?				
Operator: Ryan Truck: 1				
Tool Zero: Yes				
Reason for Video: Review

Depth	Video Findings	Casing / Perforation Information			
03'	14" Steel Casing	Casing Size:	Depth		
3'	Start of 10" PVC Casing	10" PVC	Start 3' to 335'		
111'	Mill Slot Perf Start				
335'	Bottom of Well				
		100 100			
		Perforation:	Milled Slot		
			b v makturokvansk		
			13
