PROPERTY ASSESSMENT REPORT

SAN BERNARDINO COUNTY

303 W. 5TH STREET DESIGN-BUILD PROJECT

IMEG #23005335.00

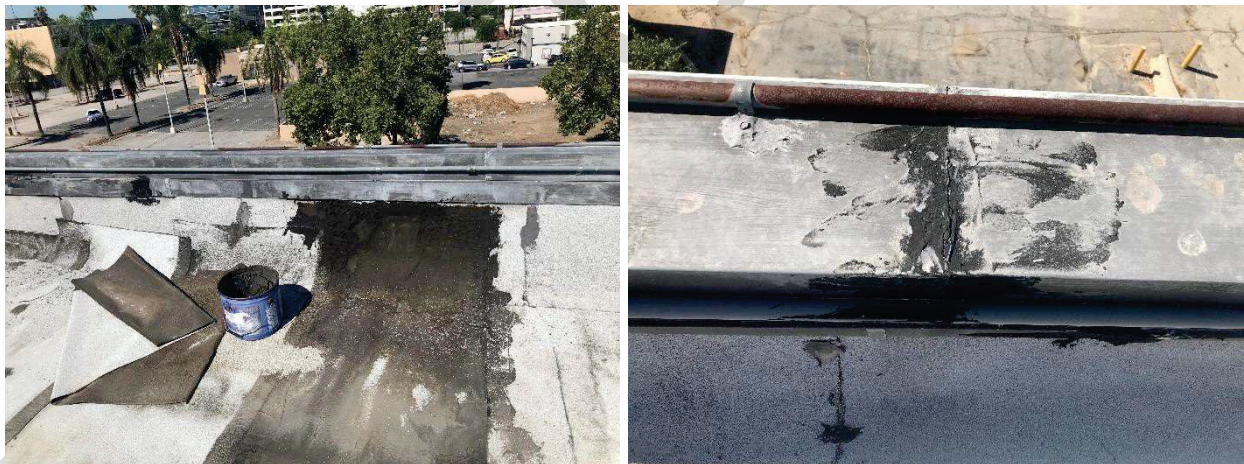
Some roof drain leakage was noted in the interior of the offices. Roof drain piping should be fully inspected. The existing piping appears to be cast iron, which may be replaced with PVC piping where rusted or damaged piping is recommended to be replaced anyway.

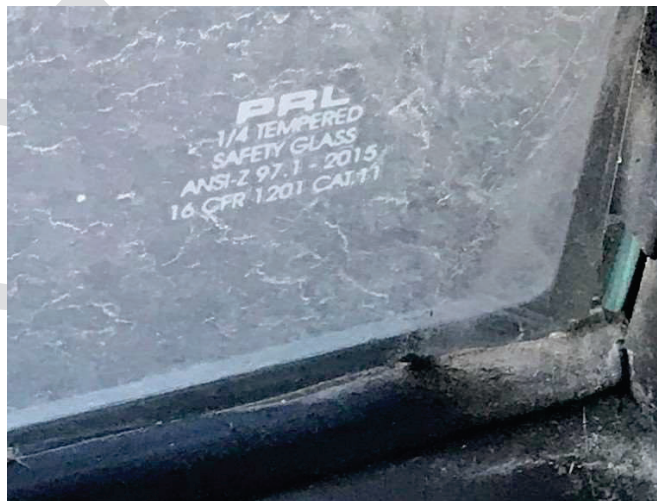
The primary joints at 303 W. 5th Street are adjacent to the glazing. All of the glazing joints, frames, seals, and glass were inspected on both exterior and interior. The glazing is 1/4 inch thick tempered safety glazing with a manually applied film tint. The stamped glazing specification indicates it meets both ANSI-Z 97.1 – 2015 Class A and CPSC 16 CFR 1201 Category II Standards. This standard requires the glazing can resist the impact of 400 lbs-force, a 100 lb bag dropped from 48 inch height, and indicates the installation of the glazing meets the sill height and glass area requirements in this use.
