**GEOTECHNICAL EVALUATION**

**SEWER IMPROVEMENT PROJECT**

**COUNTY SERVICE AREA (CSA) 82,  
TRONA, CALIFORNIA**

**PROJECT NO.: 30.30.0158**

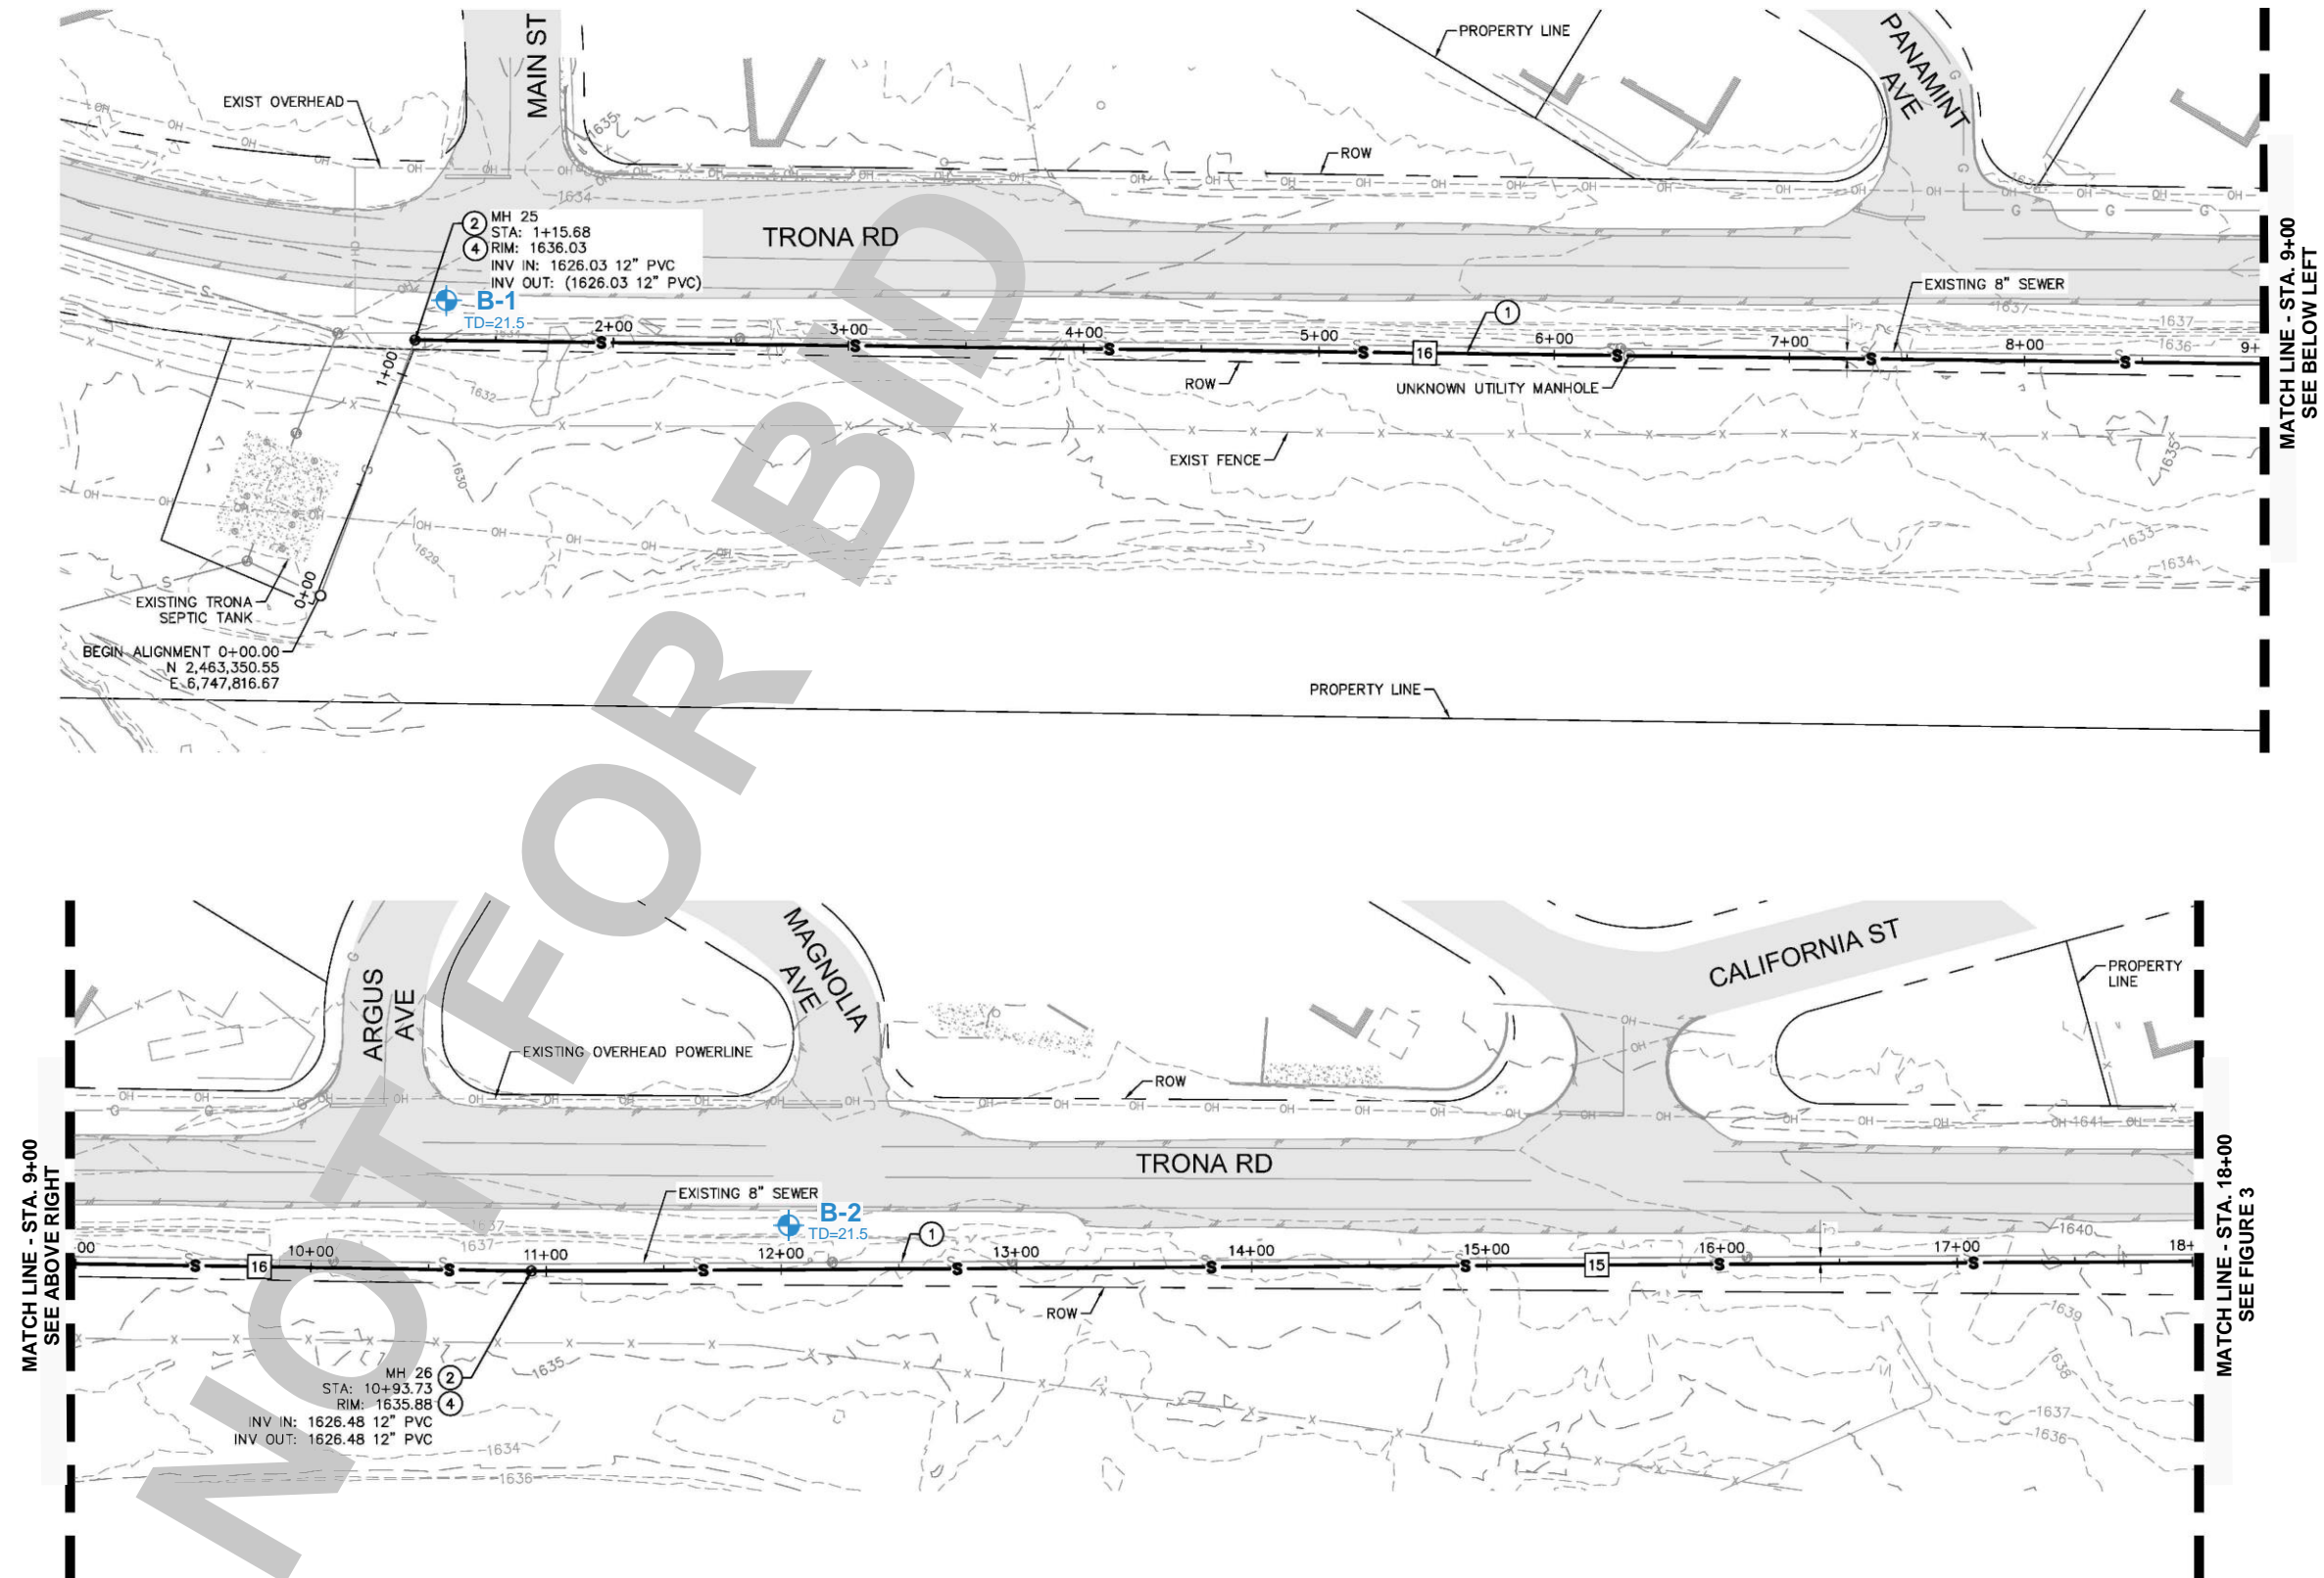
NOTE: DIMENSIONS, DIRECTIONS AND LOCATIONS ARE APPROXIMATE. I REFERENCE: KIMLEY HORN, 2023.

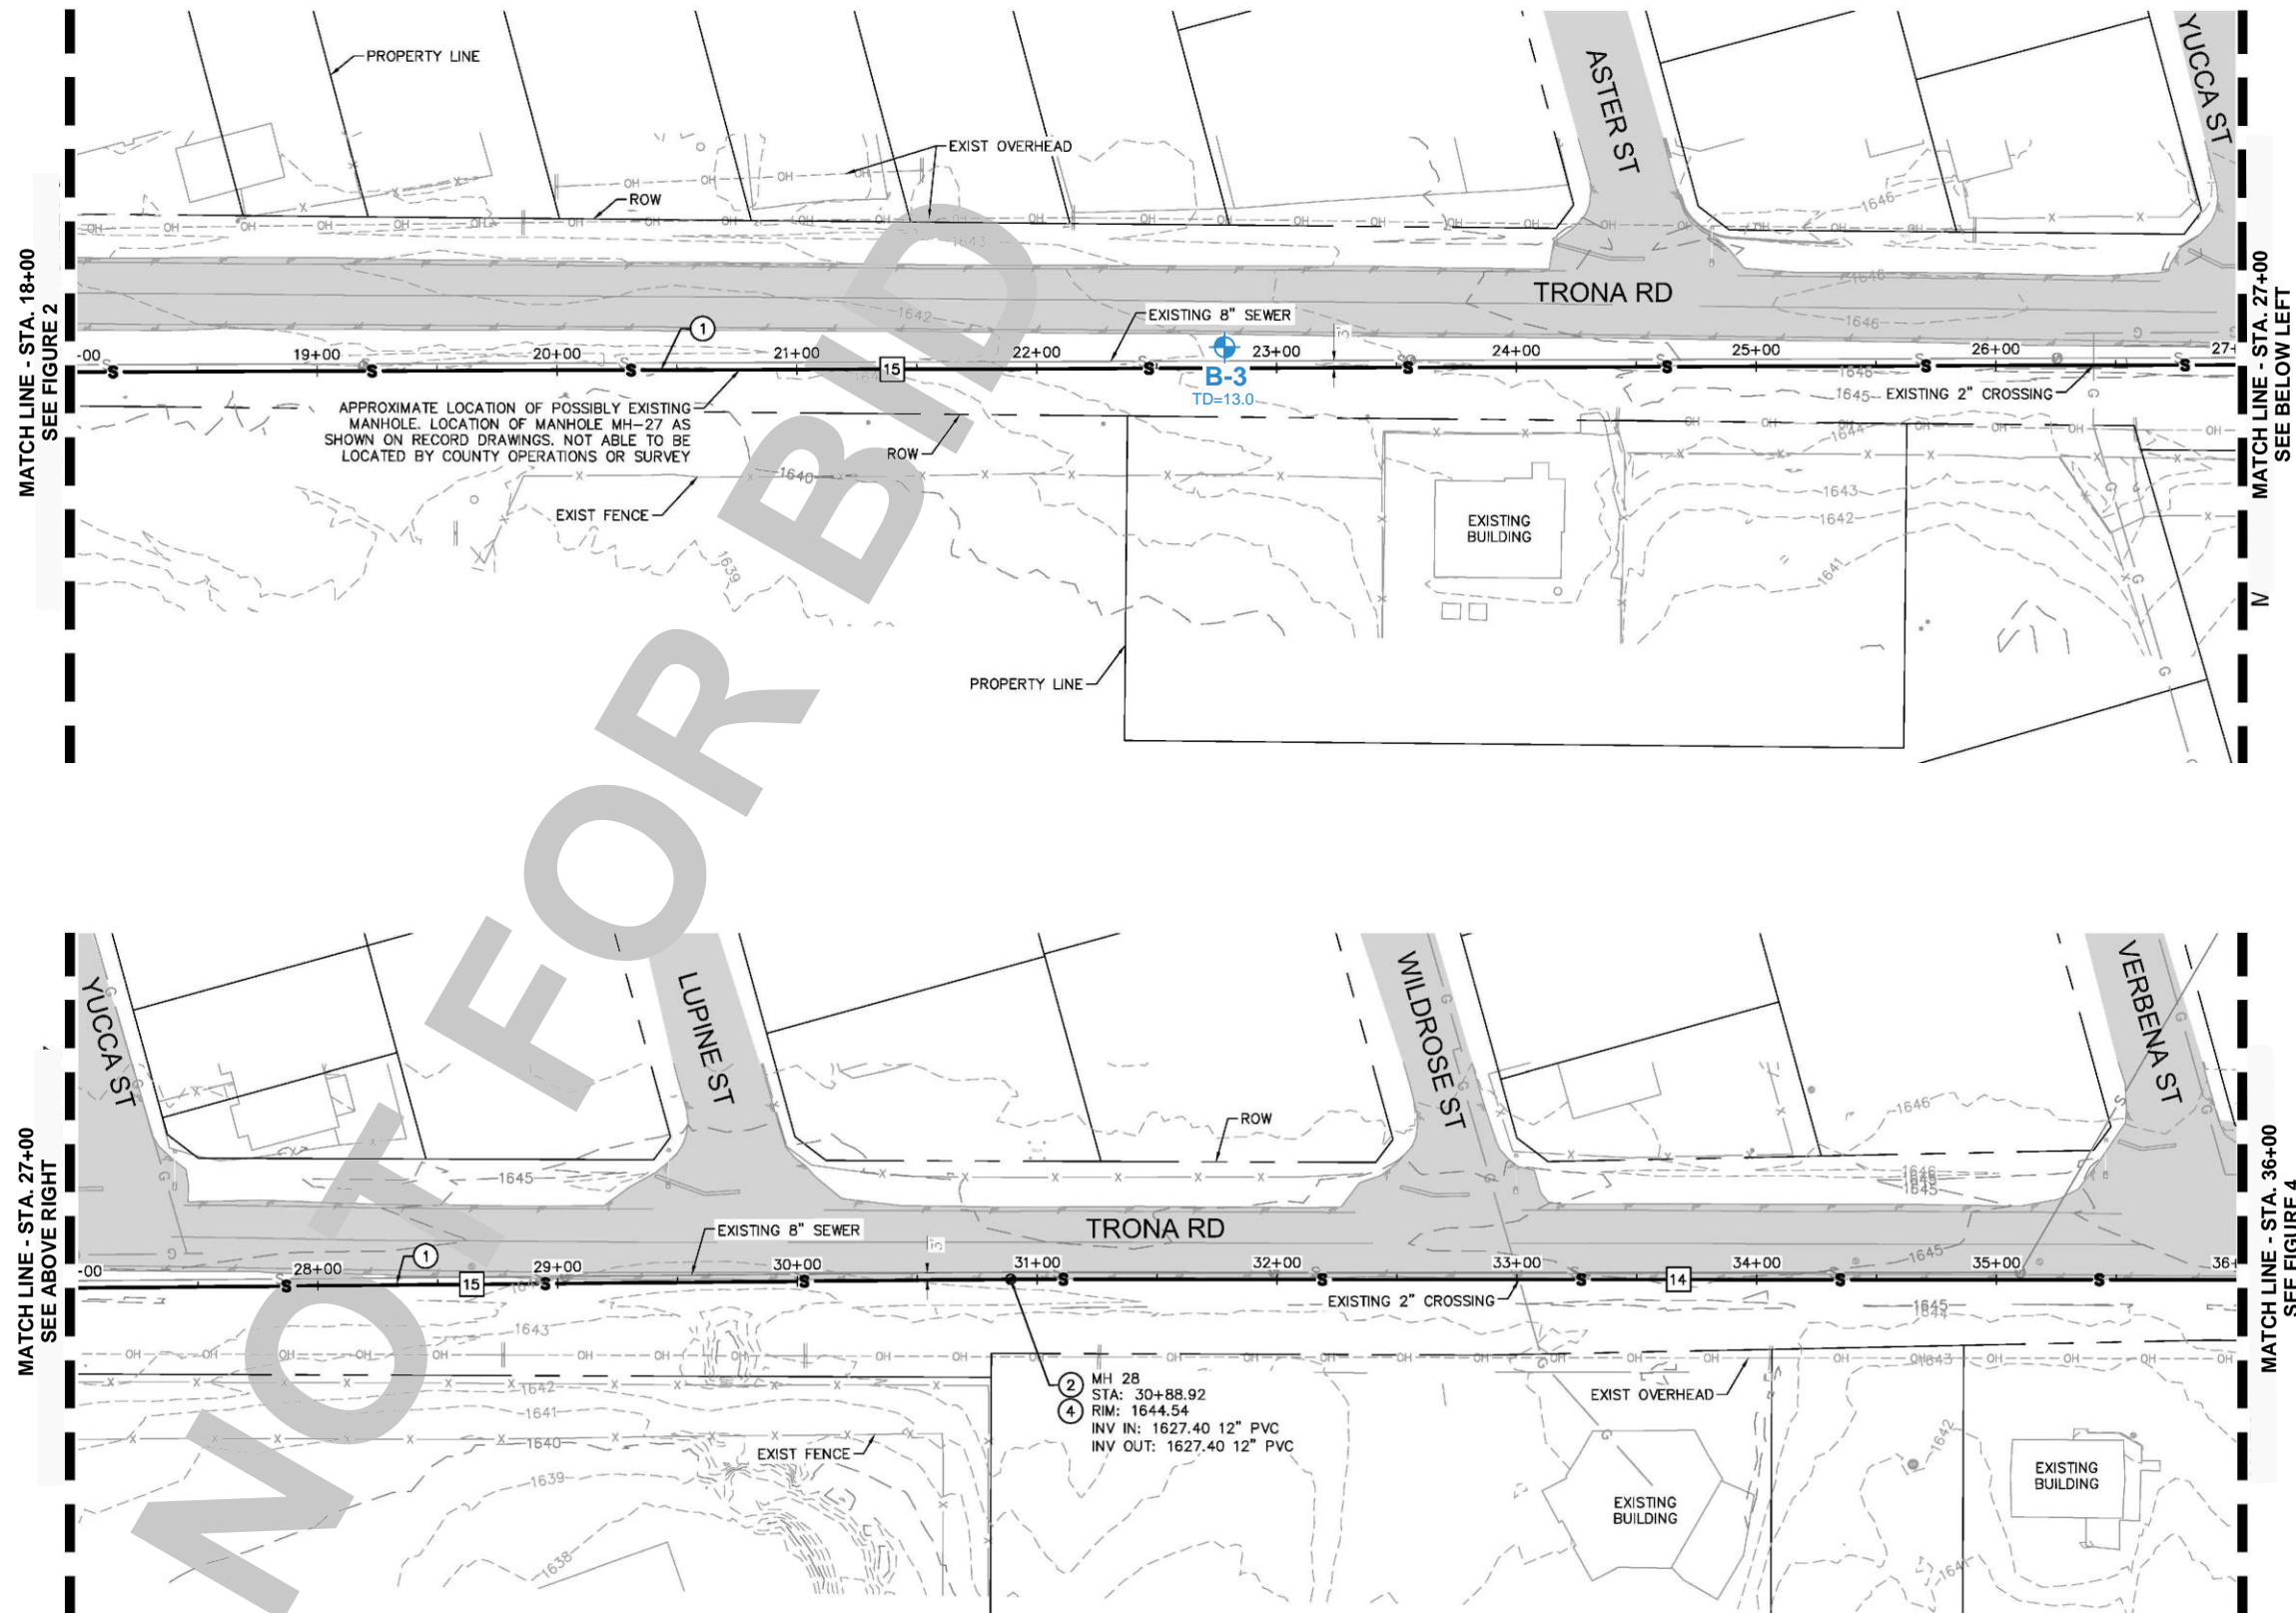
**FIGURE 3**

NOTE: DIMENSIONS, DIRECTIONS AND LOCATIONS ARE APPROXIMATE. I REFERENCE: KIMLEY HORN, 2023.

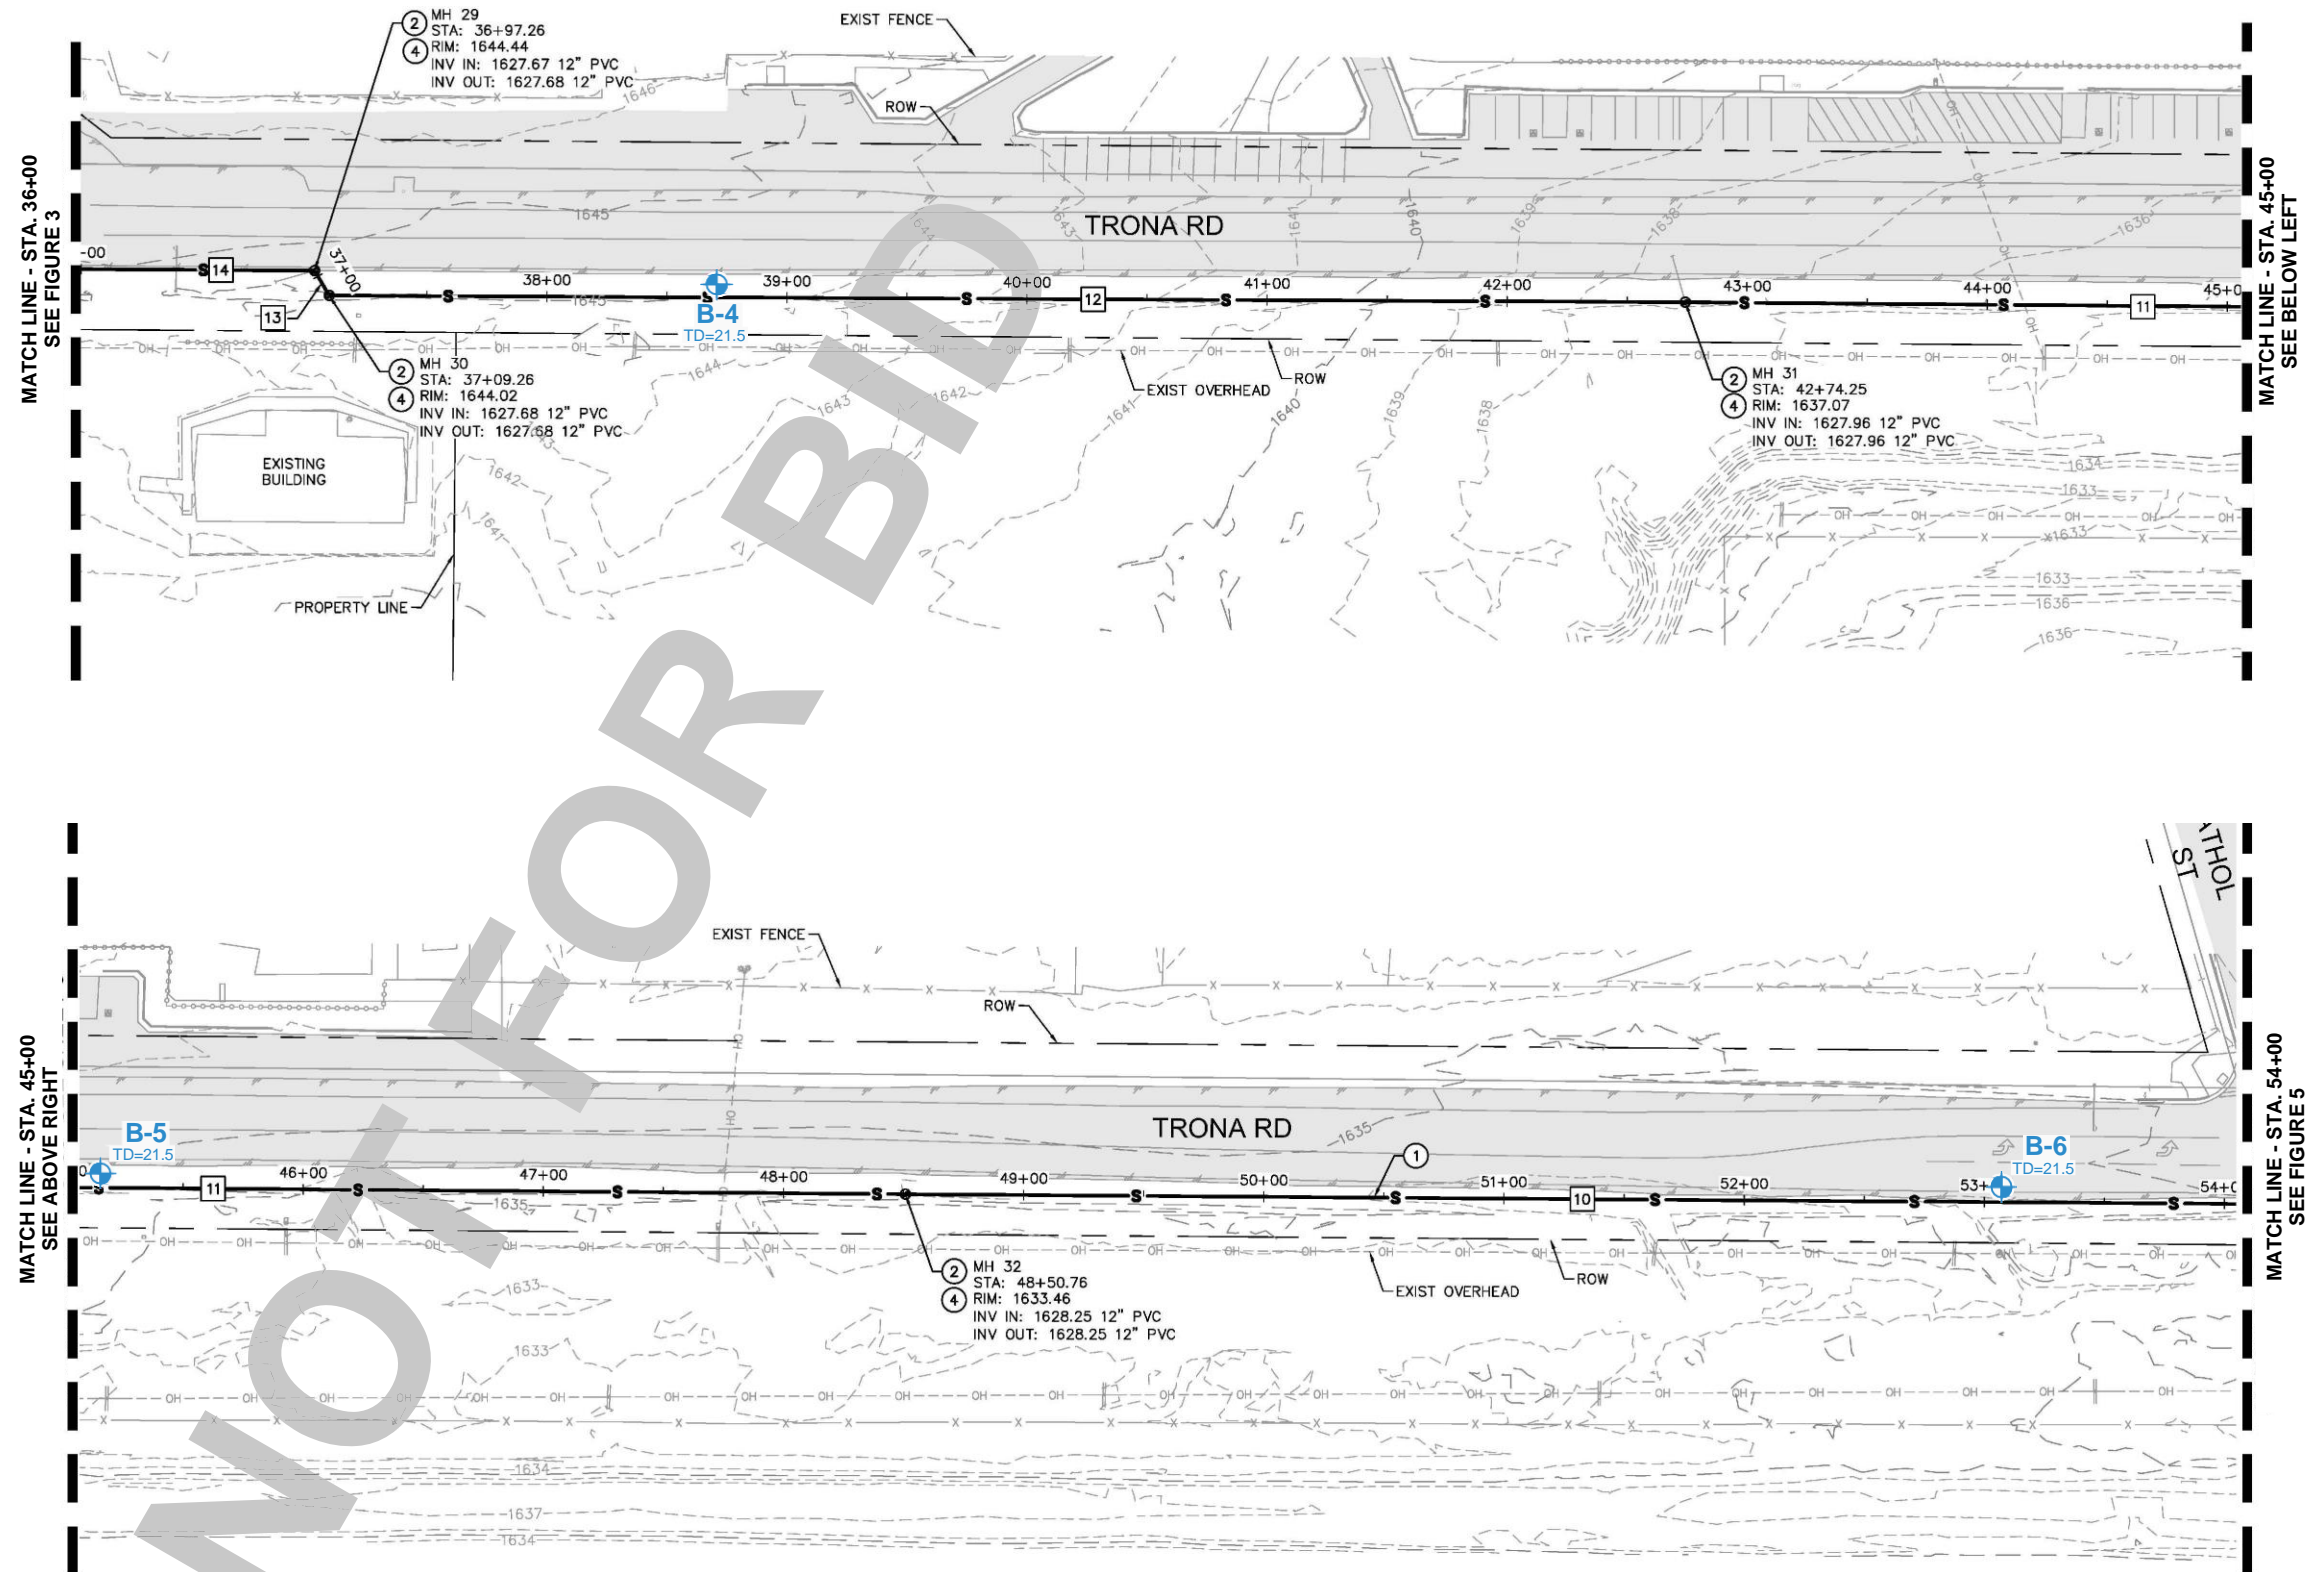
B-6 BORING:  
TD=21.5 TD=TOTAL DEPTH IN FEET

NOTE: DIMENSIONS, DIRECTIONS AND LOCATIONS ARE APPROXIMATE. I REFERENCE: KIMLEY HORN, 2023.

Groundwater was measured in boring B-5 approximately 15 minutes after drilling at a depth of approximately 11.6 feet below the ground surface. Groundwater was measured in boring B-6 approximately 30 minutes after drilling at a depth of approximately 15 feet below the ground surface. The groundwater depth measured during drilling is not considered a stabilized water level. Groundwater was not encountered in the remaining borings to the total depth explored of up to approximately 21.5 feet. However, many samples that were collected from the borings were observed to be wet, but measurable groundwater was not observed in the borehole at the completion of drilling (except for borings B-5 and B-6). The high moisture contents are probably related to the heavy rainfall that occurred from tropical storm Hilary in August, 2023.

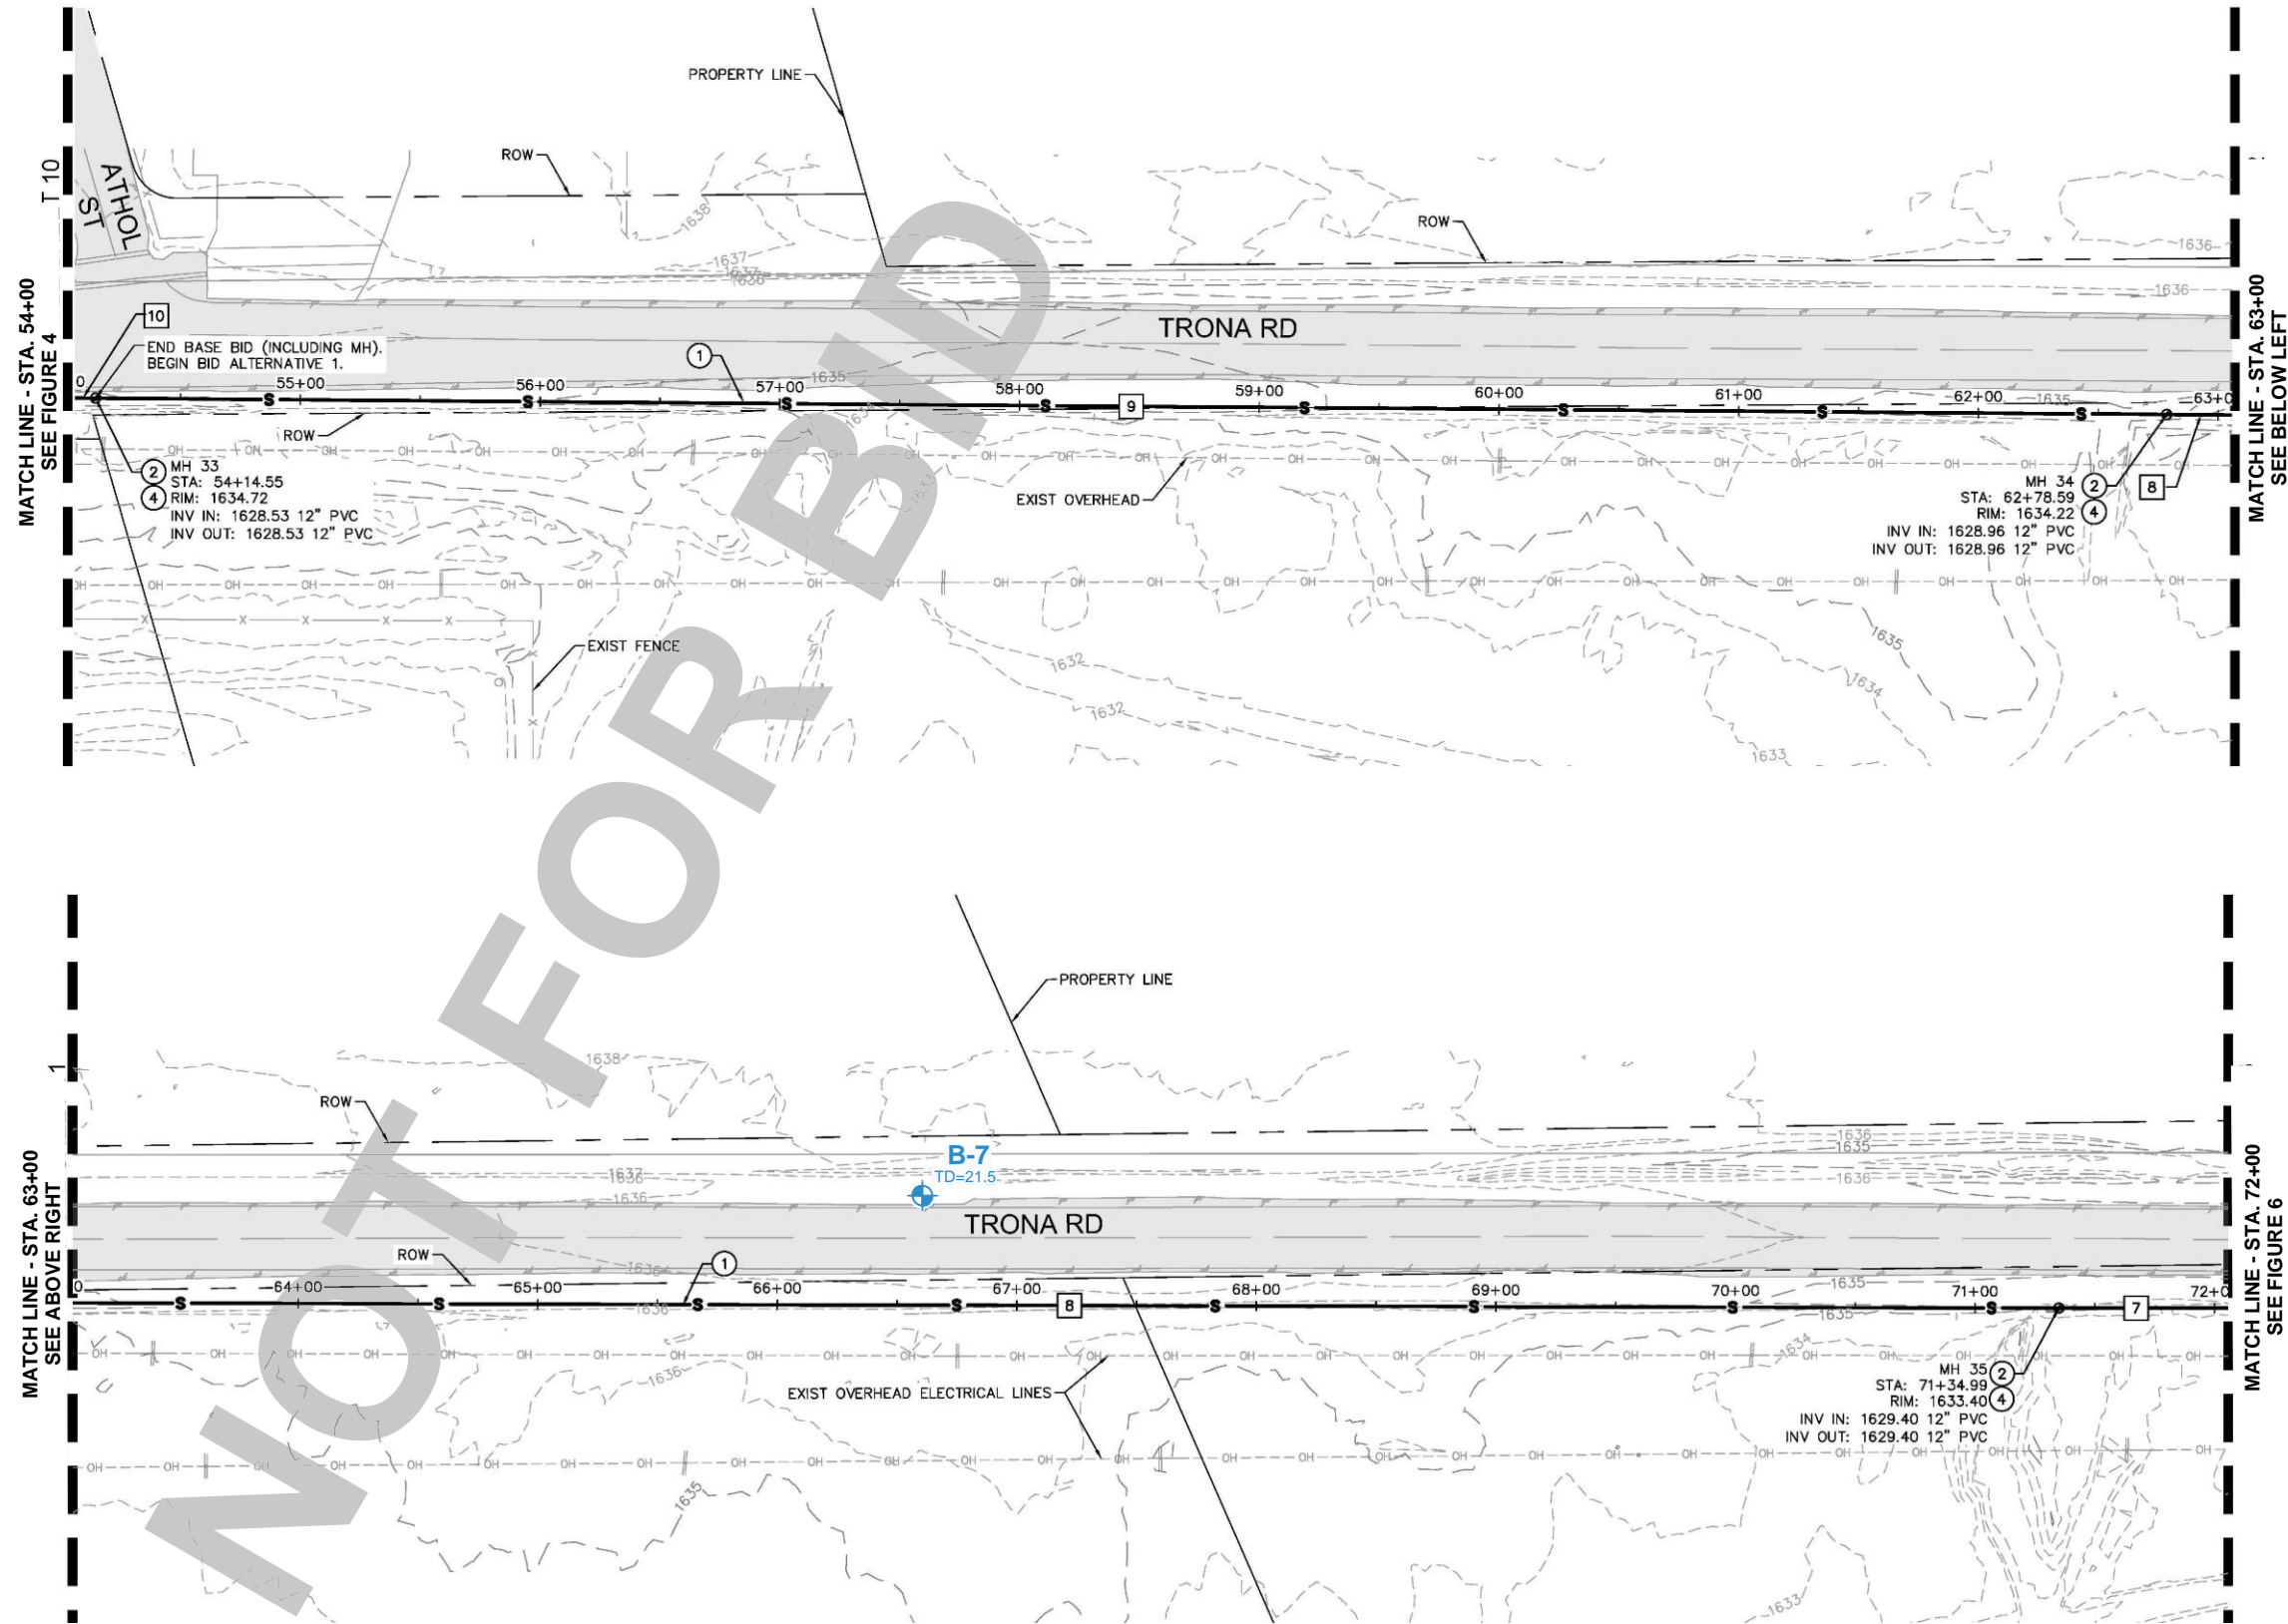
**B-7** BORING;  
 TD=21.5 TD=TOTAL DEPTH IN FEET

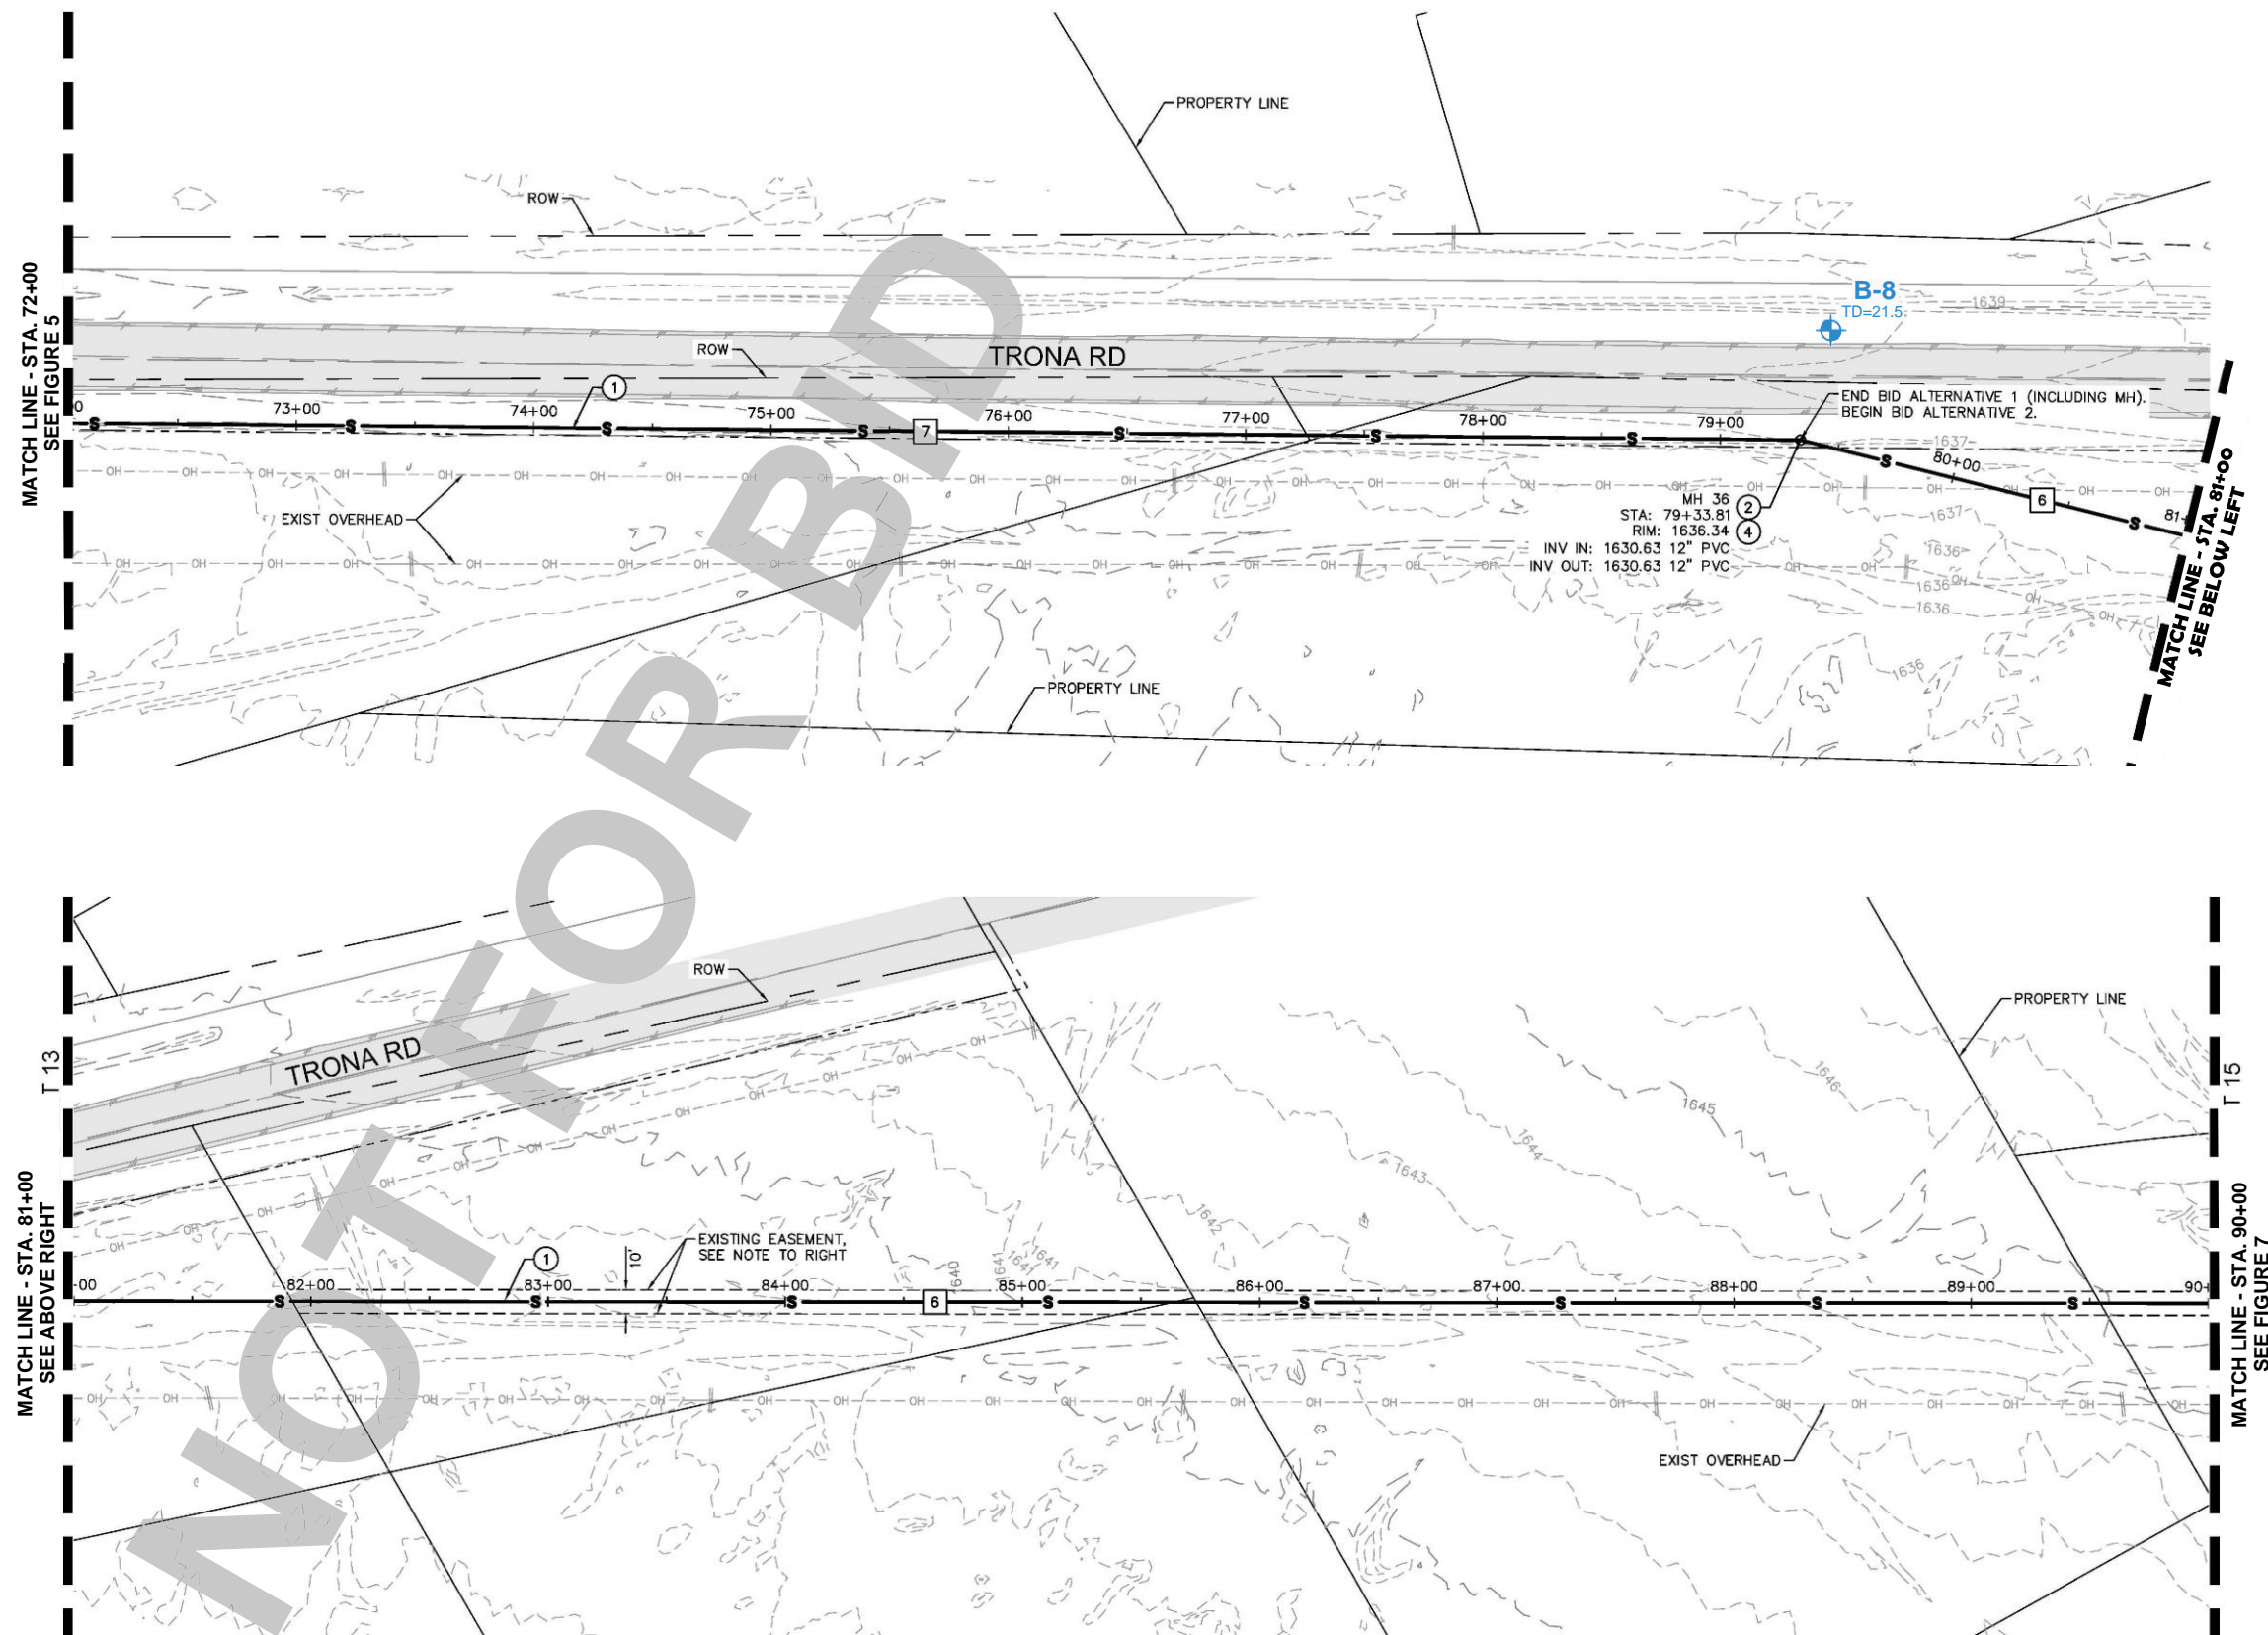
NOTE: DIMENSIONS, DIRECTIONS AND LOCATIONS ARE APPROXIMATE. I REFERENCE: KIMLEY HORN, 2023.

BORING:  
TD=TOTAL DEPTH IN FEET

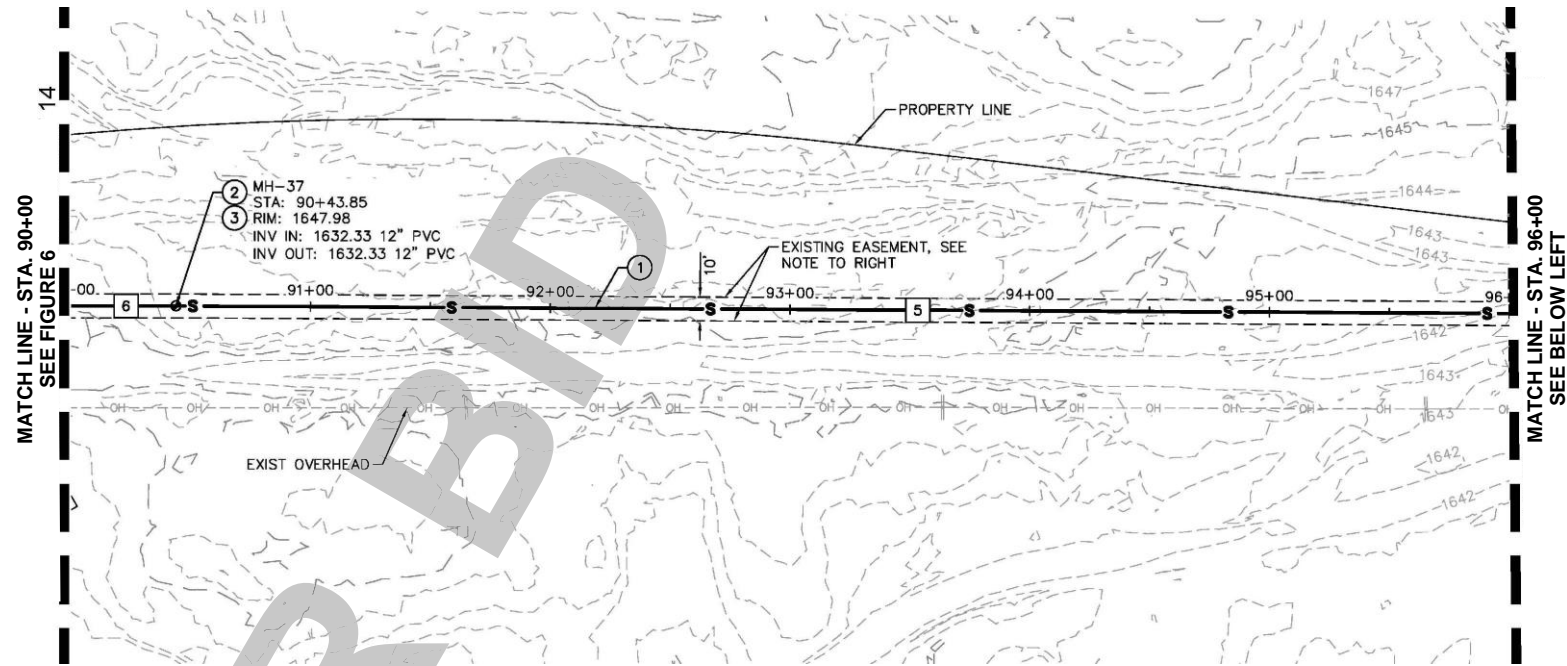
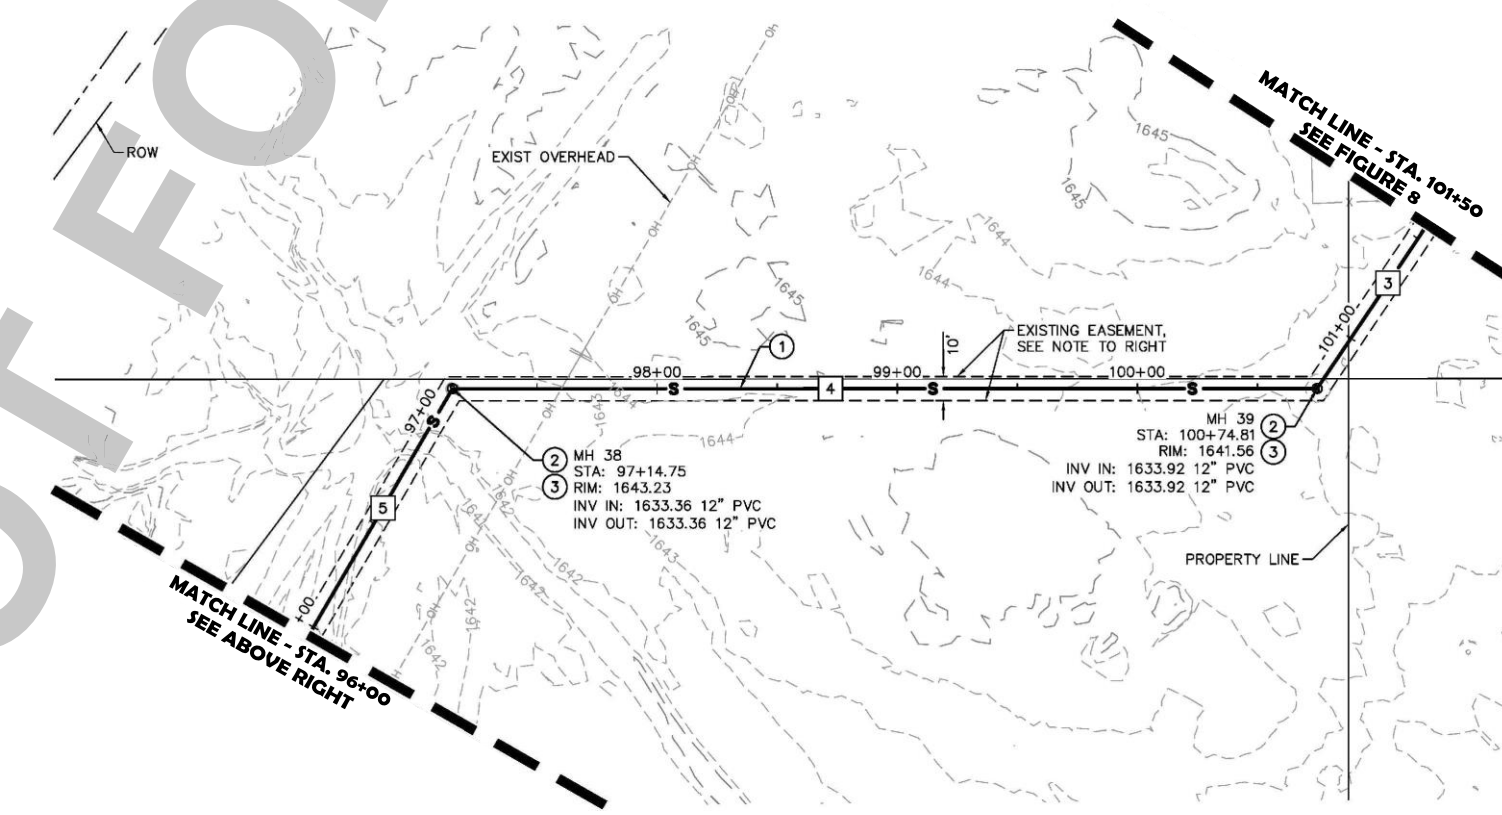
FIGURE 7

NOTE: DIMENSIONS, DIRECTIONS AND LOCATIONS ARE APPROXIMATE. I REFERENCE: KIMLEY HORN, 2023.
