**GEOTECHNICAL EVALUATION**

**SEWER IMPROVEMENT PROJECT**

**COUNTY SERVICE AREA (CSA) 82,  
TRONA, CALIFORNIA**

**PROJECT NO.: 30.30.0158**

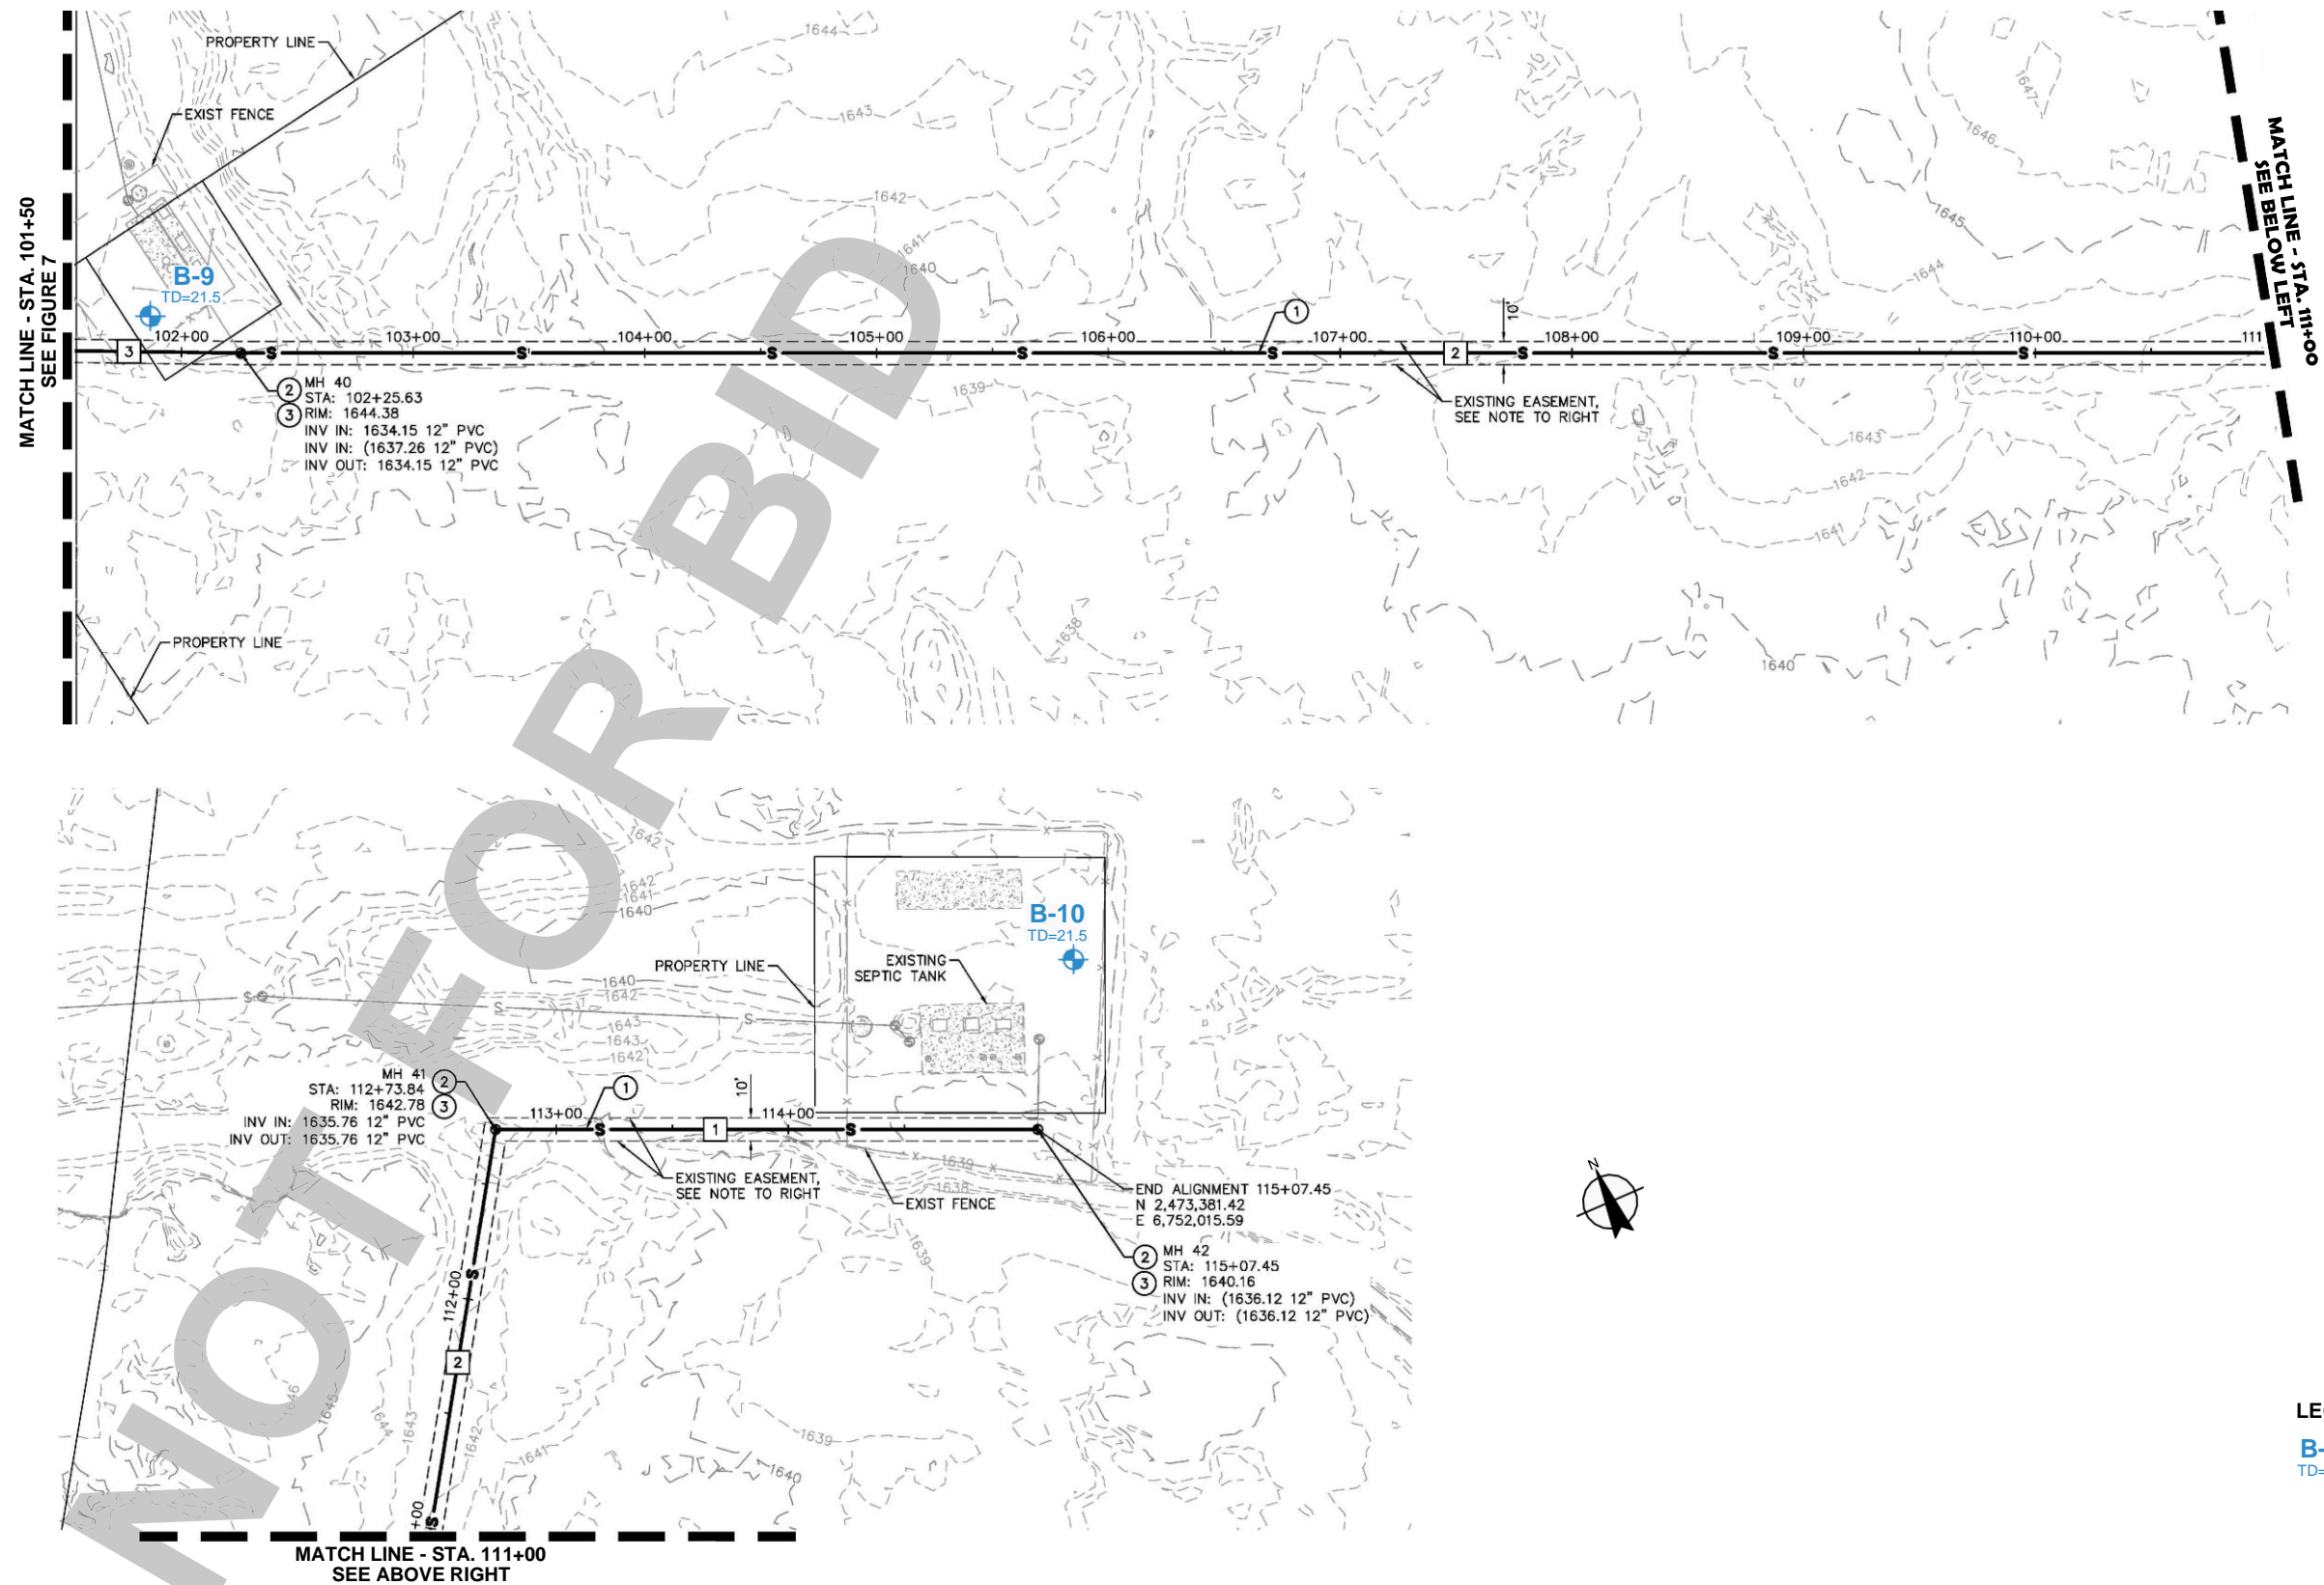
FIGURE 8

## SEWER PIPELINE ALIGNMENT WITH BORING LOCATIONS

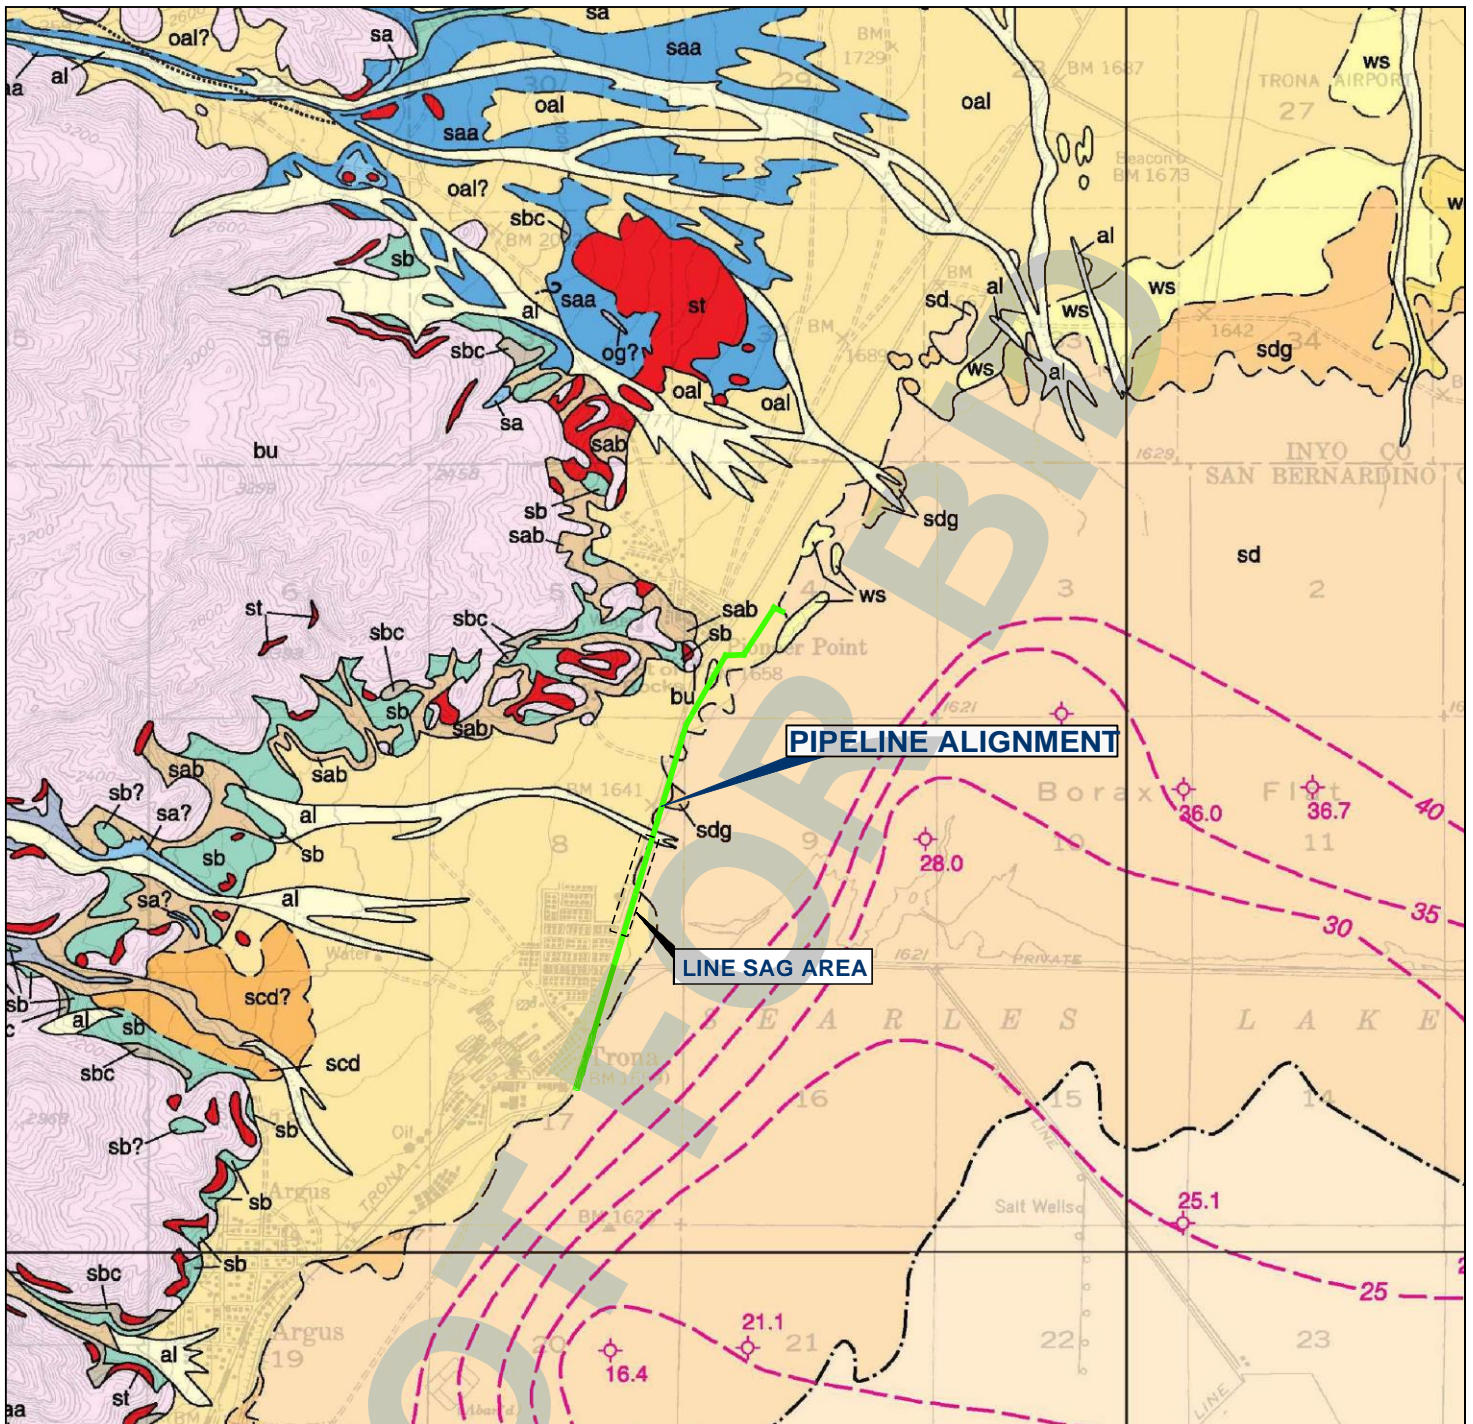
FIGURE 9

oal	OLDER ALLUVIUM	sdg	GRAVEL AND SAND LACUSTRINE DEPOSITS
al	ALLUVIUM	ws	WINDBLOWN SAND AND COLLUVIUM
sd	SAND AND SILT LACUSTRINE DEPOSITS	—	GEOLOGIC CONTACT
		- - -	ISOPACH CONTOUR SHOWING THICKNESS OF UNIT sd

Holocene age medium to coarse sand. The lacustrine deposits generally consist of gravel, sand, and silt deposits. As indicated on the regional geologic map for the site vicinity (Figure 9), the pipeline alignment is generally located along the boundary between the older alluvium and the lacustrine deposits.

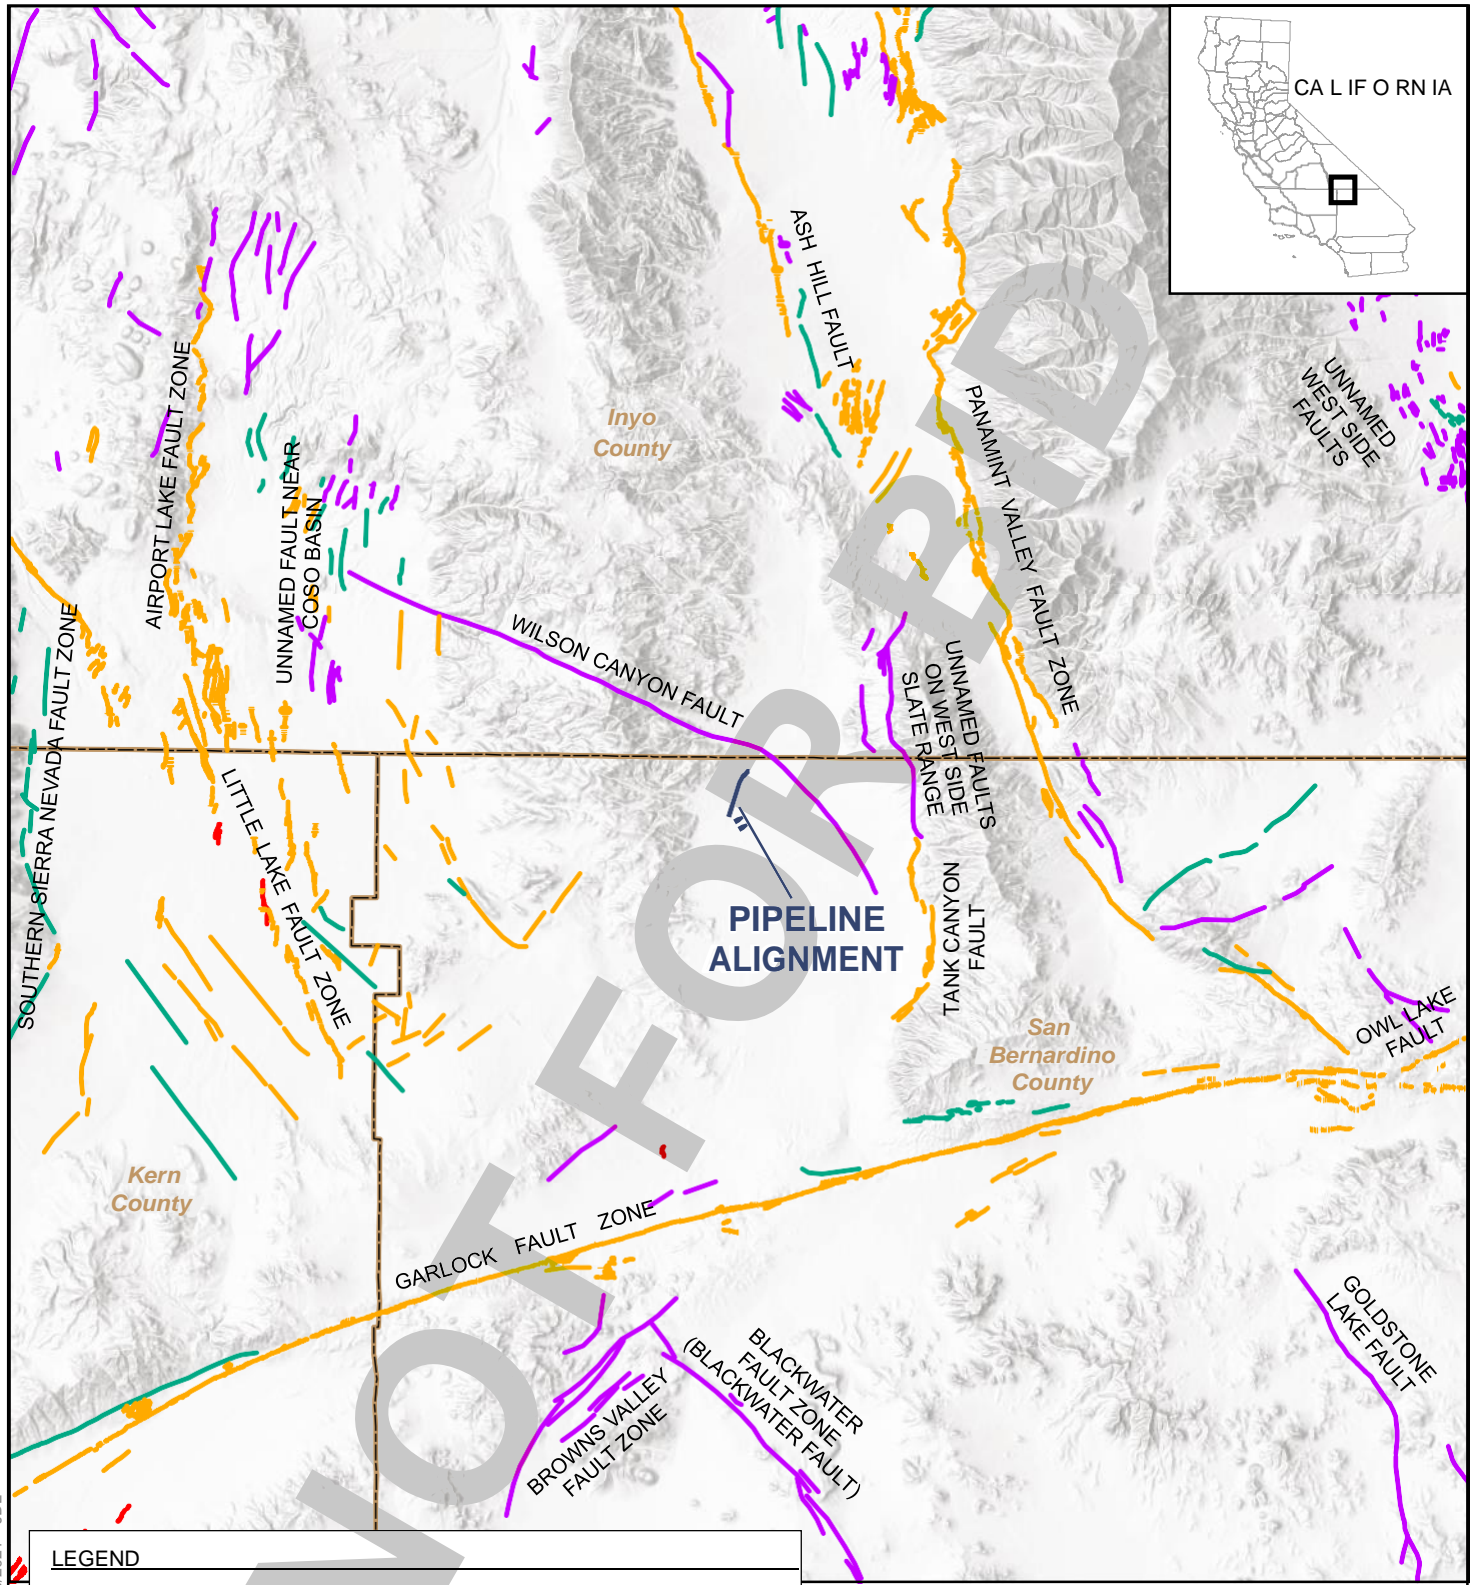
CALIFORNIA FAULT ACTIVITY	
<span style="color: red;">—</span> HISTORICALLY ACTIVE	<span style="color: purple;">—</span> QUATERNARY (POTENTIALLY ACTIVE)
<span style="color: orange;">—</span> HOLOCENE ACTIVE	<span style="color: grey;">—</span> STATE/COUNTY BOUNDARY
<span style="color: teal;">—</span> LATE QUATERNARY (POTENTIALLY ACTIVE)

The project site is located in a seismically active area, as is the majority of southern California. The numerous faults in southern California include active, potentially active, and inactive faults. As defined by the California Geological Survey (CGS), active faults are faults that have ruptured within Holocene time, or within approximately the last 11,000 years. Potentially active faults are those that show evidence of movement during Quaternary time (approximately the last 1.6 million years) but for which evidence of Holocene movement has not been established. Inactive faults have not ruptured in the last approximately 1.6 million years. The approximate locations of major active faults in the region and their geographic relationship to the project site are shown on Figure 10. The nearest mapped active fault to the site is the Tank Canyon fault located approximately 6.6 miles east of the site (United States Geological Survey [USGS], 2024). The potentially active Wilson Canyon fault is located approximately 1.0 mile northeast of the site. The Garlock Fault Zone is located about 16 miles south of the site.

Based on our review of seismic hazard maps, geologic literature, and geologic maps, the site is not located within a State of California Earthquake Fault Zone (formerly known as Alquist-Priolo Special Studies Zone) (CGS 2018), and no active faults are known to cross the subject site. The principal seismic hazards evaluated at the subject site are surface fault rupture, ground motion, and liquefaction. A brief description of these hazards and the potential for their occurrences on site are discussed in the following sections.

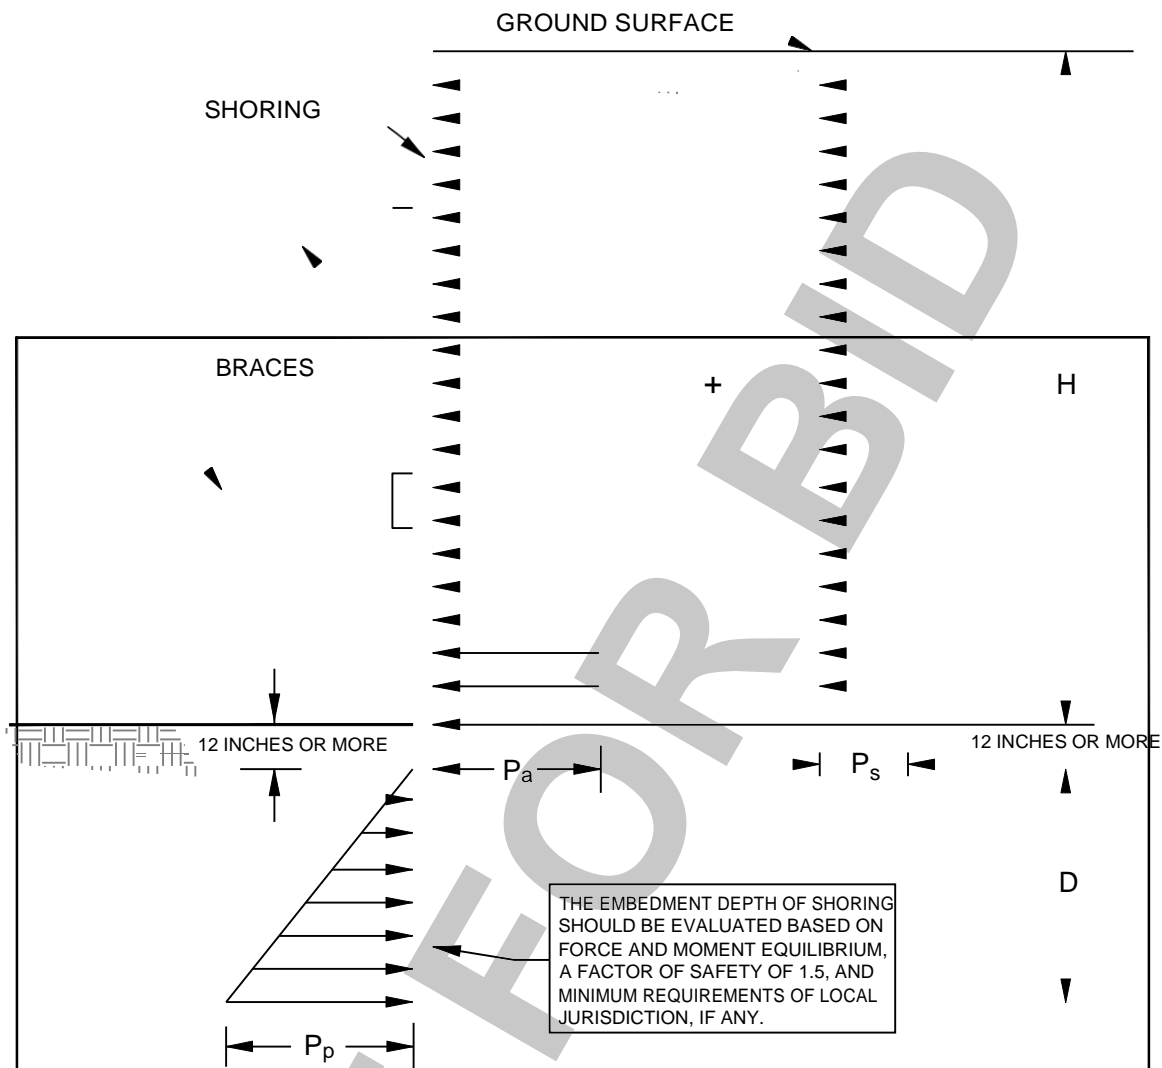
1. APPARENT LATERAL EARTH PRESSURE,  $P_a$   
 $P_a = 25H$  psf
2. CONSTRUCTION TRAFFIC INDUCED SURCHARGE PRESSURE,  $P_s$   
 $P_s = 120$  psf
3. PASSIVE LATERAL EARTH PRESSURE,  $P_p$   
 $P_p = 350D$  psf
4. ASSUMES GROUNDWATER IS NOT PRESENT
5. SURCHARGES FROM EXCAVATED SOIL OR CONSTRUCTION MATERIALS ARE NOT INCLUDED
6. H AND D ARE IN FEET

LATERAL EARTH PRESSURES FOR  
BRACED EXCAVATION

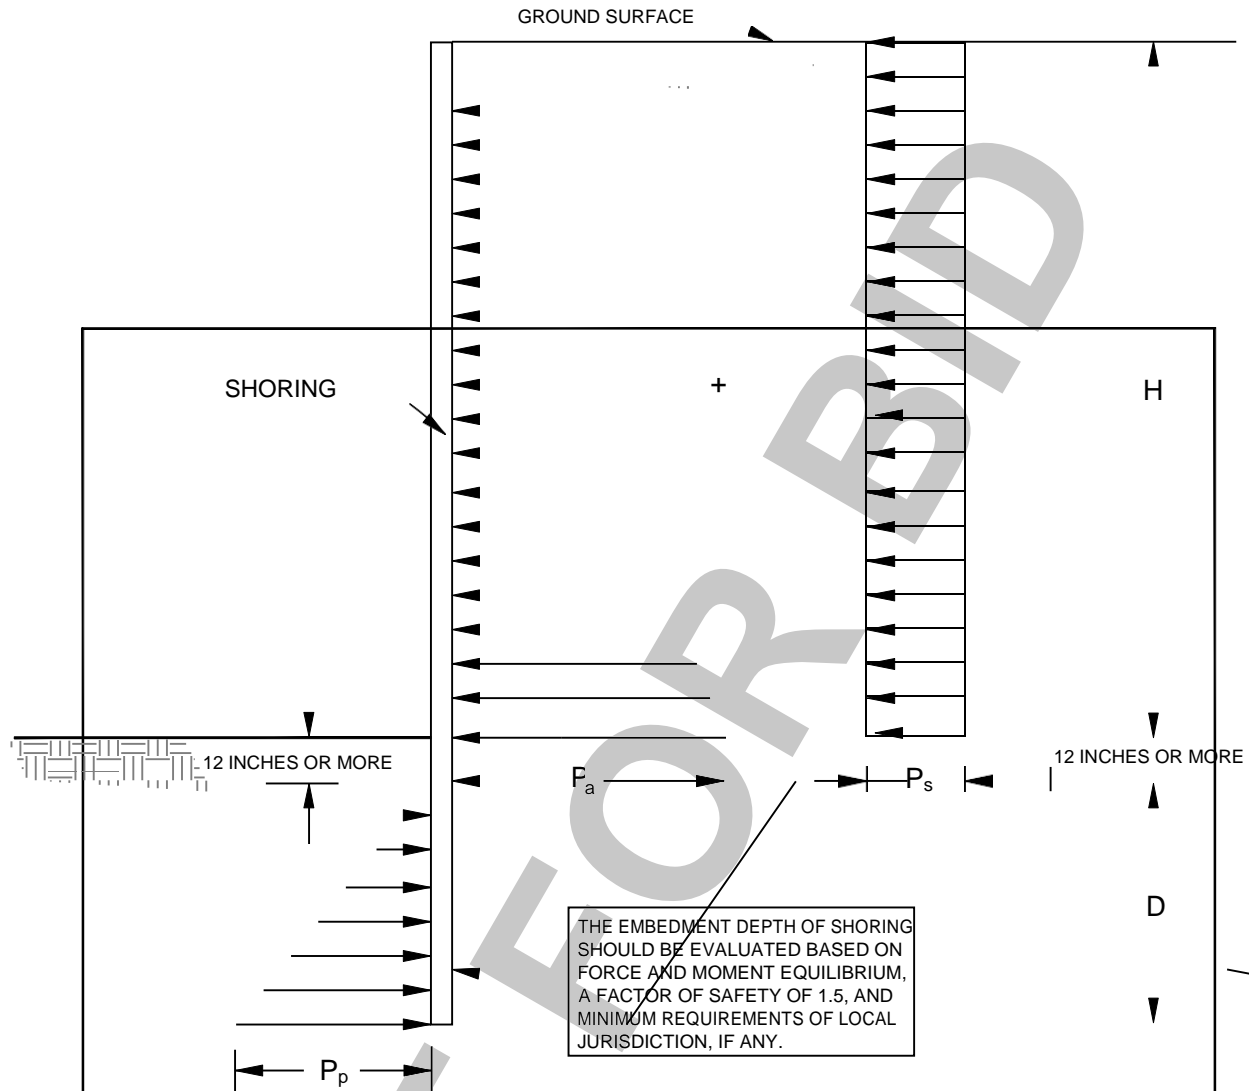
1. ACTIVE LATERAL EARTH PRESSURE,  $P_a$   
 $P_a = 38H$  psf
2. CONSTRUCTION TRAFFIC INDUCED SURCHARGE PRESSURE,  $P_s$   
 $P_s = 72$  psf
3. PASSIVE LATERAL EARTH PRESSURE,  $P_p$   
 $P_p = 350D$  psf
4. ASSUMES GROUNDWATER IS NOT PRESENT
5. H AND D ARE IN FEET

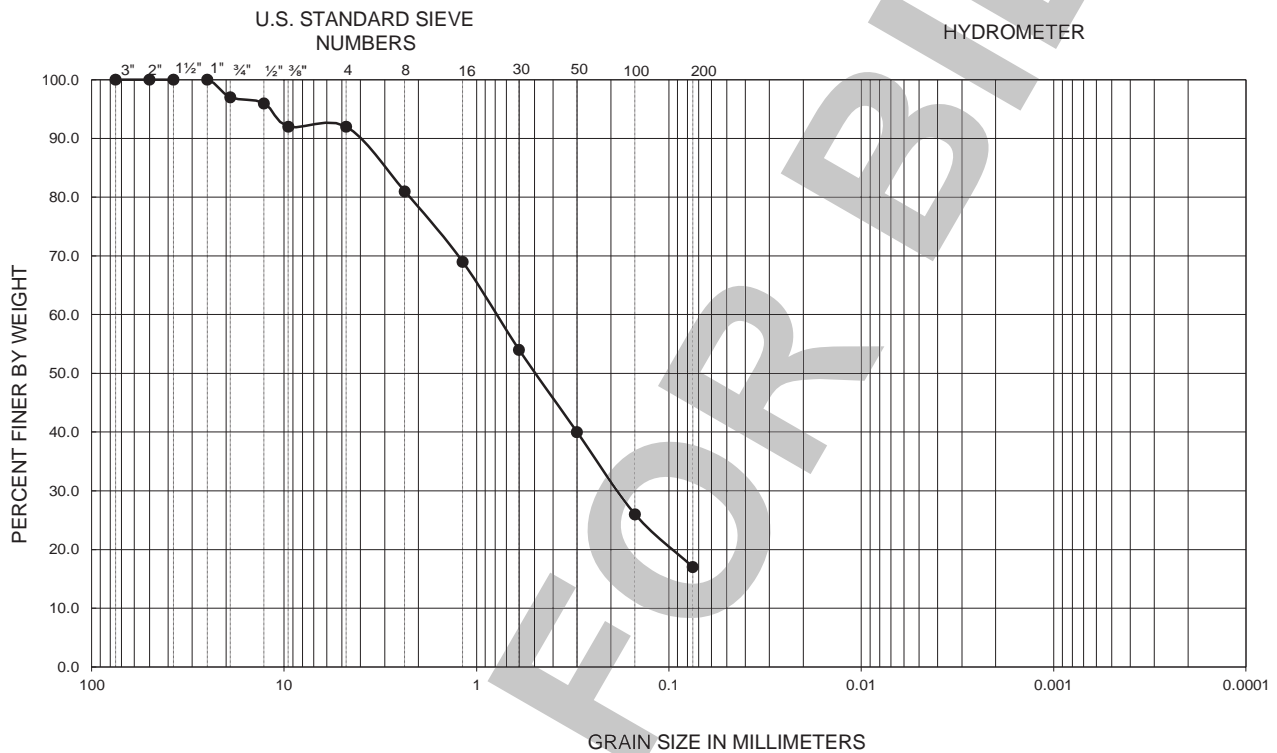
Symbol	Sample Location	Depth (ft)	Liquid Limit	Plastic Limit	Plasticity Index	D <sub>10</sub>	D <sub>30</sub>	D <sub>60</sub>	C <sub>u</sub>	C <sub>c</sub>	Passing No. 200 (percent)	USCS
●	B-1	0.0-5.0	--	--	--	--	--	--	--	--	17	SM

PERFORMED IN GENERAL ACCORDANCE WITH ASTM D 6913

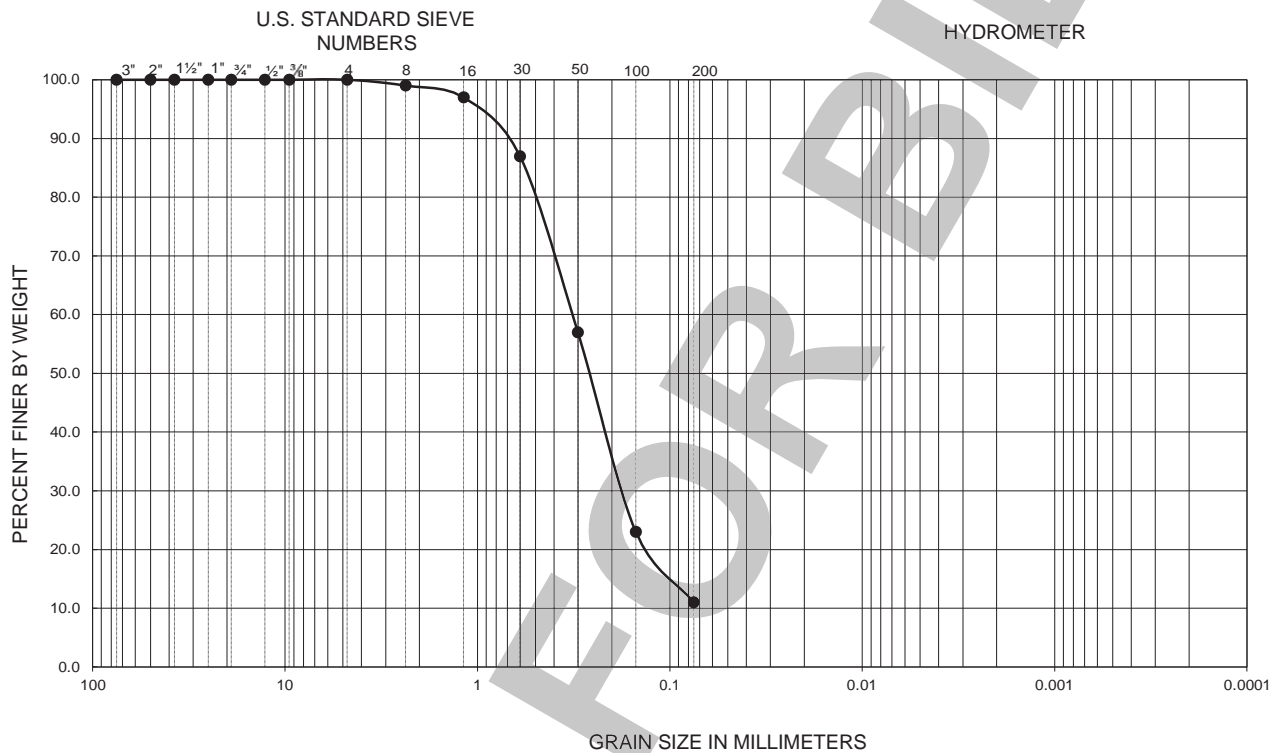
Symbol	Sample Location	Depth (ft)	Liquid Limit	Plastic Limit	Plasticity Index	D <sub>10</sub>	D <sub>30</sub>	D <sub>60</sub>	C <sub>u</sub>	C <sub>c</sub>	Passing No. 200 (percent)	USCS
●	B-9	0.0-5.0	--	--	--	--	0.18	0.32	--	--	11	SP-SM

PERFORMED IN GENERAL ACCORDANCE WITH ASTM D 6913

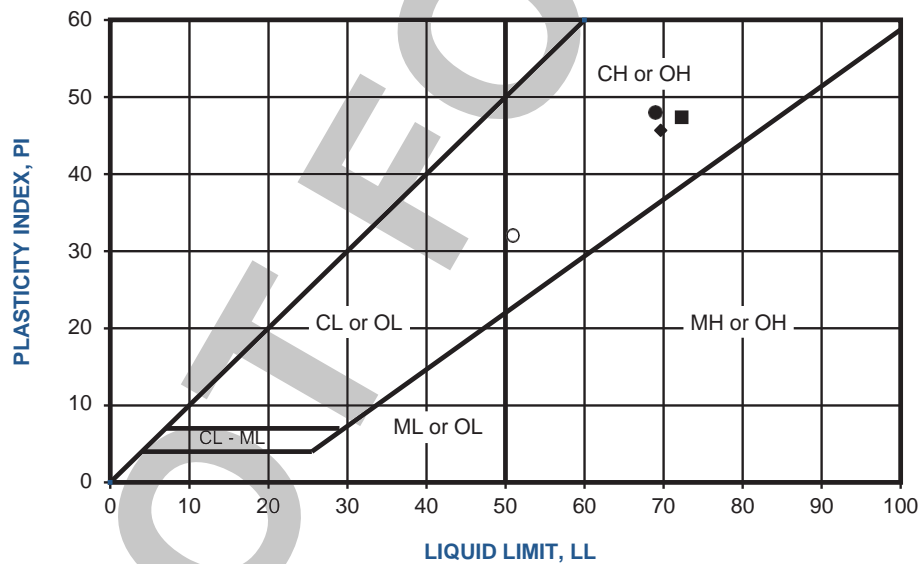
FIGURE B-4

SYMBOL	LOCATION	DEPTH (ft)	LIQUID LIMIT	PLASTIC LIMIT	PLASTICITY INDEX	USCS CLASSIFICATION (Fraction Finer Than No. 40 Sieve)	USCS
●	B-5	10.0-11.5	69	21	48	CH	CH
■	B-6	7.5-9.0	72	25	47	CH	CH
◆	B-7	10.0-11.5	70	24	46	CH	CH
○	B-8	10.0-11.5	51	19	32	CH	CH

PERFORMED IN GENERAL ACCORDANCE WITH ASTM D 4318

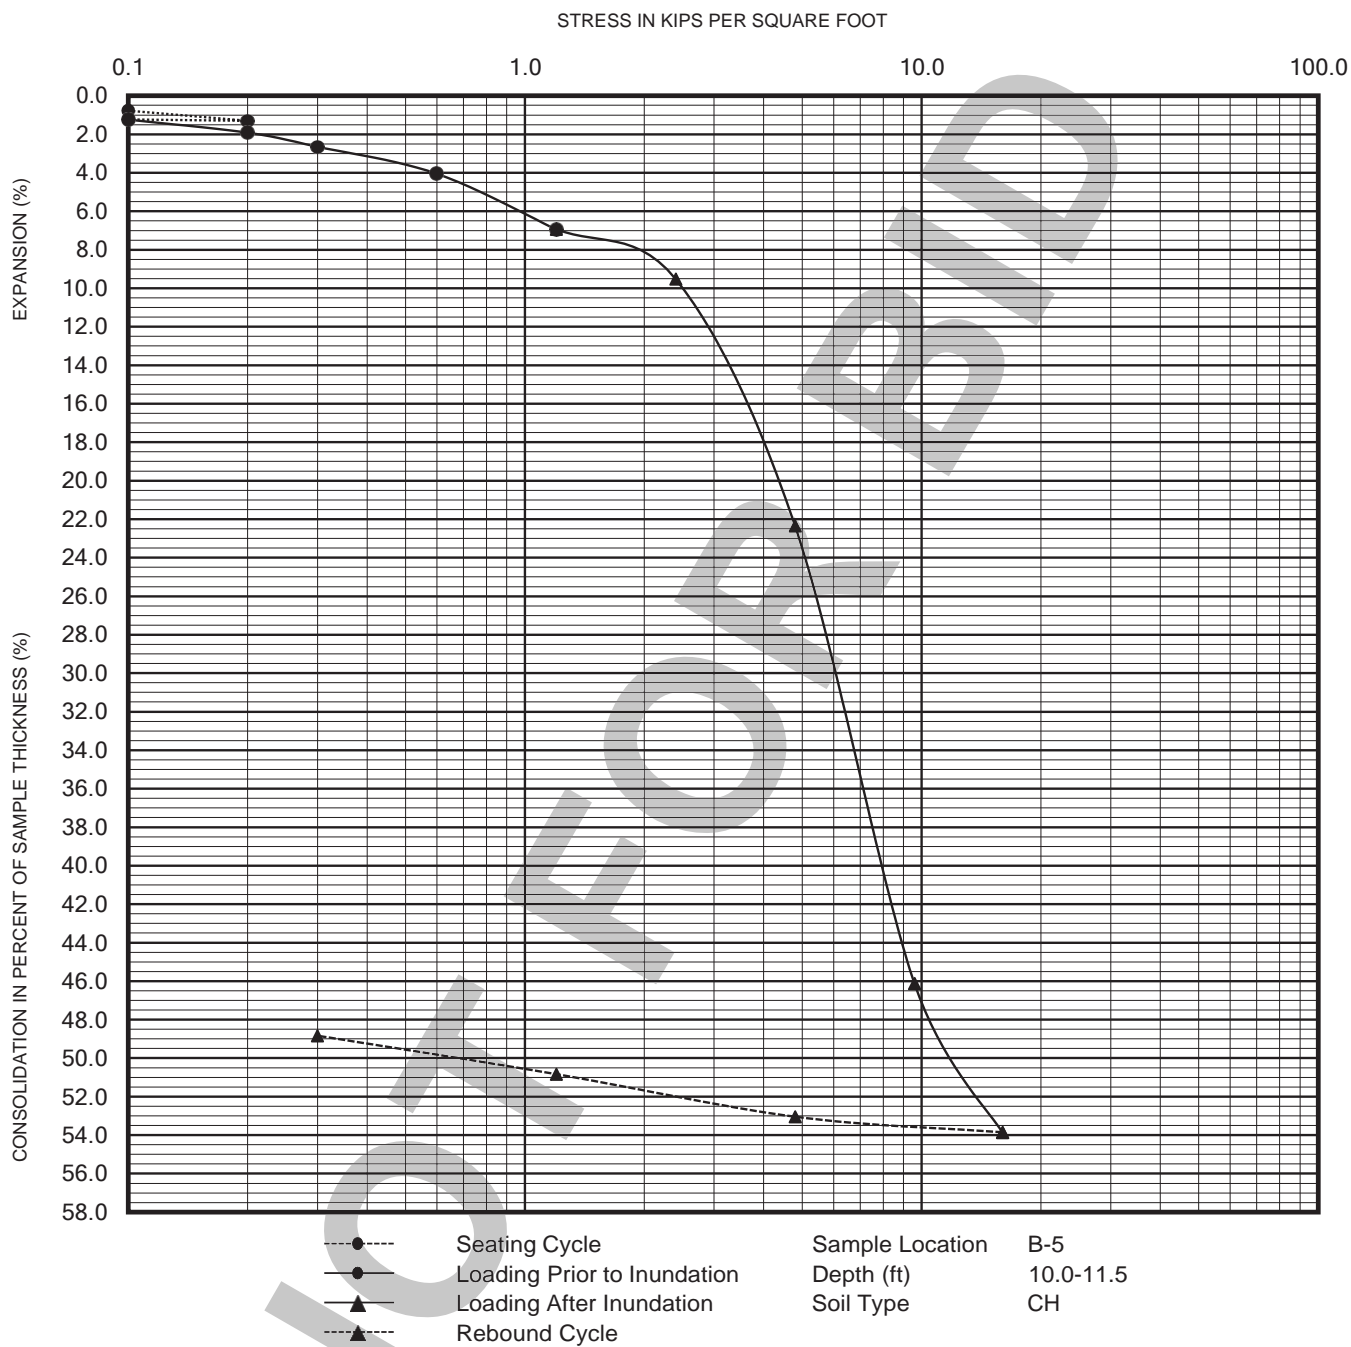
FIGURE B-5

PERFORMED IN GENERAL ACCORDANCE WITH ASTM D 2435

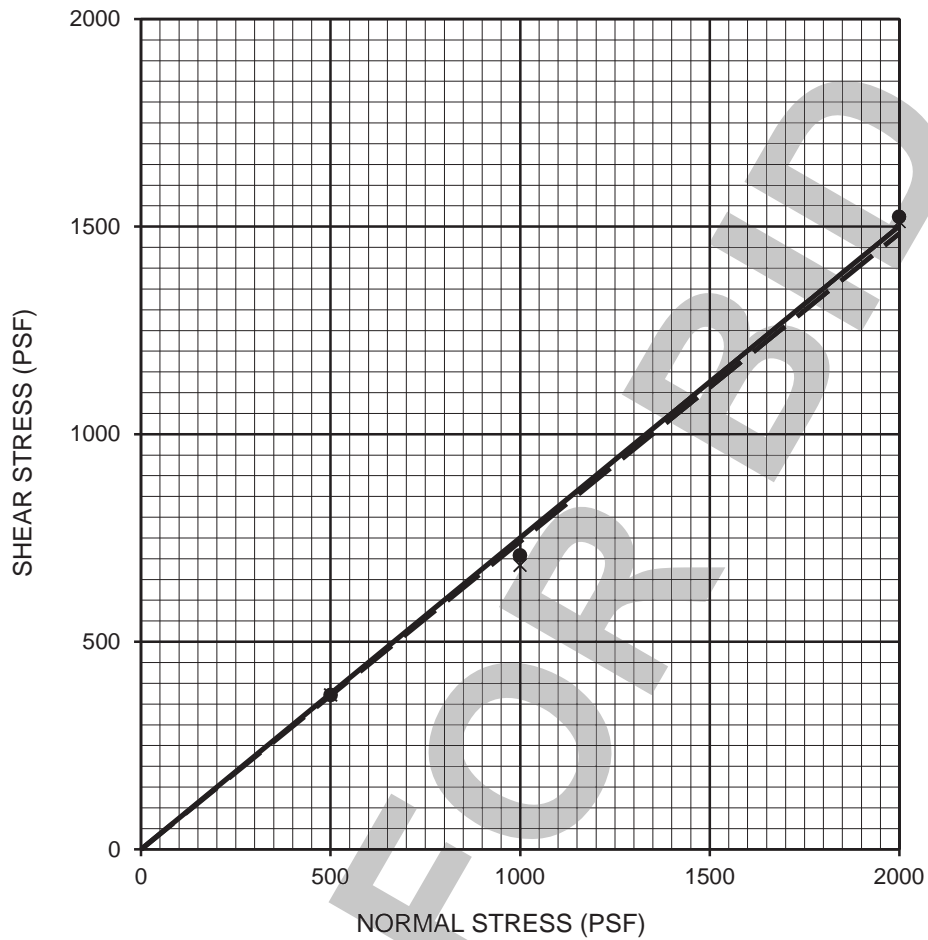
Description	Symbol	Sample Location	Depth (ft)	Shear Strength	Cohesion (psf)	Friction Angle (degrees)	Soil Type
POORLY GRADED SAND WITH SILT	●	B-3	5.0-6.5	Peak	0	38	SP-SM
POORLY GRADED SAND WITH SILT	X	B-3	5.0-6.5	Ultimate	0	38	SP-SM

PERFORMED IN GENERAL ACCORDANCE WITH ASTM D 3080

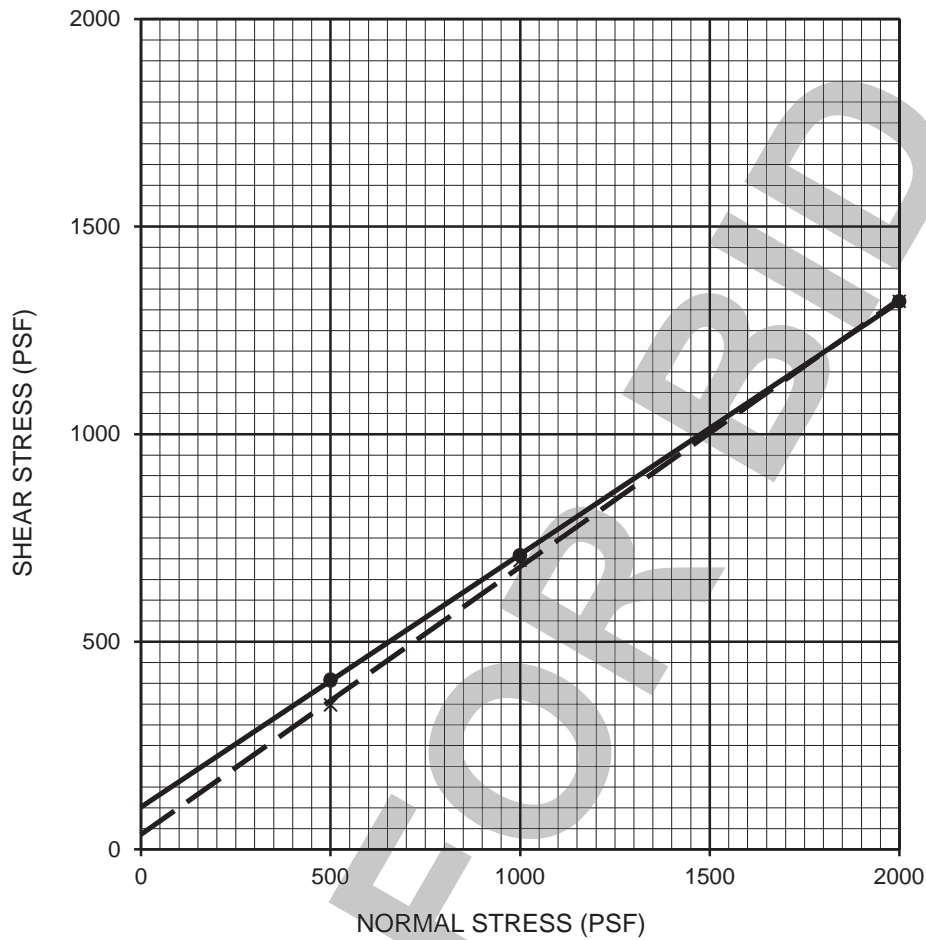
Description	Symbol	Sample Location	Depth (ft)	Shear Strength	Cohesion (psf)	Friction Angle (degrees)	Soil Type
FAT CLAY WITH SAND	—●—	B-6	7.5-9.0	Peak	102	31	CH
FAT CLAY WITH SAND	- - X - -	B-6	7.5-9.0	Ultimate	36	33	CH

PERFORMED IN GENERAL ACCORDANCE WITH ASTM D 3080
