GEOTECHNICAL REPORT

**CSA 70 D-1 LAKE ARROWHEAD
MacKay PARK
PICKLEBALL COURTS PROJECT**

GEOTECHNICAL INVESTIGATION

LAKE ARROWHEAD MACKAY PARK PICKLEBALL COURT PROJECT 321 ROUSE RANCH ROAD LAKE ARROWHEAD, CALIFORNIA

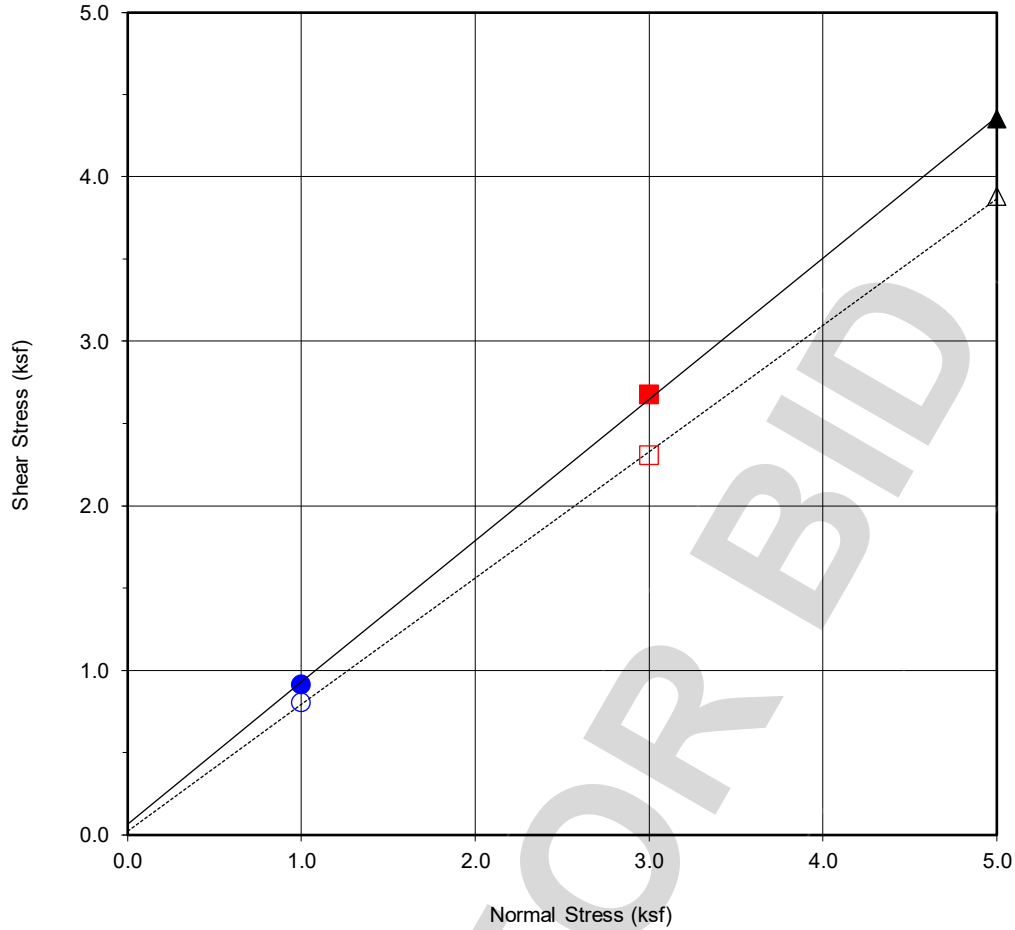
Figure B4

Boring No.	TP9
Sample No.	TP9@2'
Depth (ft)	2'
Sample Type:	Ring

Soil Identification:		
Well-Graded Sand (SW)		
Strength Parameters		
	C (psf)	ϕ ($^{\circ}$)
Peak	67	41
Ultimate	22	38

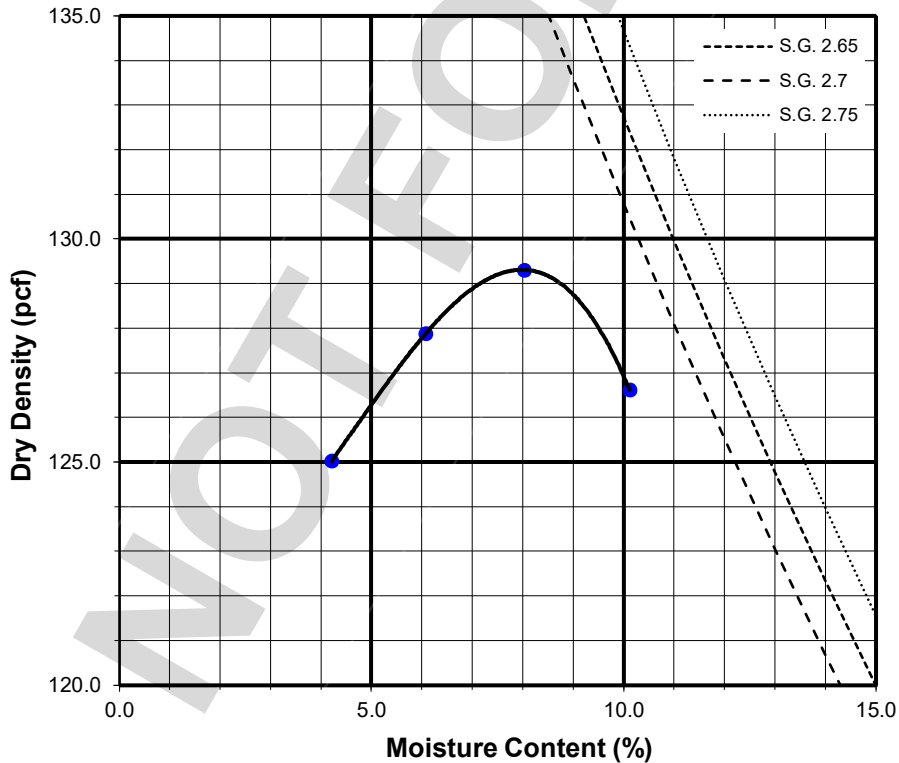
Maximum Dry Density (pcf)	129.5
Bulk Specific Gravity (dry)	2.50
Corrected Maximum Dry Density (pcf)	132.5

Optimum Moisture Content (%)	7.5
Oversized Fraction (%)	13.0
Corrected Moisture Content (%)	6.5

Preparation Method: A

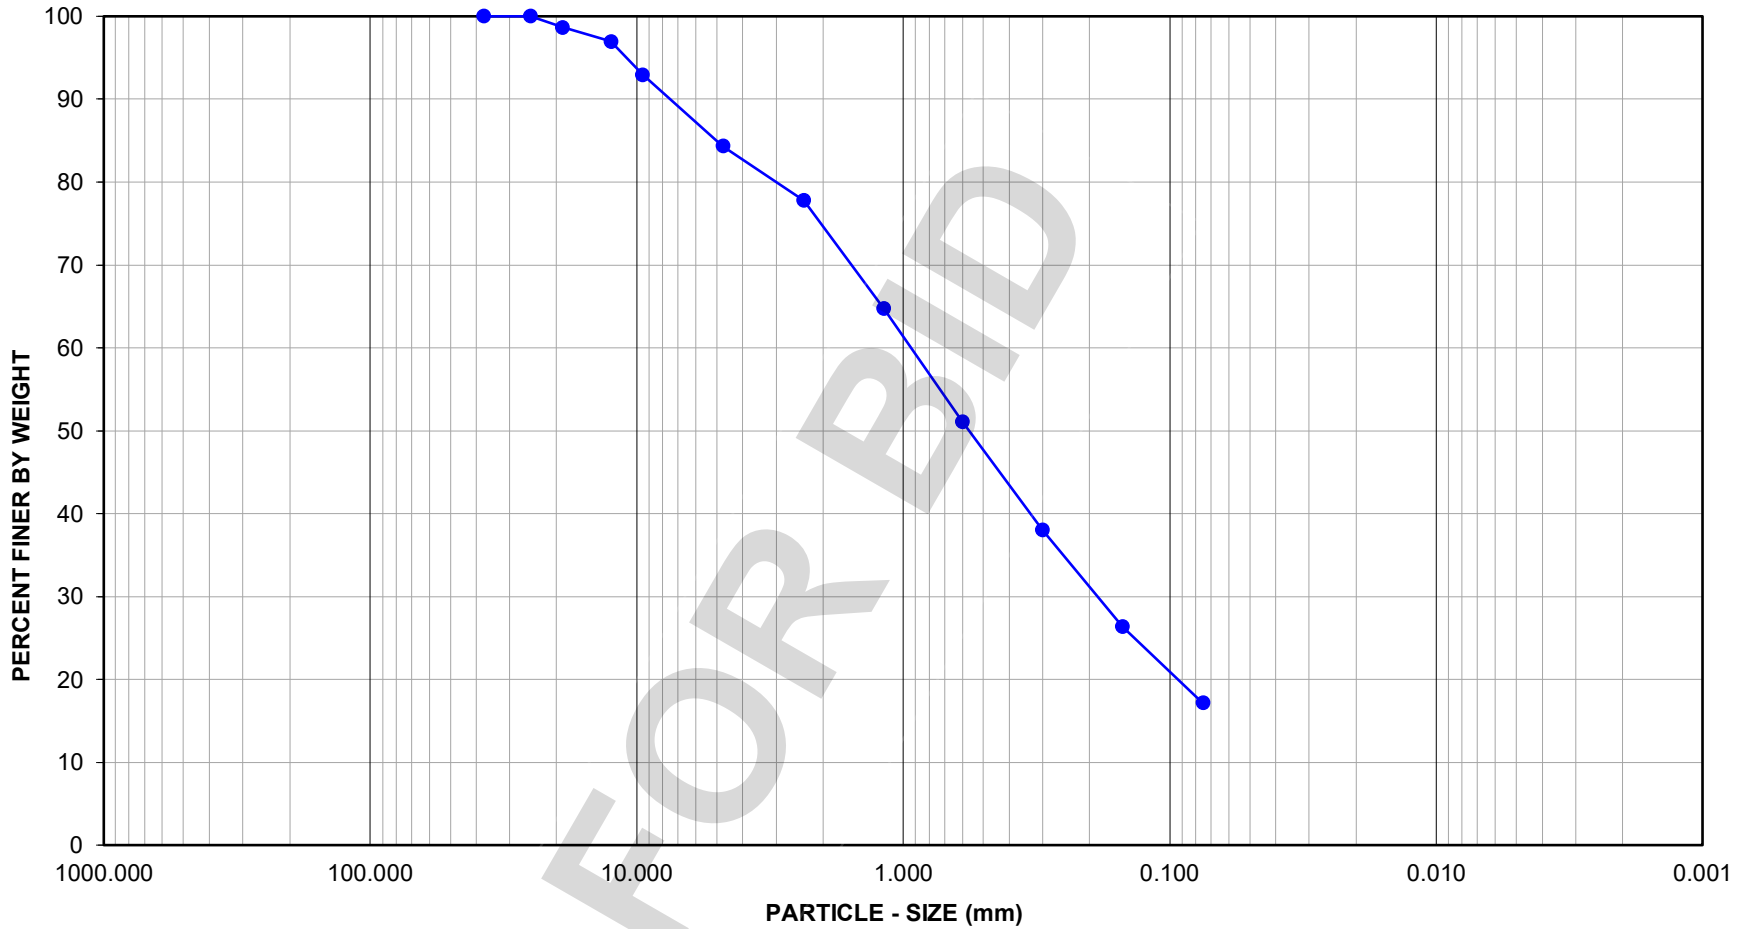
Project No.: W1661-99-03
 MACKAY PARK
 321 ROUSE RANCH ROAD
 LAKE ARROWHEAD, CALIFORNIA
 November 2023 Figure B11

PARTICLE - SIZE DISTRIBUTION
 ASTM C-136
 Checked by: RP

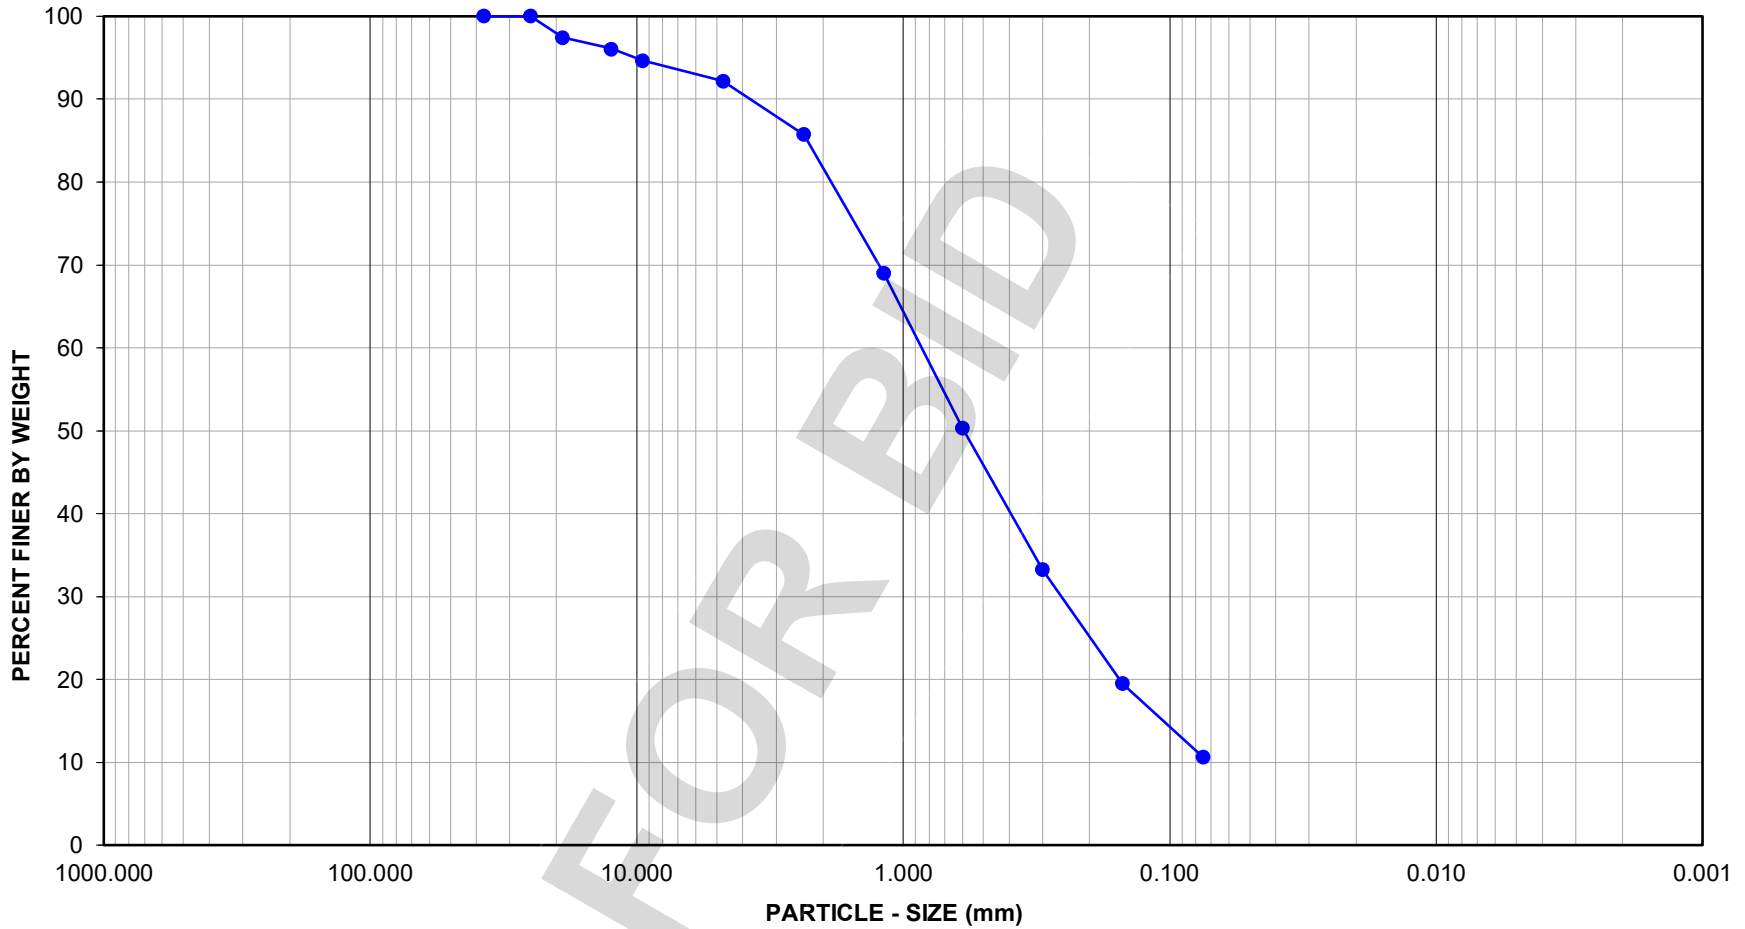
Project No.: W1661-99-03
MACKAY PARK
321 ROUSE RANCH ROAD
LAKE ARROWHEAD, CALIFORNIA
November 2023 Figure B12

PARTICLE - SIZE DISTRIBUTION
ASTM C-136
Checked by: RP
