### .12 WEST RANDALL ELEMENTARY SCHOOL

15620 Randall Ave, Fontana, CA 92335 Fontana Unified School District

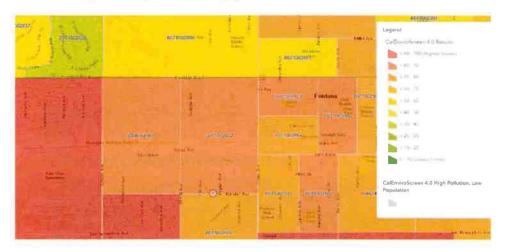
Figure 4.12.5 CalEnviroScreen 4.0 Score - West Randall Elementary School

CalEnviroScreen (CES) is a tool developed by the California Office of Environmental Health Hazard Assessment (OEHHA) that identifies communities that are disproportionately burdened by pollutants. Factors used to identify communities include exposures (traffic, pesticides, and drinking water), environmental effects (cleanup sites, solid waste), sensitive populations (asthma, low birth weight) and socioeconomic factors (education, poverty, unemployment). Scores range from 0-100 with a higher score indicating a higher effect of pollutants for a particular area. Figure 4.12.5 illustrates the CES scores for West Randall Elementary School and its surrounding area, scoring in the 80th to 90th percentile, which indicates the area is significantly burdened by pollutants.

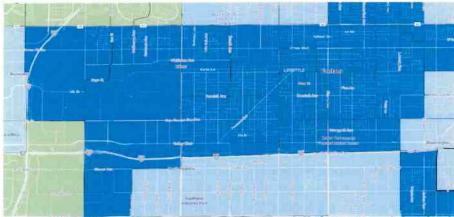
Figure 4.12.6 Healthy Place Index Score - West Randall Elementary High School

The California Healthy Places Index (HPI), developed by the Public Health Alliance of Southern California, is a tool used to explore the community conditions that impact life expectancy. The HPI tool helps prioritize public and private investments, resources, and programs in neighborhoods where they are needed the most. The HPI tool combines 23 community characteristics such as access to healthcare, housing, education, and more. The tool produces a score ranging from 0-100 with a higher score representing a healthier community. The tool's indicators reflect widely recognized thematic areas of the social determinants of health and are consistent with those described by the Centers for Disease Control (CDC). Figure 4.12.6 illustrates the area surrounding West Randall Elementary School, which shows an HPI score of 13.9, indicating less healthy conditions surrounding the school.

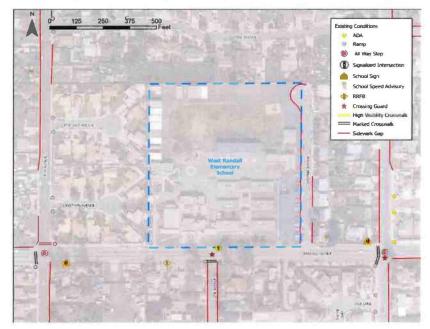
**Figure 4.12.7 Existing Pedestrian Conditions**

Figure 4.12.7 provides an overview of the existing pedestrian network and challenges observed and analyzed. The sidewalk network surrounding West Randall Elementary School is incomplete. During the site visit, missing sidewalks were observed on portions of Randall Avenue, Poplar Avenue, Lime Avenue, and Elm Avenue. A large portion of the sidewalk area is paved with asphalt instead of concrete on the north and south sides of Randall Avenue, containing cracks, bumps and irregular slopes throughout. Curb ramps are also missing on the north side of Randall Avenue at the Rectangular Rapid Flashing Beacon (RRFB) crossing at the intersection of Randall Avenue and Lime Avenue. It should be noted that the RRFB is only activatable on the north side of Randall Avenue along the school frontage and is not activatable on the south side of Randall Avenue where the crossing guard is located. During rainy days, water collects in the curb areas, pooling in some areas of sidewalk and on school property, which also disrupts walking. Two mailboxes were observed on the south side of Randall Avenue across from the school that created a path of travel that was less than 4 feet in width, which would cause potential ADA concerns. At the intersection of Elm Avenue and Randall Avenue, the east and south legs are missing.

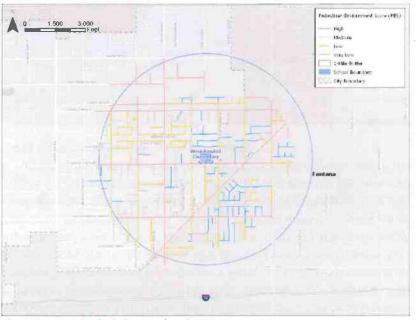
**Figure 4.12.8 Pedestrian Evaluation Score**

Challenges to walking were evaluated using the Pedestrian Evaluation Score (PES) developed by CR Associates. Based on the physical environment, surrounding land uses, and the street environment, a PES score was developed for nearby roadways. Figure 4.12.8 shows the results of the PES scoring. A sidewalk network with medium and high PES scores indicates relatively low stress for walking, whereas a low or very low PES score can be considered a stressful walking environment. The roadways near West Randall Elementary School show primarily a mix of high and low PES scores, with very low scores on Merrill Avenue, Randall

Avenue, and Beech Avenue. This indicates a stressful walking environment near the school along these roadways and may create a barrier to walking.

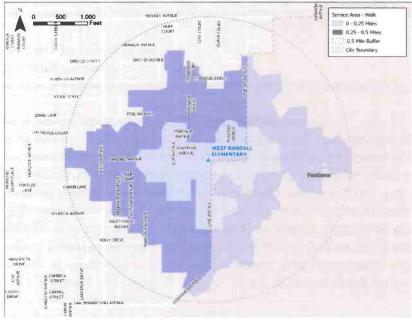
**Figure 4.12.9 Existing Pedestrian Walkshed**

Figure 4.12.9 shows the walkshed for West Randall Elementary School. The walkshed shows the area which a student can walk one-half mile from the school. The walkshed has been reviewed for sidewalk connectivity and accessibility.

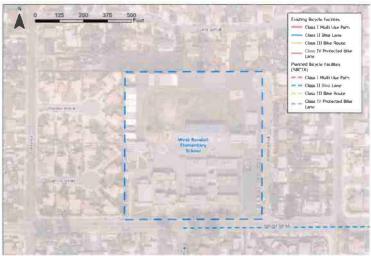
Figure 4.12.10 Existing and Planned Bicycle Condition

Currently, there are no bicycle facilities surrounding West Randall Elementary School. The San Bernadino County Transportation Authority (SBCTA) plans to implement a Class II Bike Lane along Randall Avenue east of Lime Avenue (Figure 4.12.10).

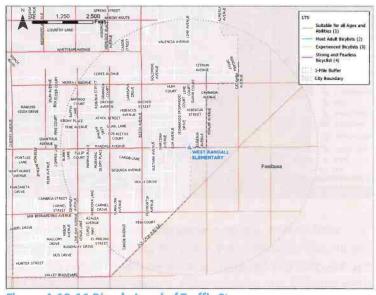
**Figure 4.12.11 Bicycle Level of Traffic Stress**

The bicycle environment was assessed using the bicycle Level of Traffic Stress (LTS) methodology for characterizing cycling environments, as developed by Mekuria, et al (2012) of the Mineta Transportation Institute. LTS classifies the street network into categories according to the level of stress it causes cyclists, taking into account a number of factors. The LTS assessment conducted by MBI concluded that the roads immediately surrounding West Randall Elementary School have LTS scores of 1 to 4, indicating a combination of low and high stress levels for cyclists (Figure 4.12.11).

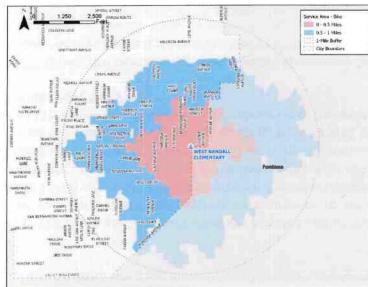
Figure 4.12.12 Existing Bikeshed

Figure 4.12.12 shows the bikeshed for West Randall Elementary School. The bikeshed shows the area where a student can bike one mile from the school.

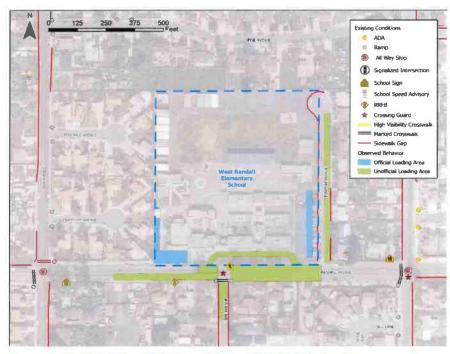
Figure 4.12.13 Existing Pick-Up and Drop-Off Vehicle Behavior

West Randall Elementary School is accessed via Randall Avenue and Eugenia Avenue. Figure 13 illustrates the existing conditions, and the behaviors observed during the mobility assessment.

There are currently two crossing guards. There is one crossing guard at the intersection of Randall Avenue at Lime Avenue. This intersection includes a Rectangular Rapid Flashing Beacon (RRFB) crossing with a high-visibility crosswalk and signage. It should be noted that the RRFB is only activatable on the north side of Randall Avenue along the school frontage and is not activatable on the south side of Randall Avenue where the crossing guard is located. The second crossing guard is located at the intersection of Randall Avenue at Poplar Avenue. This intersection is an all-way stop controlled crossing with a standard marked crosswalk and a missing curb ramp on the northwest leg. The following signs are present along the north and south sides of Randall Avenue:

Students often walk through the bus loop to cross and access the entrance or exit of the school.

Drop-off currently occurs primarily at the Eugenia Avenue parking lot just east of the school campus. During the site visit, parents were observed arriving nearly 30 minutes prior to the first bell. Many parents were seen dropping off students at the official unloading area at the Eugenia Avenue parking lot, while parents with TK-K grade students were seen using the west parking lot on Randall Avenue. Staff members were seen blocking off the bus loop on Randall Avenue after the buses drop off and pick up. The TK-K parking lot on Randall Avenue is closed at 7:35 am and requires vehicles to exit the TK-K premises beforehand. School staff recognize that vehicles use primarily unofficial spots to drop off students such as both sides of Randall Avenue, Lime Avenue, and Eugenia Avenue. Some parents park in the red curb segments on Randall Avenue and near the bus loop driveways to pick up and drop off students. Some parents pick up and drop off students in the travel lane on Randall Avenue and/or double park.

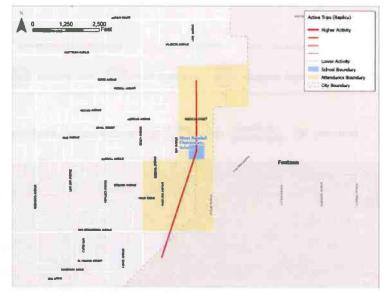
**Figure 4.12.15 Active Travel Pattern**

For each neighborhood, the number of trips made by each travel type was shown using lines on a map (see Figure 15 and Figure 16 for active trip and auto trip maps, respectively). A thicker line means more people are estimated to travel using that mode of transportation from that neighborhood. Line thickness can be compared within the same type of travel, such as comparing two walking routes. One can also get a general sense of how walking and driving compare by looking at both sets of lines side by side. However, the lines are scaled differently for each mode of travel, so they should not be compared directly. This data helps reveal how people tend to travel based on several factors, such as the existing walking or biking environment, land uses, physical barriers, population densities,

and the layout of the roadway network. For West Randall Elementary School, auto and active modes have relatively similar magnitudes for each respective mode from each TAZ.
