## 4.14 LIVE OAK ELEMENTARY SCHOOL

9522 Live Oak Ave, Fontana, CA 92335 Fontana Unified School District

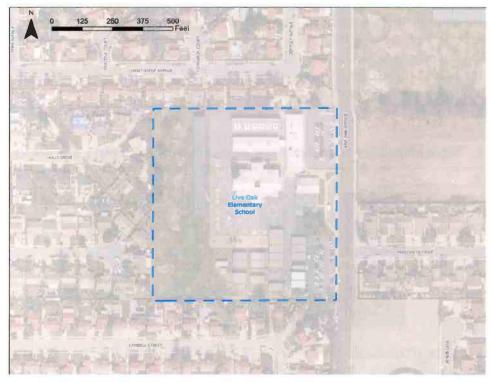
Figure 4.14.1 Context Map

Live Oak Elementary School is located in unincorporated San Bernardino County, California, within the City of Fontana Sphere of Influence. Live Oak Elementary School is located on the west side of Live Oak Avenue, between Hawthorne Avenue and San Bernardino Avenue. The school is located approximately 1.0 mile north of the Interstate 10 (I-10) freeway and approximately 0.6 miles southeast of Auto Club Speedway, a Nascar racing track. The land uses surrounding Live Oak Elementary School are primarily residential with some industrial land uses. Figure 4.14.1 shows the school area and the overall context of the school site.

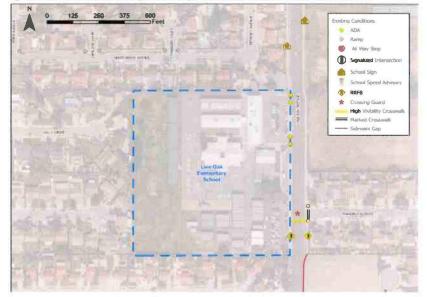
**Figure 4.14.9 Existing Pedestrian Conditions**

Figure 4.14.9 provides an overview of the existing pedestrian network challenges, observed and analyzed. The sidewalk network surrounding Live Oak Elementary School is incomplete. During the site visit, it was observed that there were no sidewalks on the east side of Live Oak Avenue south of the school's southern edge of the property line, and disconnected sidewalks on the east and west sides of Live Oak Avenue north of Sequola Avenue. Broken glass and other litter were observed within the periphery of the school's surrounding street of Live Oak Avenue.

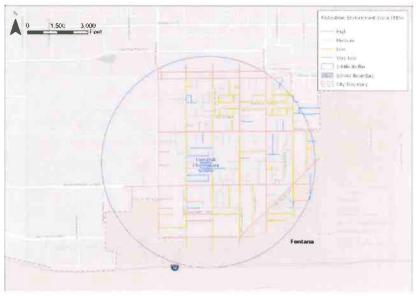
Figure 4.14.10 Pedestrian Evaluation Score

Challenges to walking were evaluated using the Pedestrian Evaluation Score (PES) developed by CR Associates. Based on the physical environment, surrounding land uses, and the street environment, a PES score was developed for nearby roadways. Figure 4.14.10 shows the results of the PES scoring. A sidewalk network with medium and high PES scores indicates relatively low stress for walking, whereas a low or very low PES score can be considered a stressful

walking environment. The roadways near Live Oak Elementary School show primarily medium and high PES scores, with very low scores on San Bernardino Avenue and Randall Avenue. This indicates a relatively lower stress walking environment near the school along the neighborhood roads, and higher stress walking environments along the larger roads.

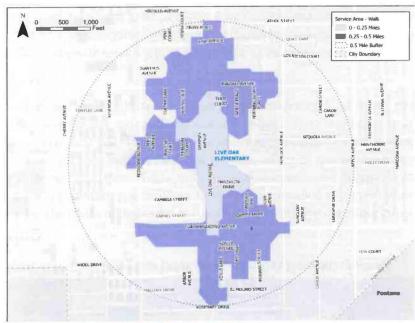
Figure 4.14.11 Existing Pedestrian Walkshed

Figure 4.14.11 shows the walkshed for Live Oak Elementary School. The walkshed shows the area where a student can walk one-half mile from the school. The walkshed has been reviewed for sidewalk connectivity and accessibility.

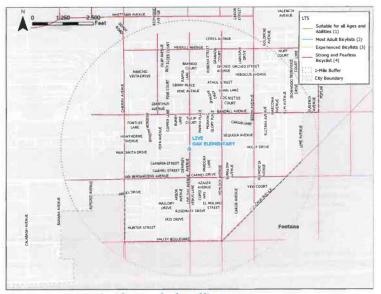
Figure 4.14.12 Bicycle Level of Traffic Stress

The bicycle environment was assessed using the bicycle Level of Traffic Stress (LTS) methodology for characterizing cycling environments, as developed by Mekuria et al. (2012) of the Mineta Transportation Institute. LTS classifies the street network into categories according to the level of stress it causes cyclists, taking into account a number of factors. The LTS assessment conducted by MBI concluded that the roads immediately surrounding Live Oak Elementary School have LTS scores of 4, indicating high stress levels for cyclists (Figure 4.14.12).

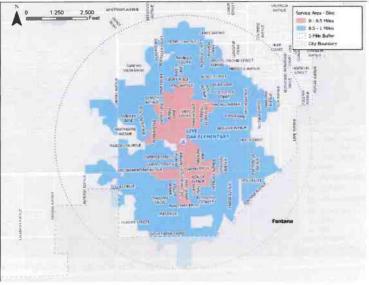
Figure 4.14.13 Existing Bikeshed

Figure 4.14.13 shows the bikeshed for Live Oak Elementary School. The bikeshed shows the area where a student can bike one mile from the school.

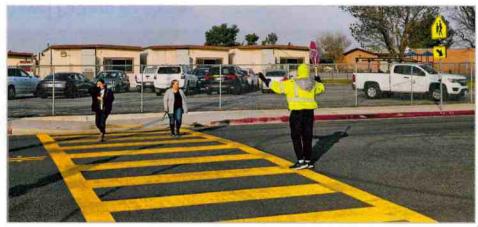
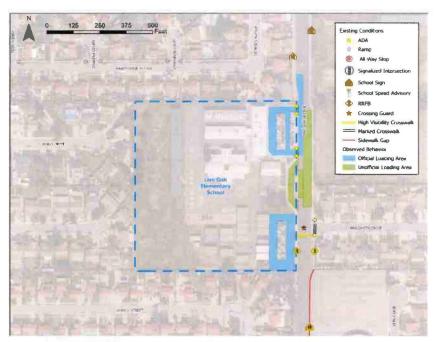
Figure 4.14.14 Existing Pick-Up and Drop-Off Vehicle Behavior

Live Oak Elementary School is accessed via Live Oak Avenue and Sequoia Avenue. Figure 4.14.14 illustrates the existing conditions, and the behaviors observed during the mobility assessment.

Drop-off currently occurs at the Live Oak Avenue parking lot just in front of the school campus. During the site visit, parents were observed arriving nearly 30 minutes prior to the first bell and parking along the school curbside of Live Oak Avenue. Many parents were seen dropping off students at the official unloading area right in front of the school, while other parents were seen dropping off along Live Oak Avenue. The bus loop is located south of the main pick up/drop off loop and is used informally by parents during arrival and dismissal. The south parking lot is open for TK-K parents to park and walk the students over to the school gate. School staff recognize that vehicles park in unofficial spots to drop off students, such as the east side of Live Oak Avenue and the red curb zones throughout Live Oak Avenue. Some parents also double park and drop students off in the travel lane on Live Oak Avenue.

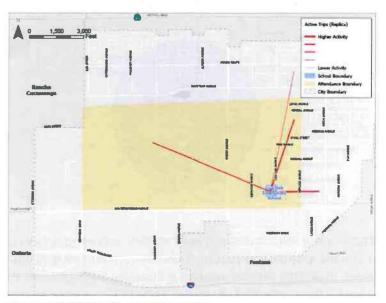
**Figure 4.14.16 Active Travel Pattern**

For each neighborhood, the number of trips made by each travel type was shown using lines on a map (see Figure 4.14.16 and Figure 4.14.17 for active trip and auto trip maps, respectively). A thicker line means more people are estimated to travel using the mode of transportation from that neighborhood. Line thickness can be compared within the same type of travel, such as comparing two walking routes. One can also get a general sense of how walking and driving compare by looking at both sets of lines side by side. However, the lines are scaled differently for each mode of travel, so they should not be compared directly. This data helps reveal how people tend to travel based on several factors, such as the existing walking or biking environment, land uses, physical barriers, population densities and the layout of the roadway network, For Live Oak Elementary School, auto and active modes have relatively similar magnitudes for each respective mode. It should be noted that there is a TAZ north of the school that shows higher activity for auto trips, compared to active trips. This difference in activity may be due to existing active infrastructure barriers, more car-dominant lifestyles or a longer distance between the school and the respective TAZ.

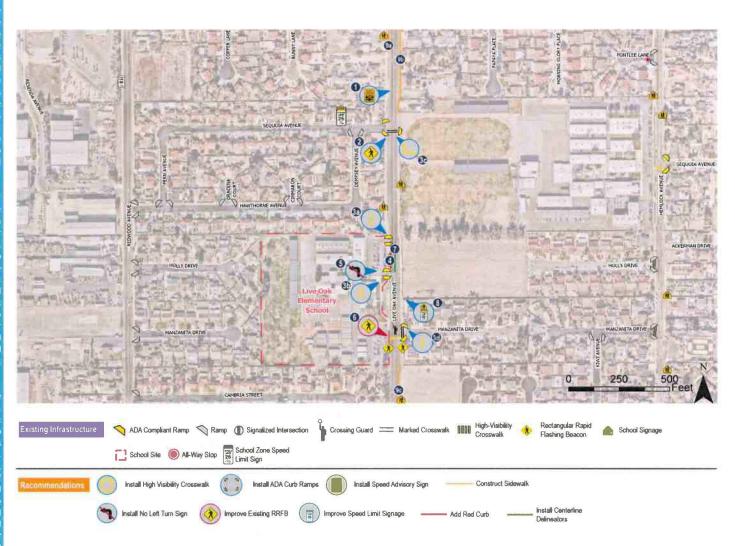
Several recommendations are provided to improve the traveling experience to and from Live Oak Elementary School A speed feedback sign is recommended along Live Oak Avenue north of Sequoia Avenue to discourage speeding. To improve visibility and accessibility, high visibility crosswalks and sidewalks are recommended along Live Oak Avenue To increase and improve east-west crossing opportunities an RRFB is recommended to be added at the intersection of Sequoia Avenue and Live Oak Avenue. To prevent northbound left turning movements into the school drop off and pick up loop, delineators and a "No Left Turn" sign are recommended at the intersection of Live Oak Avenue and the north school driveway. These recommendations are highlighted in Figure 4.14.18. A summary list of recommendations is provided Table 4.14.11.
