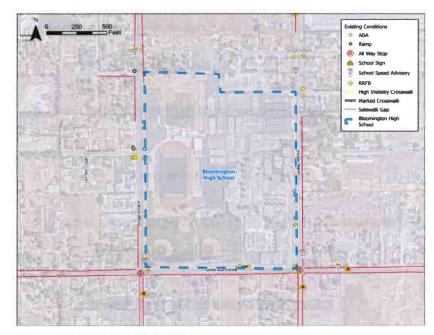
Figure 4.3.9 Existing Pedestrian Conditions

Figure 4.3.9 provides an overview of the existing pedestrian network and challenges observed during the mobility assessment. Bloomington High School has an existing sidewalk with ADA-compliant curb ramps that surround the school's boundary. Beyond the immediate school boundary, the sidewalk network is incomplete or broken. There is no sidewalk on the east side of Laurel Avenue or the south side of Santa Ana Avenue. During the principal interview and during the walk audit, it was noted that the intersection at Santa Ana Avenue and Alder Avenue has draining issues that make it very difficult to walk to the school when the intersection floods. During the pick-up observations, students were seen walking on the dirt path east of Laurel Avenue and crossing in the middle of the street to get to their vehicles.

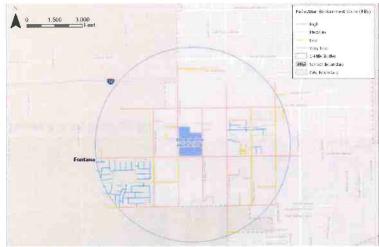
Figure 4.3.10 Pedestrian Evaluation Score

Challenges to walking were evaluated using the Pedestrian Evaluation Score (PES) developed by CR Associates. Based on the physical environment, surrounding land uses, and the street environment, a PES score was developed for nearby roadways. Figure 4.3.10 shows the results of the PES scoring. A sidewalk network with medium and high PES scores indicates low stress for walking, whereas low or very low PES scores can be considered a stressful walking environment. The

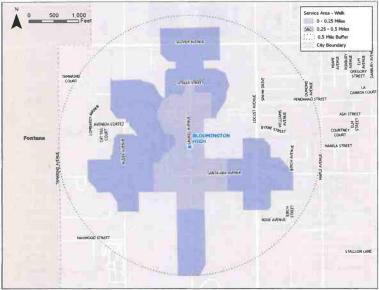
Figure 4.3.11 Existing Pedestrian Walkshed

Figure 4.3.11 shows the walkshed for Bloomington High School. The walkshed shows the area which a student can walk a half mile from the school. The walkshed has been reviewed for sidewalk connectivity and accessibility.

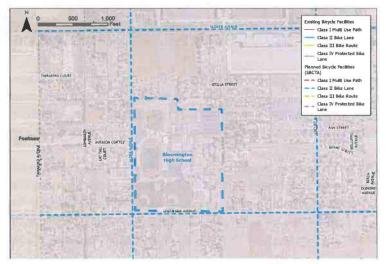
Figure 4.3.12 Existing and Planned Bicycle Conditions

Currently, there are no bicycle facilities surrounding Bloomington High School. There are plans to implement a Class II Bike Lane along Jurupa Avenue and Cedar Avenue through San Bernardino County Transportation Authority (SBCTA). (Figure 4.3.12).

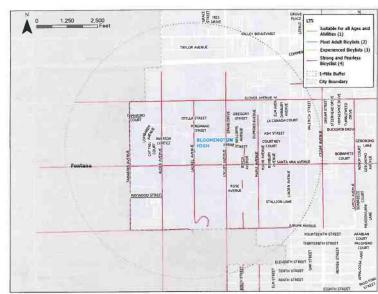
Figure 4.3.13 Bicycle Level of Traffic Stress

The bicycle environment was assessed using the bicycle Level of Traffic Stress (LTS) methodology for characterizing cycling environments, as developed by Mekuria, et al (2012) of the Mineta Transportation Institute. LTS takes into account a number of factors to classify the street network into categories according to the level of stress it causes cyclists. The LTS assessment conducted by MBI concluded that the roads immediately surrounding Bloomington High School have high LTS scores indicating higher stress levels for cyclists (see Figure 4.3.13).

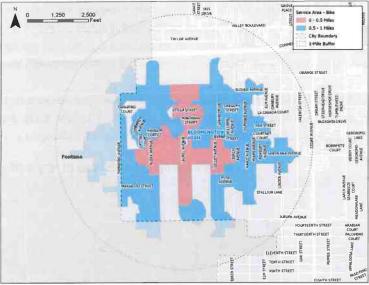
Figure 4.3.14 Existing Bikeshed

Figure 4.3.14 shows the bikeshed for Bloomington High School. The bikeshed depicts the area which a student can bike one mile from the school.

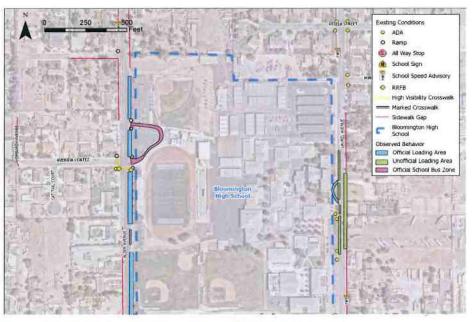
Figure 4.3.15 Existing Pick-Up and Drop-Off Vehicle Behavior

Bloomington High School is accessed via Alder Avenue and Laurel Avenue. Laurel Avenue, a two-lane road with no parking on either side, accesses the front of the school, and is where many students are picked up by their parents. Alder Avenue, a two-lane road with parking along one side of the road, accesses the back of the school where the student parking lot is located and where the school bus drops students off. Figure 4.3.15 illustrates the existing pick-up and drop-off conditions, and the behaviors observed during the mobility assessment.

At the front of the school along Laurel Avenue, vehicles were observed lining up to pick up students approximately fifteen minutes before the bell rang. After the bell, many students were seen walking into traffic, crossing Laurel Avenue to get to the cars parked on the dirt path on the east side of the street. Many vehicles were seen double parking along the red curb at the front of the school.

At the back of the school along Alder Avenue, there is an existing double-parking buffer along the west side of the street. Vehicles were observed lining up to pick up students approximately fifteen minutes before the bell rang. After the bell, many students were seen walking southbound on Alder Avenue.

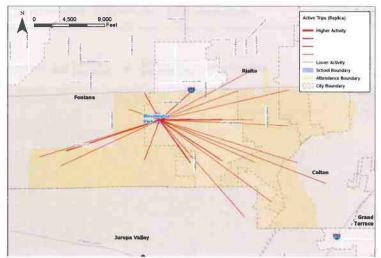
Figure 4.3.17 Active Travel Pattern

For each neighborhood, the number of trips made by each travel type was shown using lines on a map (Figure 4.3.17 and 4.3.18). A thicker line means more people are estimated to travel using that mode from that TAZ. Line thickness can be compared within the same mode of travel, such as comparing two walking routes from two different TAZs. One can also get a general sense of how walking and

driving compare by looking at both sets of lines from the same TAZ side by side. For example, a thicker line for auto, compared to active for a particular TAZ indicates more of an interest to drive compared to walking or biking. It should be noted the lines are scaled differently with regards to trips for each mode of travel (auto and active), so they should not be compared directly. This data helps reveal how people tend to travel based on several factors; existing walking or biking environment, land uses, physical barriers, population densities, and the layout of the roadway network.

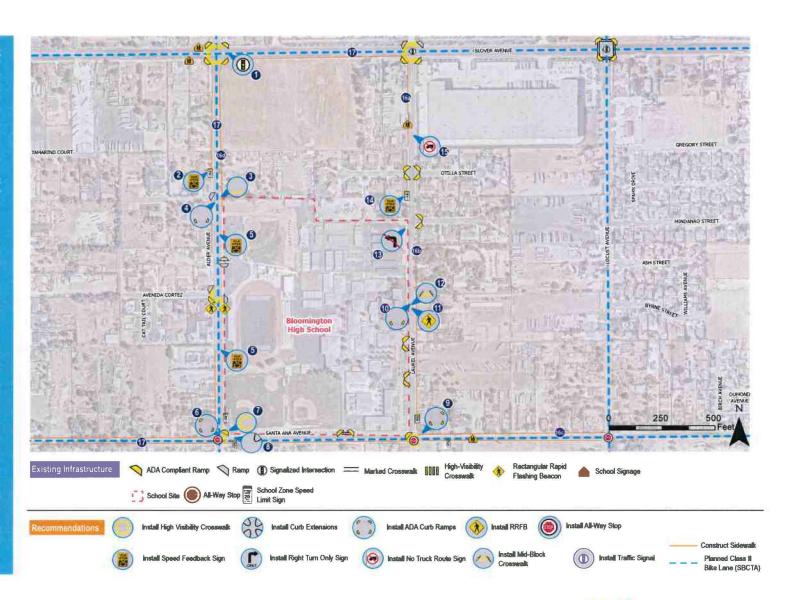
BLOOMINGTON HIGH SCHOOL

Several challenges were identified during the mobility assessment conducted for Bloomington High School. There are currently missing sidewalks along Laurel Avenue, Santa Ana Avenue, and Alder Avenue. Intersections currently have only one or two ADA-compliant curb ramps, and semi-trucks were seen driving along Laurel Avenue and Alder Avenue during school pickup time. It should be noted that this is not a truck route, but trucks were observed driving on Laurel Avenue. During the walk audit, many school staff noted that many students walk southbound on Alder Avenue to the neighborhoods south of the school. A major concern was that the intersection at Alder Avenue and Santa Ana Avenue flooded frequently, making it difficult to cross the street without getting wet. There is currently no bicycle infrastructure, but students were observed rolling on skateboards after school. Speeding was also cited as a main concern along Sana Ana Avenue. Laurel Avenue, and Alder Avenue.

Several projects to improve waiking and rolling are recommended. It is recommended to fill in the existing sidewalk gaps along Laurel Avenue, Santa Ana Avenue, and Adler Avenue, allowing students to avoid walking along dirt paths or in the road. Since so many vehicles double park on the east side of Laurel Avenue, it is recommended to install a high-visibility mid-block crossing at the school frontage, giving students a place to safely cross the street to the school on the west side. To address speeding concerns, speed feedback signs are recommended along the roadways surrounding the school. These recommendations are highlighted in the graphic provided. A summary list of recommendations is provided in Table 4.3.1.
