# 4.8 PAAKUMA K-8 SCHOOL

17825 Sycamore Creek Loop Pkwy, San Bernardino, CA 92407 San Bernardino City Unified School District

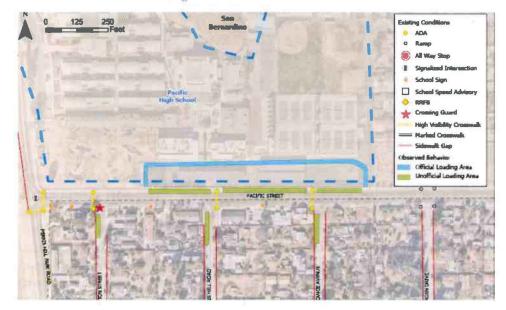
Figure 4.7.15 Existing Pick-Up and Drop-Off Vehicle Behavior

Pacific High School is accessed via Pacific Street, a four-lane road, and Perris Park Hill Road, a two-lane road. Figure 15 illustrates the existing conditions, and the behaviors observed during the mobility assessment. There are currently three uncontrolled crossings across Pacific Street at Barton Street, Perris Hill Road, and Tippecanoe Avenue. Two of the crossings had a road light that were not functioning. A crossing guard is located at Perris Hill Road and Pacific Street. Students were seen crossing Pacific Street during drop-off. Many vehicles dropping off students were seen double parking on the north side of Pacific Street creating a buildup of traffic. Additionally, the existing Omnitrans bus was seen to be another form of transportation for students.

One of the biggest concerns that was mentioned during the walk audit was that the crosswalks at the intersection of Pacific Street and Perris Hill Park Road are very dangerous due to the fact that many drivers coming from Pacific Street do not realize that it is a three way road and drive through the intersection into the existing culvert.

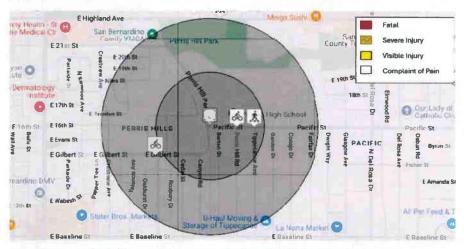
Figure 4.7.16 Bicycle and Pedestrian Involved Collisions (2019-2023)

Between 2019 and 2023, there were two bicycle, and two pedestrian involved collisions within a half mile radius of Pacific High School (Figure 4.7.16). All four collisions caused the party to have a complaint of pain. Within a quarter of a mile of the school, a bicycle involved crash and a pedestrian involved collision occurred on Pacific Street at the school frontage.

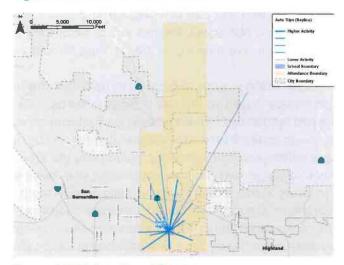
Figure 4.7.18 Auto Travel Pattern

For each neighborhood, the number of trips made by each travel type was shown using lines on a map (Figure 4.7.17 and 4.7.18). A thicker line means more people are estimated to travel using that mode from that TAZ. Line thickness can be compared within the same mode of travel, such as comparing two walking routes from two different TAZs. One can also get a

general sense of how walking and driving compare by looking at both sets of lines from the same TAZ side by side. For example, a thicker line for auto, compared to active for a particular TAZ indicates more of an interest to drive compared to walking or biking. It should be noted the lines are scaled differently with regards to trips for each mode of travel (auto and active), so they should not be compared directly. This data helps reveal how people tend to travel based on several factors, such as the existing walking or biking environment, land uses, physical barriers, population densities, and the layout of the roadway network.

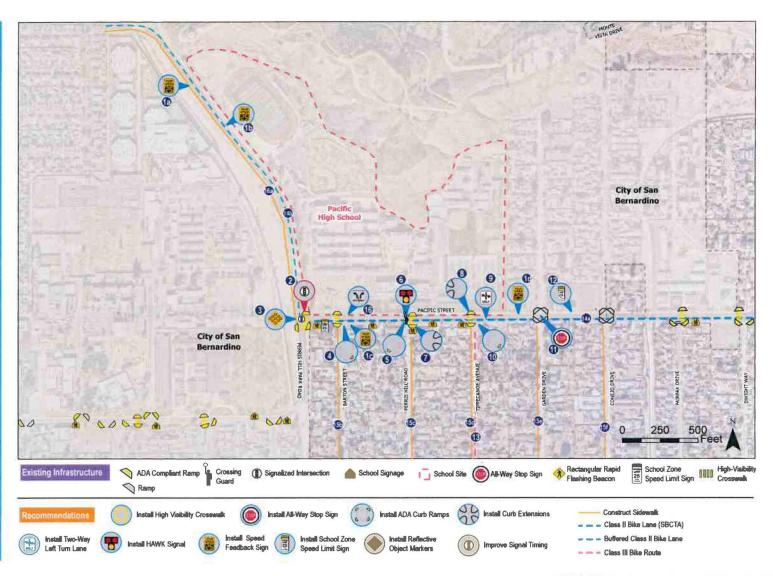
A series of enhancements to the project area are recommended to improve the experience for students. On Pacific Street, inscalling a HAWK beacon (high intensity activated crosswalk beacon) is recommended at Pacific Street and Perris Hill Road. Speed feedback signs are also recommended along both Pacific Street and Perris Hill Park Road to function as an additional traffic calming measure. Restriping Pacific Street to allow for one travel lane in each direction and a two way left-turn center lane is recommended. Currently, vehicles who want to turn left must stop in the middle of traffic and wait to turn. Restriping Pacific Street from 4 lanes to 3 lanes will also leave room for a potential bike lane as planned by SCBTA.

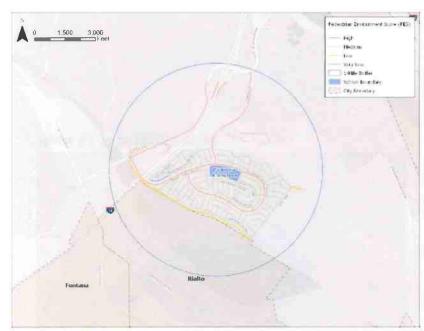
**Figure 4.8.9 Pedestrian Evaluation Score**

Challenges to walking were evaluated using the Pedestrian Evaluation Score (PES) developed by CR Associates. Based on the physical environment, surrounding land uses, and the street environment, a PES score was developed for nearby roadways. Figure 4.8.9 shows the results of the PES scoring. A sidewalk network with medium and high PES scores indicates low stress for walking, whereas a low or very low PES score can be considered a stressful walking environment. The roadways near Paakumá K-8 School show primarily high PES scores, with very low scores on Sycamore Creek and Clearwater Parkway. This indicates a stressful walking environment near the school along these roadways and may create an access barrier to walking.

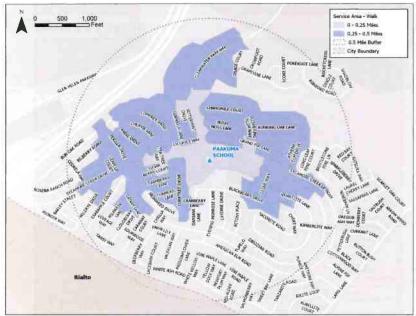
Figure 4.8.10 Existing Pedestrian Walkshed

Figure 4.8.10 shows the walkshed for Paakumá K-8 School. The walkshed shows the area which a student can walk a half mile from the school. The walkshed has been reviewed for sidewalk connectivity and accessibility.

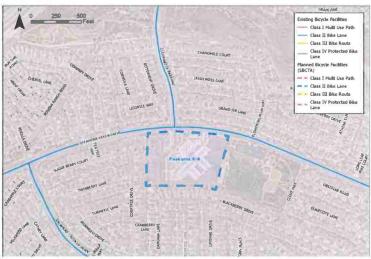
Figure 4.8.11 Existing and Planned Bicycle Conditions

Currently, there is a Class II Bike Lane along Sycamore Creek Drive and Sycamore Creek Loop Parkway (Figure 4.8.11).
