4.15 SEQUOIA MIDDLE SCHOOL

9452 Hemlock Ave, Fontana, CA 92335 Fontana Unified School District

SEQUOIA MIDDLE SCHOOL

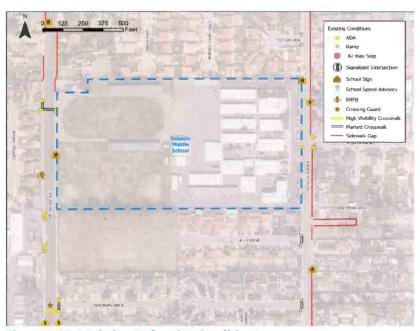
Figure 4.15.6 Existing Pedestrian Conditions

Figure 4.15.6 provides an overview of the existing pedestrian network and challenges observed and analyzed. The sidewalk network surrounding Sequoia Middle School is incomplete. During the site visit, it was observed that there were no sidewalks on the east side of Hemlock Avenue. The east and west sides of Live Oak Avenue also have some missing sidewalk segments. Vehicles were observed parking on the dirt pathway blocking the path of travel, where there should be sidewalk, on the east side of Hemlock Avenue. These vehicles then reverse into the lane of travel to leave, stopping northbound traffic and creating potential conflict points.

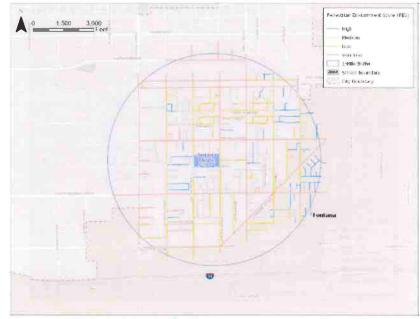
Figure 4.15.7 Pedestrian Evaluation Score

Challenges to walking were evaluated using the Pedestrian Evaluation Score (PES) developed by CR Associates. Based on the physical environment, surrounding land uses, and the street environment, a PES score was developed for nearby roadways. Figure 4.15.7 shows the results of the PES scoring. A sidewalk network with medium and high PES scores indicates relatively low stress for walking, whereas a low or very low PES score can be considered a stressful walking environment. The roadways near Sequoia Middle School show primarily low PES scores, with very low scores on Randall Avenue, San Bernardino Avenue and Beech Avenue. This indicates a stressful walking environment near the school along these roadways and may create a barrier to walking.

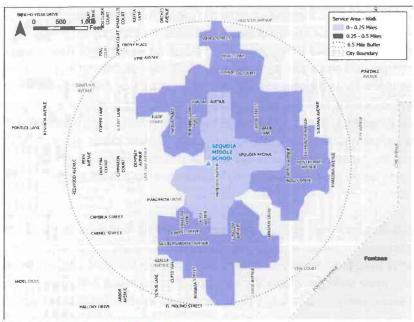
Figure 4.15.8 Existing Pedestrian Walkshed

Figure 4.15.8 shows the walkshed for Sequoia Middle School. The walkshed shows the area where a student can walk one-half mile from the school. The walkshed has been reviewed for sidewalk connectivity and accessibility.

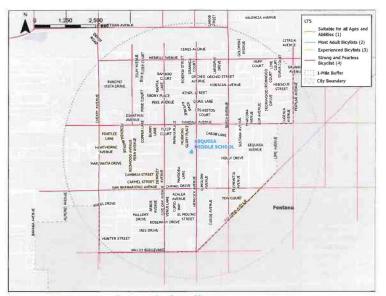
Figure 4.15.9 Bicycle Level of Traffic Stress

The bicycle environment was assessed using the bicycle Level of Traffic Stress (LTS) methodology for characterizing cycling environments, as developed by Mekuria et al. (2012) of the Mineta Transportation Institute. LTS classifies the street network into categories according to the level of stress it causes cyclists, taking into account a number of factors. The LTS assessment conducted by MBI concluded the roads immediately surrounding Sequoia Middle School have LTS scores of 4, indicating high stress levels for cyclists (Figure 4.15.9).

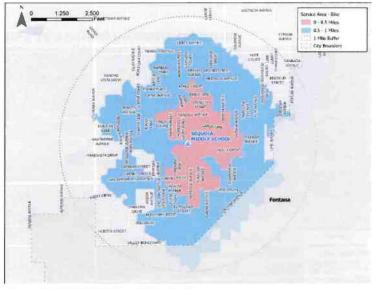
Figure 4.15.10 Existing Bikeshed

Figure 4.15.10 shows the bikeshed for Sequoia Middle School. The bikeshed shows the area where a student can bike one mile from the school.

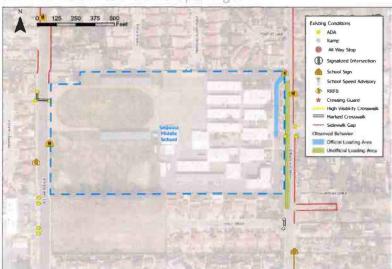
Figure 4.15.11 Existing Pick-Up and Drop-Off Vehicle Behavior

Sequoia Middle School is accessed via Hemlock Avenue and Sequoia Avenue. Figure 11 illustrates the existing conditions, and the behaviors observed during the mobility assessment.

Drop-off and pick-up currently occur primarily at the school parking lot on Hemlock Avenue. During the site visit, parents were observed arriving approximately 15 minutes prior to the dismissal bell. Many of the early arrival parents park along the school curbside of Hemlock Avenue to pick up students, while the late arrival parents were seen picking up students in the travel lane on Hemlock Avenue. Staff members were seen blocking off the main pick-up/drop-off entrance for the first 5 to 8 minutes of the dismissal bell to make sure there is clear access for school buses in the school parking lot. School staff recognize that vehicles park in unofficial spots to pick up students at the unpaved pathway on the east side of Hemlock Avenue across the school parking lot.

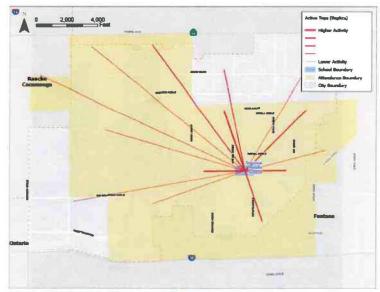
Figure 4.15.13 Active Travel Pattern

For each neighborhood, the number of trips made by each travel type was shown using lines on a map (Figure 13 and Figure 14 for active trip and auto trip maps, respectively). A thicker line means more people are estimated to travel using that mode of transportation from that neighborhood. Line thickness can be compared within the same type of travel, such as comparing two walking routes. One can also get a general sense of how walking and driving compare by looking at both sets of lines side by side. However, the lines are scaled differently for each mode of travel, so they should not be compared directly. This data helps reveal how people tend to travel based on several factors, such as the existing walking or biking environment, land uses, physical barriers, population densities and the layout of the roadway network.

For Sequoia Middle School, auto and active modes have similar magnitudes for each respective mode. It should be noted that TAZs that are further away from the school TAZ, particularly to the west, north, and east, show slightly higher activity for auto trips. The slight difference in activity in the further away TAZs may be due to poor active transportation connectivity to the school, active infrastructure barriers, more car-dominant lifestyles, or a longer distance between the school and the respective TAZ compared to other TAZs.

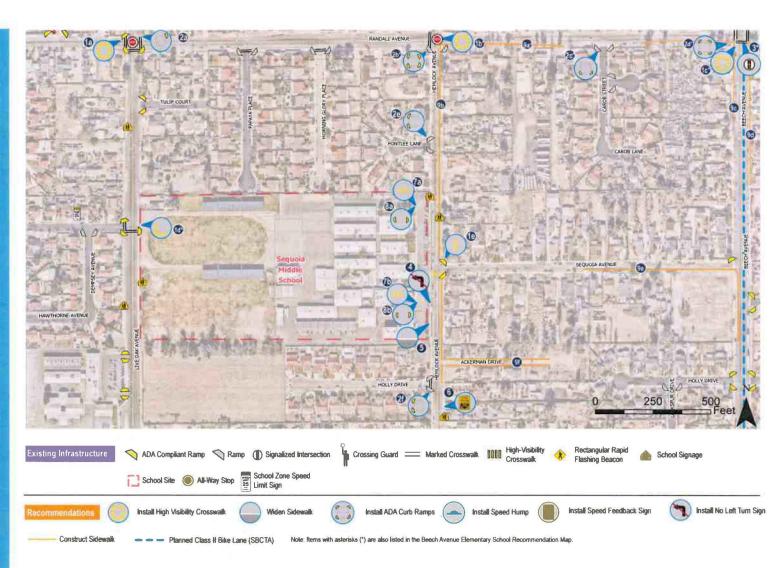
To improve visibility and accessibility, high visibility crosswalks. **ADA-compliant curb ramps**, and sidewalks are recommended at the school frontage and surrounding intersections. These recommendations are highlighted in Figure 4.15.15. A summary list of recommendations is provided on Table 4.15.1.

Speeding was cited as a concern on Hemlock Avenue. This is visible along Hemlock Avenue where drivers were seen increasing their speed. A speed feedback sign is recommended along Hemlock Avenue south of Sequoia Middle School to discourage speeding in the northbound direction towards the school

Another issue noted was vehicles making U-turn movements on Hemlock Avenue near the school exit driveway. To prevent northbound U-turn movements near the school exit-only driveway, a "No Left Turn" sign is recommended at the intersection of Hemlock Avenue and the school exit-only driveway to reinforce appropriate turning movements near Sequoia Middle School
