4.17 DORIS DICKSON ELEMENTARY SCHOOL

3930 Pamela Dr, Chino, CA 91710 Chino Valley Unified School District

4.18 LYLE S. BRIGGS FUNDAMENTAL SCHOOL

4.19 MISSION ELEMENTARY SCHOOL

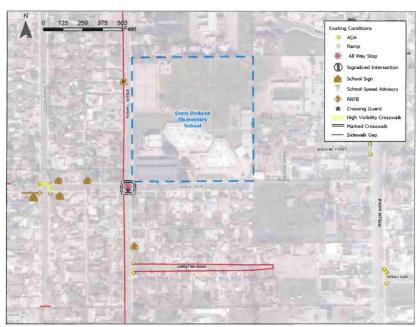
Figure 4.18.7 Existing Pedestrian Conditions

Figure 4.17.7 provides an overview of the existing pedestrian network and challenges observed and analyzed. The sidewalk network surrounding Doris Dickson Elementary School is incomplete. During the site visit, it was observed that there were no sidewalks on the west side of Roswell Avenue and the north and south sides of Christina Road. There is a lack of interest in walking and biking because families do not believe the infrastructure is conducive to walking or safe. The intersection of Pamela Drive and Roswell Avenue is very wide. Pedestrians contend with low visibility crossings, missing truncated domes, poor driving behavior at intersections, minimal tree canopy, and a culture of using buses and driving, despite being considered a neighborhood school.

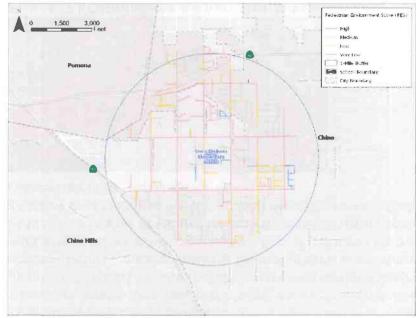
Figure 4.17.8 Pedestrian Evaluation Score

Challenges to walking were evaluated using the Pedestrian Evaluation Score (PES) developed by CR Associates. Based on the physical environment, surrounding land uses, and the street environment, a PES score was developed for nearby roadways. Figure 4.17.8 shows the results of the PES scoring. A sidewalk network with medium and high PES scores indicates relatively low stress for walking, whereas a low or very low PES score can be considered a stressful walking environment. The roadways near Doris Dickson Elementary School show a variety of PES scores, including very low scores on Riverside Drive, Chino Avenue, Pipeline Avenue and East End Avenue. Roswell Avenue along the school frontage received a low score. This indicates a stressful walking environment near the school along these roadways and may create a barrier to walking.

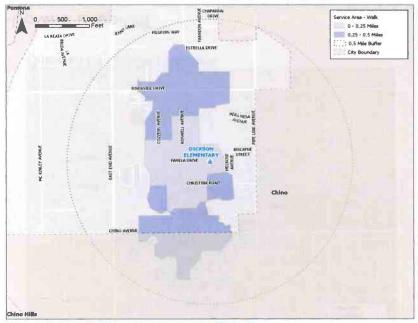
Figure 4.17.9 Existing Pedestrian Walkshed

Figure 4.17.9 shows the walkshed for Doris Dickson Elementary School. The walkshed shows the area where a student can walk a one-half mile from the school. The walkshed has been reviewed for sidewalk connectivity and accessibility.

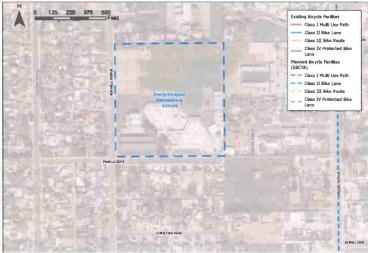
Figure 4.17.10 Existing and Planned Bicycle Condition

Currently, there are no bicycle facilities surrounding Doris Dickson Elementary School. The San Bernardino County Transportation Authority (SBCTA) plans to implement a Class II bike lane along Pipeline Avenue (Figure 4.17.10).

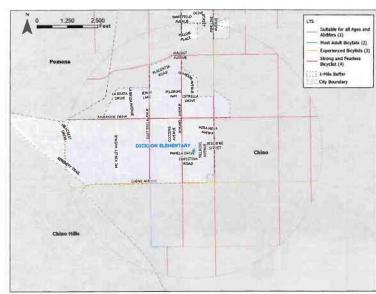
Figure 4.17.11 Bicycle Level of Traffic Stress

The bicycle environment was assessed using the bicycle Level of Traffic Stress (LTS) methodology for characterizing cycling environments, as developed by Mekuria, et al (2012) of the Mineta Transportation Institute. LTS classifies the street network into categories according to the level of stress it causes cyclists, taking into account a number of factors. The LTS assessment conducted by MBI concluded that the roads immediately surrounding Doris Dickson Elementary School have LTS scores of 1 to 4 indicating a combination of low and high stress levels for cyclists (Figure 4.17.11).

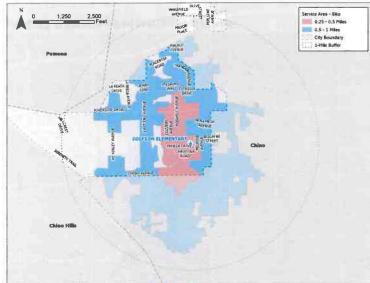
Figure 4.17.12 Existing Bikeshed

Figure 4.17.12 shows the bikeshed for Doris Dickson Elementary School. The bikeshed shows the area which a student can bike one mile from the school.

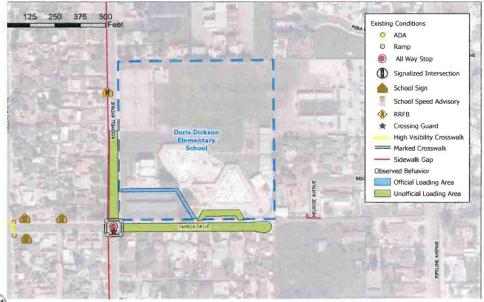
Doris Dickson Elementary School is accessed via Pamela Drive and Roswell Avenue. Figure 4.17.13 illustrates the existing conditions and the behaviors observed during the mobility assessment.

There is currently one crossing guard at the intersection of Pamela Drive and Roswell Avenue, which is an all-way stop-controlled intersection with low-visibility crosswalks and signage. The following signs are present along the east and west side of Roswell Avenue and north and south side of Pamela Drive:

Parents dropping off their student are noted to park along the west side of Roswell Avenue and cross the street with their children at unmarked segments of Roswell Avenue.

Pick-up currently occurs primarily at the school parking lot pick-up and drop-off loop on Pamela Drive. During the site visit, parents were observed arriving nearly 15 minutes prior to the dismissal bell. The bus loading zone is located on the east side of Roswell Avenue near the exit of the pick-up and drop-off loop. Many parents were seen dropping off students at the official unloading area right in front of the school, while other parents were seen dropping off within the emergency vehicle loop on Pamela Drive. School staff recognize that vehicles use unofficial spots to drop off students such as the bus loading zone, the onstreet curbsides of Roswell Avenue and Pamela Drive, and the travel lanes within the school's parking lot loop. Parents also park in the red curb/ fire lane areas on Roswell Avenue near the exit of the driveway loop.

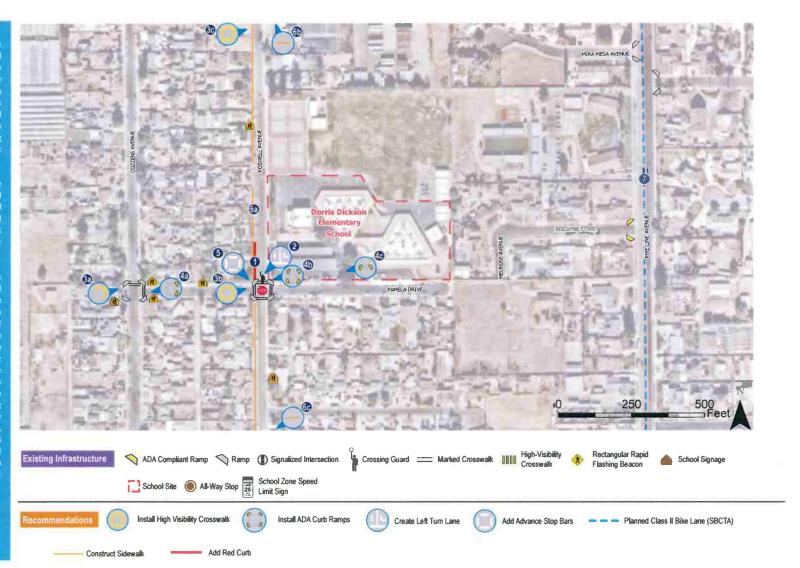
A dedicated southbound left-turn lane is recommended at the intersection of Roswell Avenue and Pamela Drive to assist with queuing issues in the southbound direction at the intersection due to the combination of through turning and left-turning vehicles in one lane. This would be coupled with red curb to prevent parking along the portion of the roadway leading to this intersection. Advance stop bars are recommended at all four legs of this intersection to add a buffer between pedestrians crossing and vehicles proceeding through the intersection. To improve visibility and accessibility, high visibility crosswalks. ADA-compliant curb ramps, and sidewalks are recommended at the school frontage and surrounding intersections. All recommendations are highlighted in Figure 4.17.17. A summary list of recommendations is provided Table 4.17.1.

ID	Improvement	Description	Location
1	Red Curb	Install red curb paint on west side of Roswell Avenue to accommodate a southbound left- turn lane.	Roswell Avenue (W) north of Pamela Drive
2	Pavement Markings	Add a southbound dedicated left-turn lane	Pamela Drive and Roswell Avenue
3a	High-Visibility Crosswalk	Install high-visibility crosswalk on north and east legs of the intersection	Cozzens Avenue and Pamela Drive
3b	High-Visibility Crosswalk	Install high-visibility crosswalk on all four legs of the intersection	Roswell Avenue and Pamela Drive
3с	High-Visibility Crosswalk	Install high-visibility crosswalk on the east and south legs of the intersection	Roswell Avenue and Riverside Drive
4a	ADA Compliant Curb Ramps	Install ADA compliant curb ramps on the southeast and northeast corners of the intersection	Cozzens Avenue and Pamela Drive
4b	ADA Compliant Curb Ramps	Install ADA compliant curb ramps on all four corners of the intersection	Roswell Avenue and Pamela Drive

4c	ADA Compliant Curb Ramps	Install ADA compliant curb ramps and applicable sidewalk to connect the existing internal crosswalk located at the west school driveway on Pamela Drive	Pamela Drive and West School Driveway
5	Advance Stop Bars	Install advance stop bars at the intersection	Roswell Avenue and Pamela Drive
6a	Sidewalk	Construct sidewalk	Roswell Avenue (W) from Riverside Drive to Chino Drive
6b	Sidewalk	Construct sidewalk	Riverside Drive from East End Avenue to Pipeline
6c	Sidewalk	Construct sidewalk	Chino Avenue from East End Avenue to Pipeline
7	Planned Class II Bike Lane (SBCTA)	Coordinate with SBCTA to construct Class II Bike Lanes per SBCTA planned bikeways	Pipeline Path from Francis Avenue to Drainage Channel

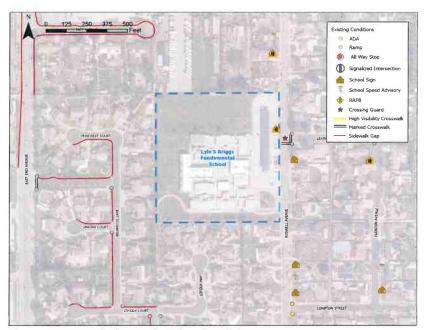
Figure 4.18.7 Existing Pedestrian Conditions

Figure 4.18,7 provides an overview of the existing pedestrian network and challenges observed and analyzed. The sidewalk network surrounding Lyle S. Briggs Fundamental School is incomplete. During the site visit, it was observed that there were missing sidewalks on East End Avenue, Pipeline Avenue, Francis Avenue, the north side of Philadelphia Street, and Roswell Avenue north of Francis Avenue and south of Philadelphia Street. Pedestrians contend with low visibility crossings, missing truncated domes, poor driving behavior, and minimal tree canopy.

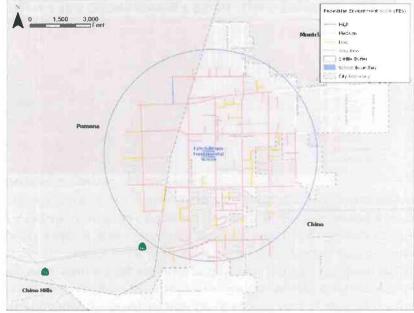
Figure 4.18.8 Pedestrian Evaluation Score

Challenges to walking were evaluated using the Pedestrian Evaluation Score (PES) developed by CR Associates. Based on the physical environment, surrounding land uses, and the street environment, a PES score was developed for nearby roadways. Figure 4.18.8 shows the results of the PES scoring. A sidewalk network with medium and high PES scores indicates relatively low stress for walking, whereas a low or very low PES score can be considered a stressful walking environment. With the exception of some residential streets, most of the streets nearby or adjacent to the school show very low PES scores. This indicates a stressful walking environment near the school and may create a barrier to walking.

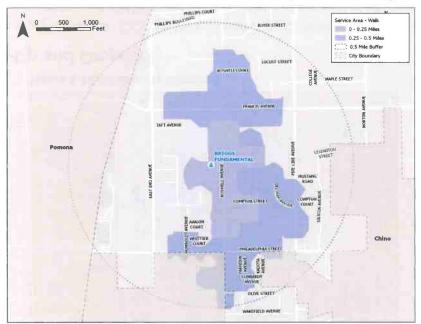
Figure 4.18.9 Existing Pedestrian Walkshed

Figure 4.18.9 shows the walkshed for Lyle S. Briggs Fundamental School. The walkshed shows the area where a student can walk 0.5 mile from the school. The walkshed has been reviewed for sidewalk connectivity and accessibility.

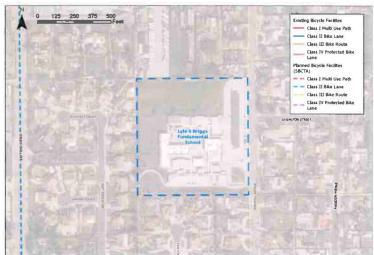
Figure 4.18.10 Existing and Planned Bicycle Condition

Currently, there are no bicycle facilities surrounding Lyle S. Briggs Fundamental School. The San Bernardino County Transportation Authority (SBCTA) plans to implement a Class II bike lane along East End Avenue (Figure 4.18.10).

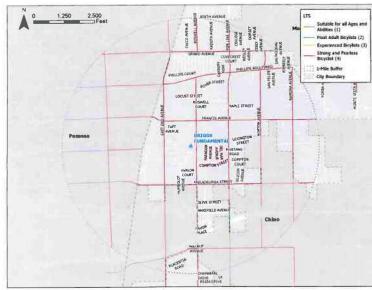
Figure 4.18.11 Bicycle Level of Traffic Stress

The bicycle environment was assessed using the bicycle Level of Traffic Stress (LTS) methodology for characterizing cycling environments, as developed by Mekuria, et al (2012) of the Mineta Transportation Institute. LTS classifies the street network into categories according to the level of stress it causes cyclists, taking into account a number of factors. The LTS assessment conducted by MBI concluded that the roads immediately surrounding Lyle S. Briggs Fundamental School have LTS scores of 2 and 4 indicating a combination of low and high stress levels for cyclists (Figure 4.18.11).

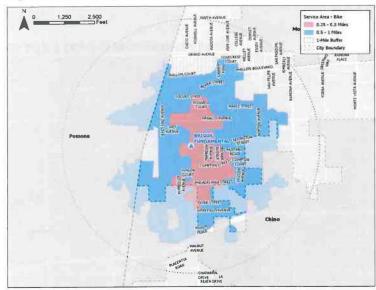
Figure 4.18.12 Existing Bikeshed

Figure 4.18.12 shows the bikeshed for Lyle S. Briggs Fundamental School. The bikeshed shows the area which a student can bike 1.0 mile from the school.

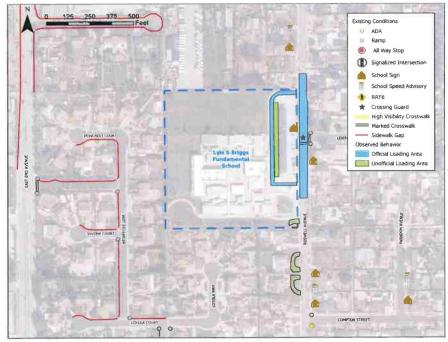
Figure 4.18.13 Existing Pick-Up and Drop-Off Vehicle Behavior

Lyle S. Briggs Fundamental School is accessed via Roswell Avenue. Figure 4.18.13 illustrates the existing conditions and the behaviors observed during the mobility assessment.

There is currently one crossing guard at the intersection of Roswell Avenue and Lexington Avenue, which is a side-street stop controlled intersection with low-visibility crosswalks and signage. The following signs are present along the east and west side of Roswell Avenue:

Parents dropping off their children are advised to park along the east side of Roswell Avenue and cross the street with their children. Drop-off currently occurs primarily at the school parking lot drop-off/pick-up loop on Roswell Avenue or along Roswell Avenue. During the site visit, parents were observed arriving nearly 15 minutes prior to the first bell. Many parents were seen dropping off students at the official unloading area along Roswell Avenue. The bus loading zone is located within the pick-up/drop-off loop on Roswell Avenue. School staff recognize that vehicles use unofficial spots to drop off students such as the travel lanes within the school loop, the entrance of the closed loop south of the school, the red curb zones, and private residential driveways on Roswell Avenue.

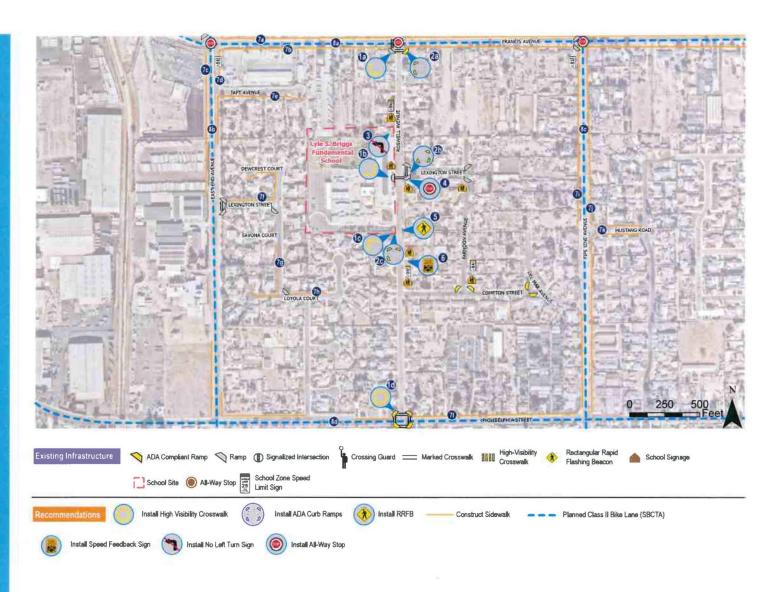
LYLE S. BRIGGS FUNDAMENTAL SCHOOL

A speed feedback sign is recommended along Roswell Avenue to discourage speeding. To improve visibility and accessibility, high visibility crosswalks, ADA-compliant curbramps, and sidewalks are recommended at the school frontage and surrounding intersections. Planned Class II bike lanes are recommended along East End Avenue, Francis Avenue, Pipeline Avenue, and Philadelphia Street in accordance with SBCTA's plans. An all-way stop is recommended at the intersection of exington Street and Roswell Avenue, pending further analysis. A Rectangular Rapid Flashing Beacon (RRFB) crossing is recommended at the intersection of Roswell Avenue and the South School Driveway to increase crossing opportunities along Roswell Avenue. These recommendations are highlighted in Figure 4.18.17. A summary list of recommendations is provided Table 4.18.1.

ID	Improvement	Description	Location
1a	High-Visibility Crosswalk	Install high-visibility crosswalk on south and west legs of the intersection	Francis Avenue and Roswell Avenue
1b	High-Visibility Crosswalk	Install high-visibility crosswalk on south and east legs of the intersection	Lexington Avenue and Roswell Avenue
1c	High-Visibility Crosswalk	Install high-visibility crosswalk on north and west legs of the intersection	Roswell Avenue and South School Driveway
1d	High-Visibility Crosswalk	Install high-visibility crosswalk on all legs of the intersection	Roswell Avenue at Philadelphia Street
2a	ADA Compliant Curb Ramps	Install ADA compliant curb ramps on the northwest and southwest corners of the intersection	Francis Avenue and Roswell Avenue
2b	ADA Compliant Curb Ramps	Install ADA compliant curb ramps on the northeast, southeast, and southwest corners of the intersection	Lexington Avenue and Roswell Avenue

2c	ADA Compliant Curb Ramps	Install ADA compliant curb ramps on the northwest, northeast, and southwest corners of the intersection	Roswell Avenue and South School Driveway
3	No Left-Turn Sign	Install signage to restrict northbound left-turns at the intersection	Roswell Avenue and North School Driveway
4	All-Way Stop	Add all-way stop (*)	Roswell Avenue/Lexington Street
5	Rectangular Rapid Flashing Beacon (RRFB)	Add RRFB crossing	Roswell Avenue and South School Driveway
6	Speed Feedback Sign	Add a speed feedback sign on Roswell Avenue.	Roswell Avenue between South School Driveway and Compton Street
7a	Sidewalk	Construct sidewalk	Francis Avenue (N) between East End Avenue and Norton Avenue
7b	Sidewalk	Construct sidewalk	Francis Avenue (S) between East End Avenue and Norton Avenue
7c	Sidewalk	Construct sidewalk	East End Avenue (W) from Francis Avenue to Philadelphia Street
7d	Sidewalk	Construct sidewalk	East End Avenue (E) from Francis Avenue to Philadelphia Street

7e	Sidewalk	Construct sidewalk	Taft Avenue (S) east of East End Avenue
7f	Sidewalk	Construct sidewalk	Dewcrest Court (S) and Lexington Street (N) east of East End Avenue
7g	Sidewalk	Construct sidewalk	Briar Rose Lane (W) between Dewcrest Lane and Loyola Court
7h	Sidewalk	Construct sidewalk	Loyola Court (N) west of Humbolt Place
7i	Sidewalk	Construct sidewalk	Pipeline Avenue (W) between Francis Avenue and Philadelphia Street
7j	Sidewalk	Construct sidewalk	Pipeline Avenue (E) between Francis Avenue and Philadelphia Street
7k	Sidewalk	Construct sidewalk	Mustang Road (N and S) between Pipeline Avenue and Silicon Avenue

ID	Improvement	Description	Location
71	Sidewalk	Construct sidewalk	Philadelphia Street (N) between East End Avenue and Pipeline Avenue
8a	Planned Class II Bike Lane (SBCTA)	Coordinate with SBCTA to construct Class II Bike Lanes per SBCTA planned bikeways	Francis Avenue from .11m W East End Ave to .13m E Telephone
8b	Planned Class II Bike Lane (SBCTA)	Coordinate with SBCTA to construct Class II Bike Lanes per SBCTA planned bikeways	East End Avenue from Grand Avenue to Maxon Lane
8c	Planned Class II Bike Lane (SBCTA)	Coordinate with SBCTA to construct Class II Bike Lanes per SBCTA planned bikeways	Pipeline Path from Francis Avenue to Drainage Channel
8d	Planned Class II Bike Lane (SBCTA)	Coordinate with SBCTA to construct Class II Bike Lanes per SBCTA planned bikeways	Philadelphia Street from W County Limit

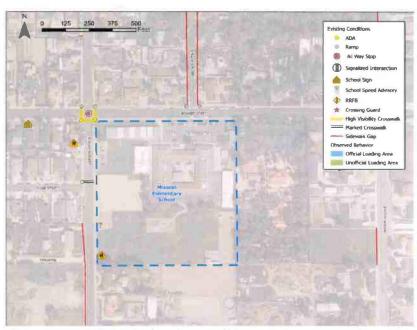
Figure 4.19.7 Existing Pedestrian Conditions

Figure 4.19.7 provides an overview of the existing pedestrian network and challenges observed and analyzed. The sidewalk network surrounding Mission Elementary School is incomplete. During the site visit, it was observed that there were no sidewalks on the east and west sides of Bel Air Avenue north of Howard Street, the west side of Vernon Avenue south of Clair Street and the north and sides of Phillips Boulevard within the school vicinity There are no crossing guards and the Principal reported that most students live east of the school on, or east of Benson Avenue, a busy north-south roadway.

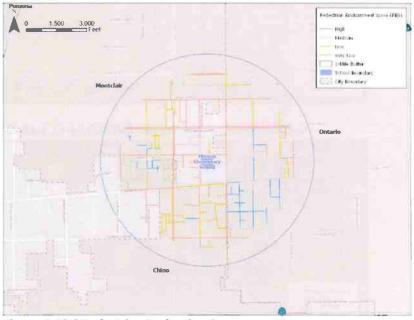
Figure 4.19.8 Pedestrian Evaluation Score

Challenges to walking were evaluated using the Pedestrian Evaluation Score (PES) developed by CR Associates. Based on the physical environment, surrounding land uses, and the street environment, a PES score was developed for nearby roadways. Figure 4.19.8 shows the results of the PES scoring. A sidewalk network with medium and high PES scores indicates relatively low stress for walking, whereas a low or very low PES score can be considered a stressful walking environment. The roadways near Mission Elementary School show primarily low PES scores, with very low scores on Howard Street, Mission Boulevard, Central Avenue, and Benson Avenue. This indicates a stressful walking environment near the school along these roadways and may create a barrier to walking.
