SB COUNTY PROPERTY ASSESSMENT - 303 W. 5TH STREET

Date: September 19, 2023
Job Number: 23005335.00
Engineer: Craig Chamberlain, S.E.
PE Number/State: CA SE 4588

MODIFIED FEMA-310 WORKSHEET

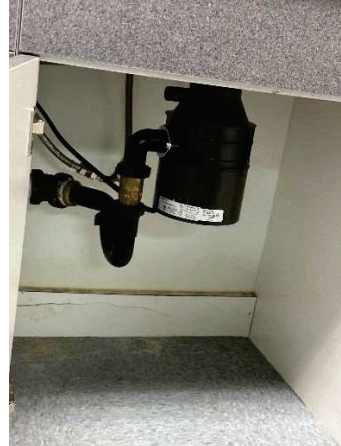
P14 – existing sink disposal

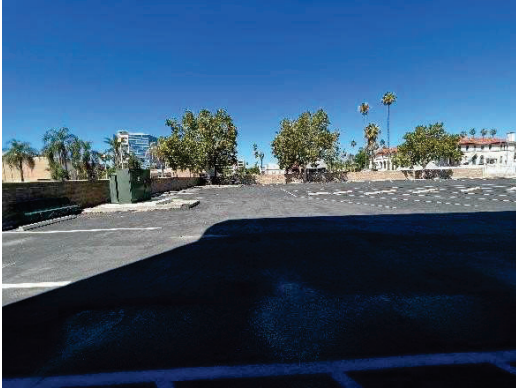
E1 - SCE Utility Transformer 500KVA, 12KU - 480/277V #P5055246 with 8' x 10' Slab box @ Parking Lot

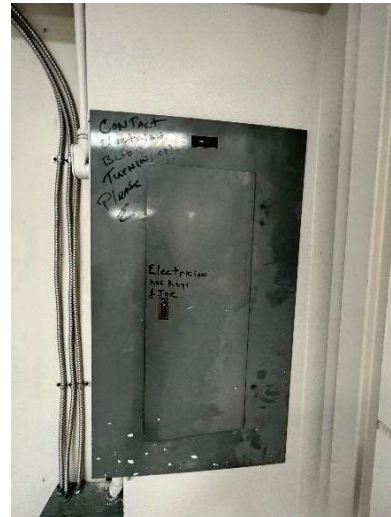
E6 - Panel LA 3P225A, 120/208V, 3P, 4W @ 2nd Floor Stair Closet

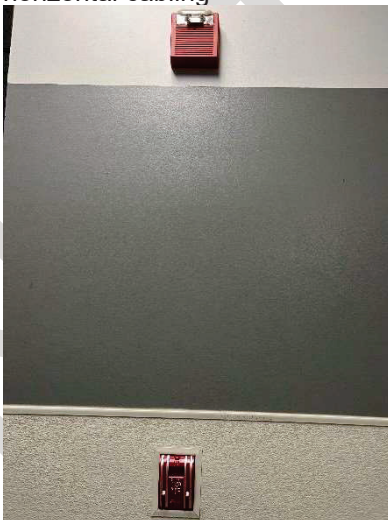
E34 - Fire Alarm Horn/Strobe and Fire Alarm Pull
Station
